IRONWOOD RESTORATION, LLC

The Pillsbury Bandstand

August 20, 2022

Within the following pages of this brief report, I have done my best to document and encompass the existing conditions of the Milford, NH bandstand in hopes that it will encourage and allow for the future restoration and preservation of this unique historic structure.

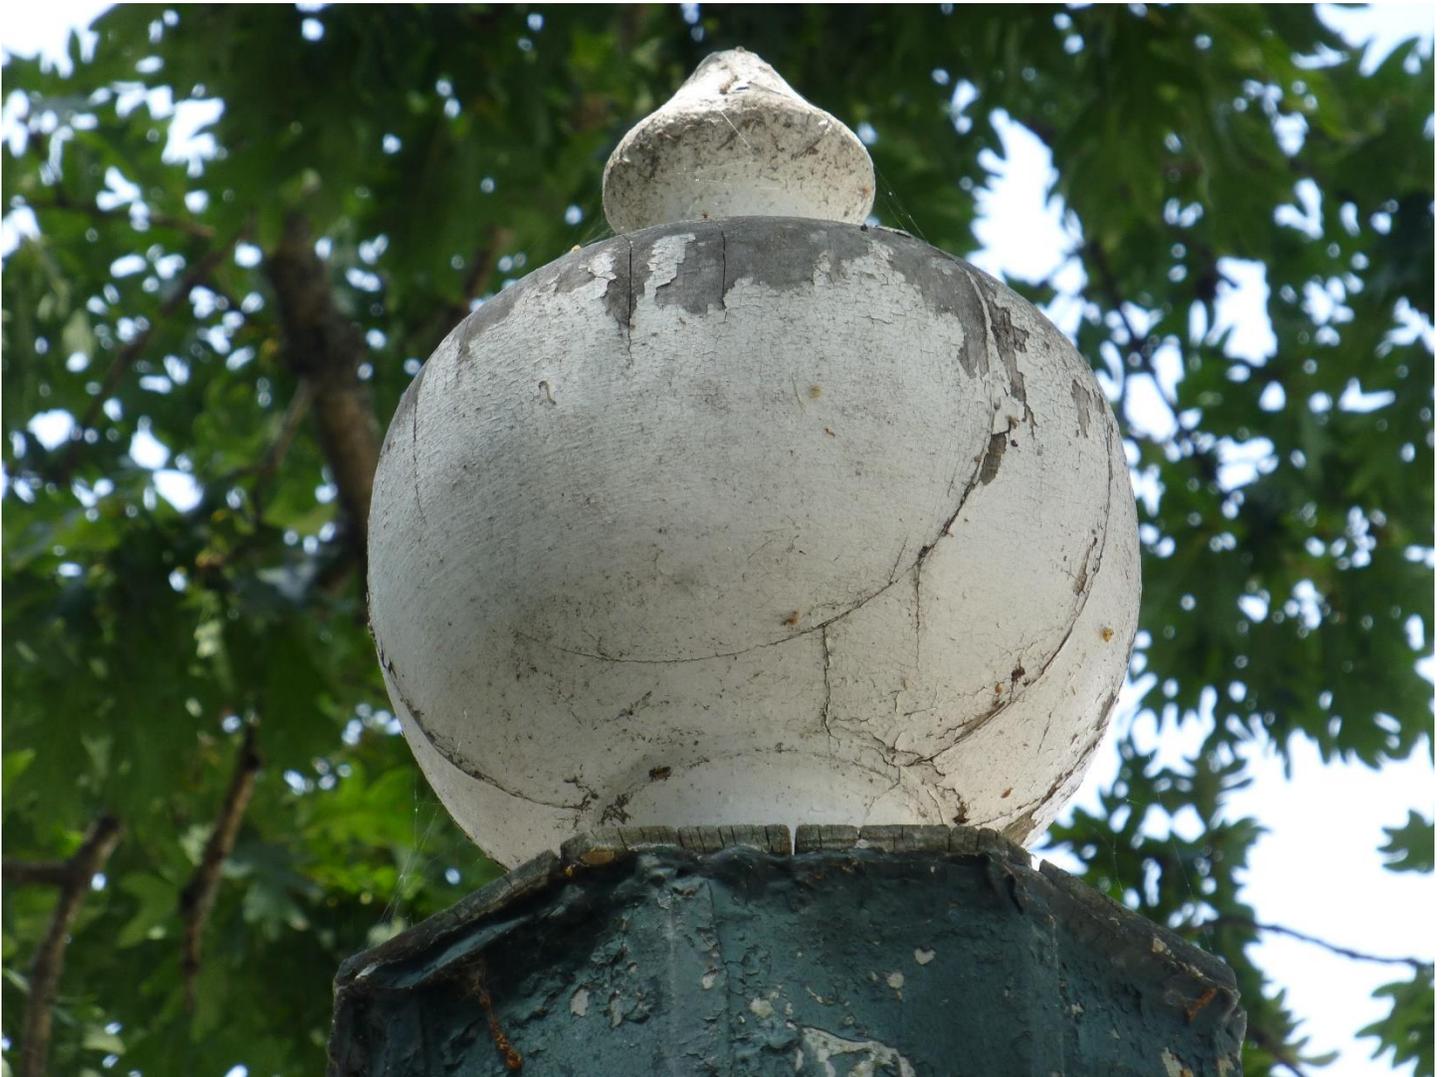
The band stand finial was replaced probably a few decades ago, from the few old photos that I have been able to view, it appears that it matches the original profile. One can see the glue lines from laminating multiple layers of wood together to form a large enough block to then turn the profile of the finial on a wood lathe (the original typically would have been one solid block). While the main body of the finial appears to be in fairly good shape, the finial base has substantial weather checking. The finial should be removed and stripped of all paint and repaired utilizing epoxy components.

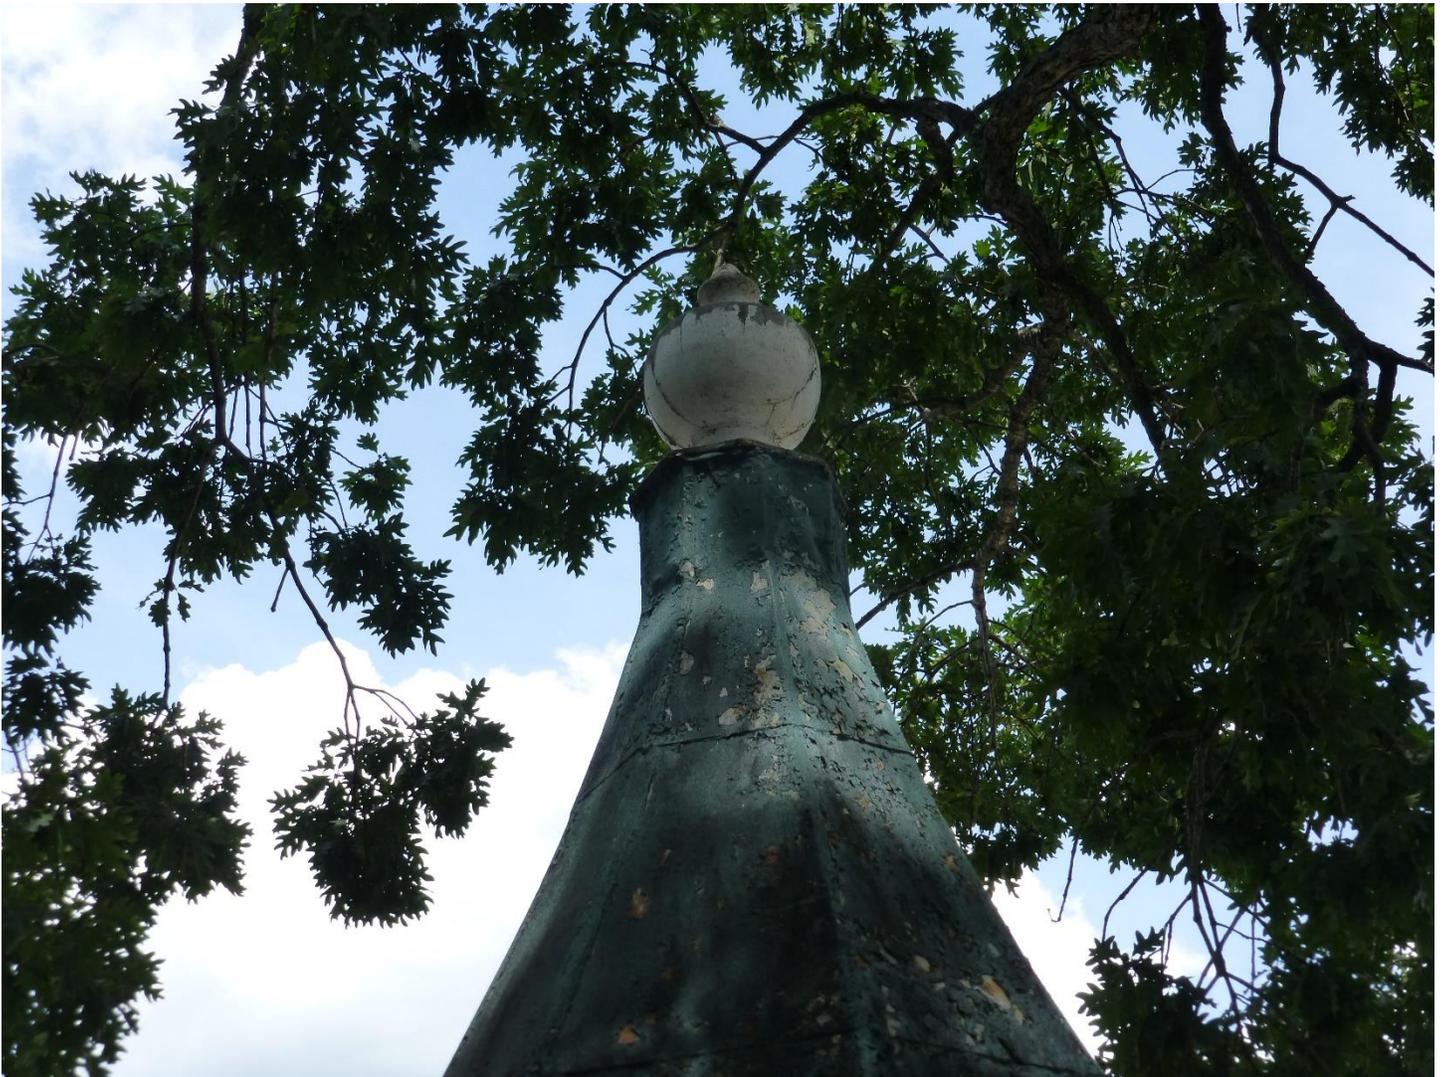
Upper area of roof with well-formed terne metal roofing. While the paint is failing the terne roofing in this area is in very good shape. As with other areas of the roof, loose paint should be removed down to solidly adhered material and the surface put through a series of processes resulting in application of new paint.

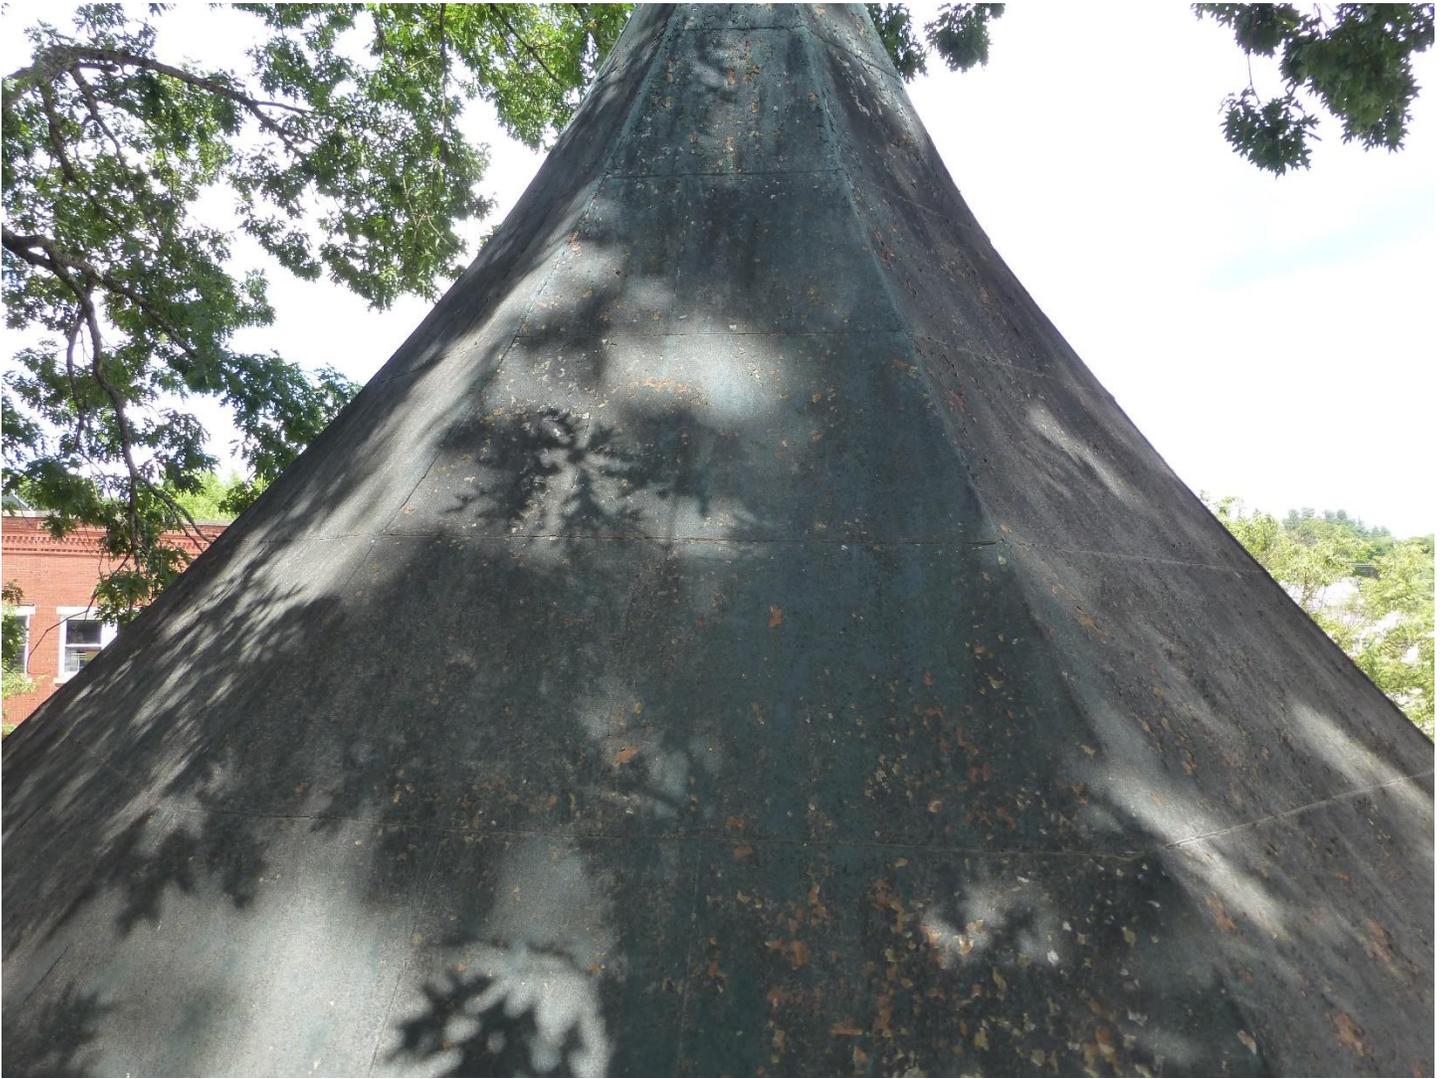
A view of the main body of the bandstand's roof, again showing the majority of the roof surface is in good condition. Not particularly easy to see in this photograph are the well-executed soldered seams.

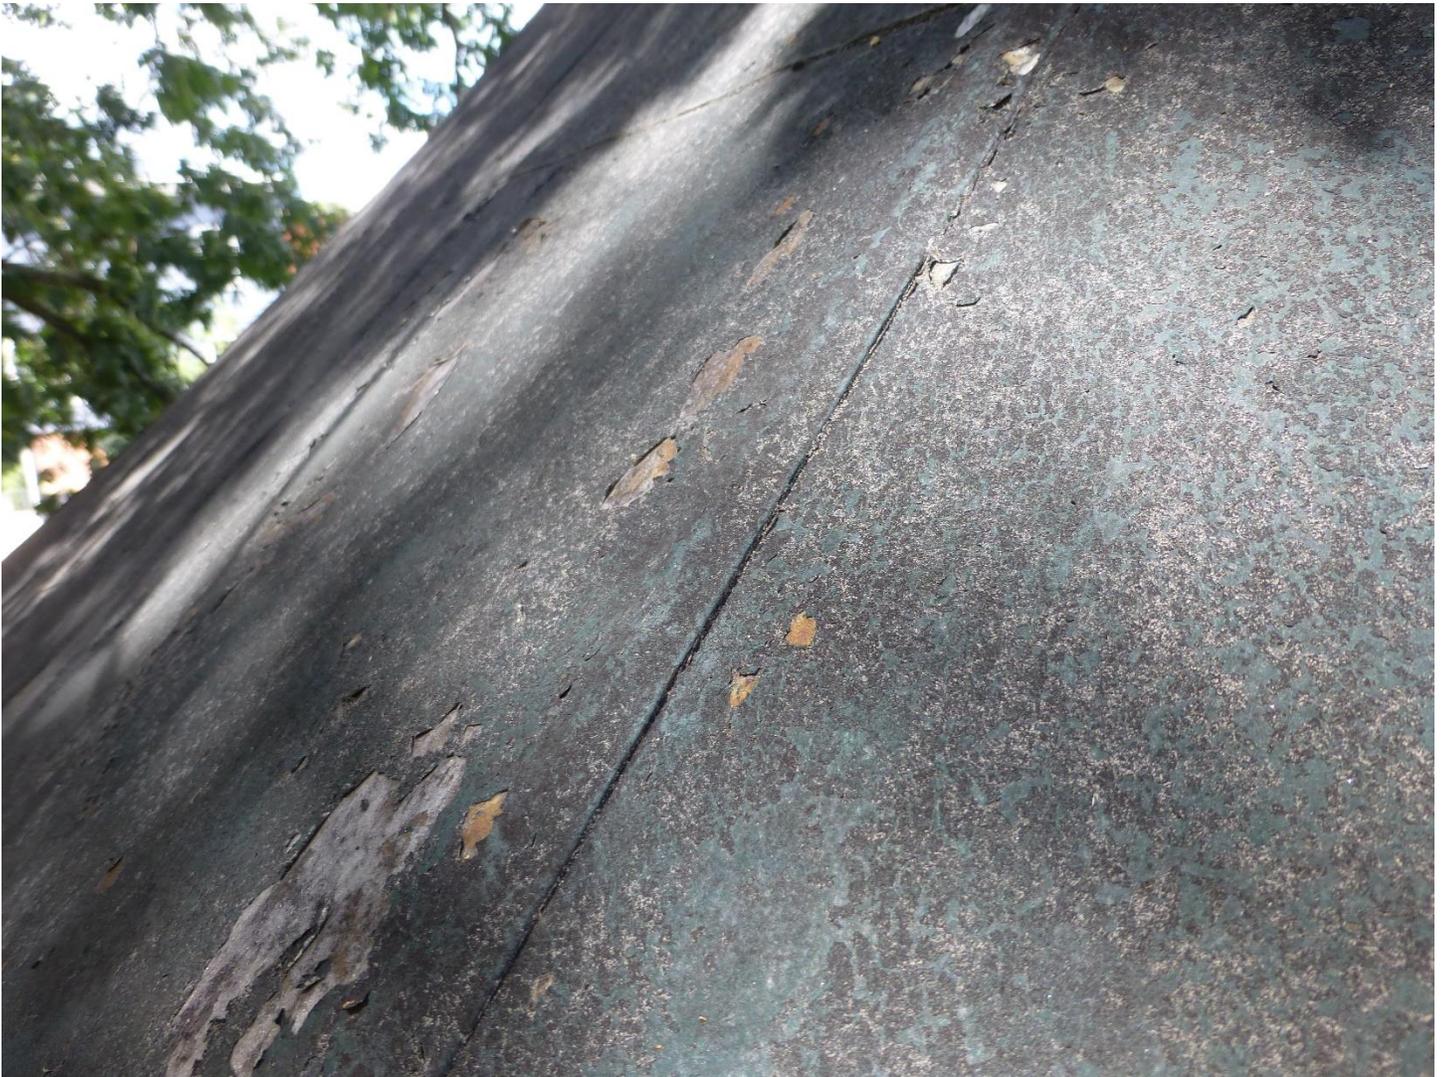
One example a soldered seam on the curved hip of the roof. The craftsmen who completed this work were certainly well versed in their trade. All seam lines viewed on the main body of the roof were well formed and still tight.

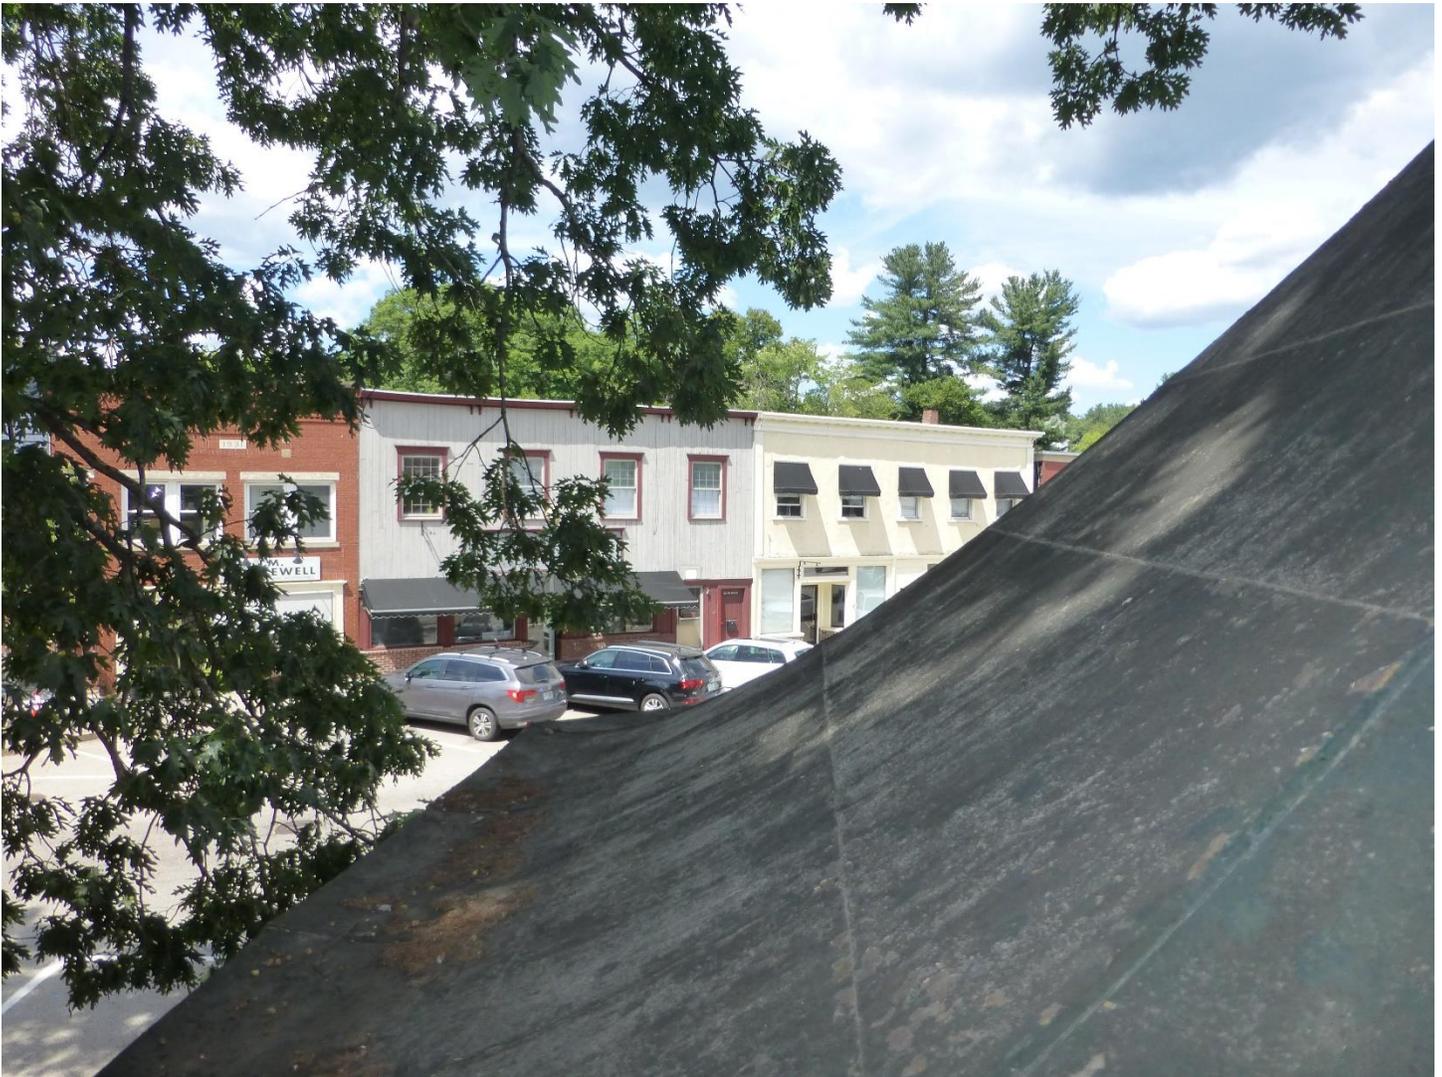
A better view of the lower curving of the bandstand roof, again seam lines are in excellent shape for their age. As one can imagine the lower portion of the roof has taken the brunt of New England weather.

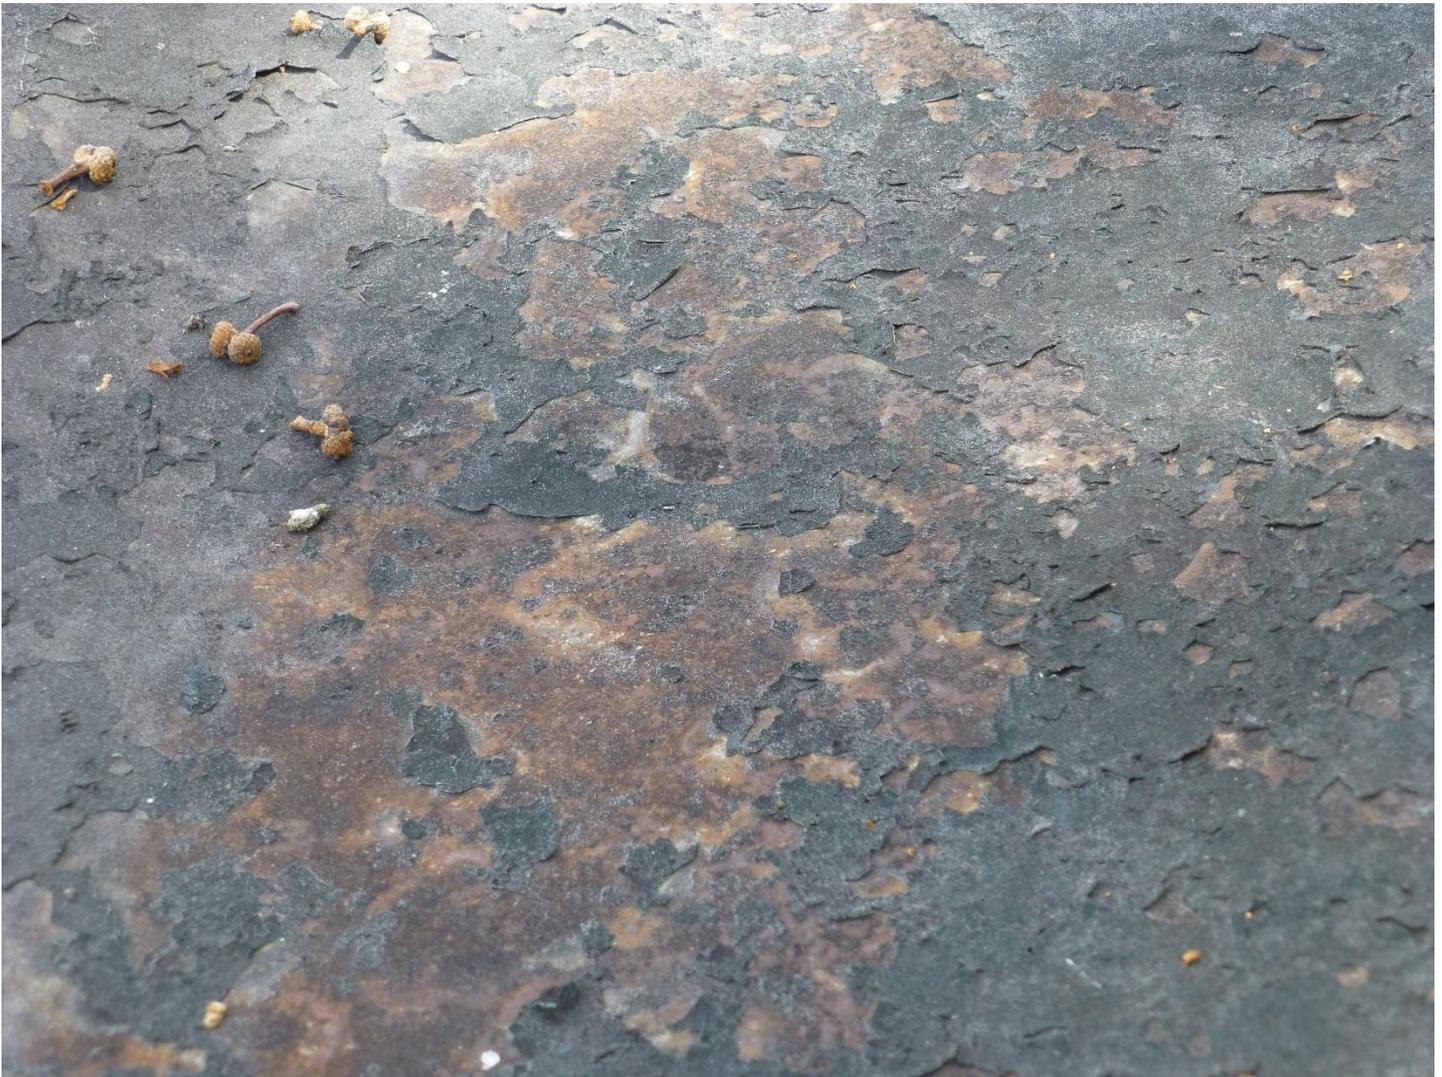
Surface rust was wide spread, more so on the lower less sloped areas of the roof. This can generally be cleaned up and coated with specific products once a treatment process has been established. Sadly, Follansbee Steel Corporation went out of business some time ago, no doubt this metal roof was produced by them. There are a few other manufacturers still producing Terne metal roofing and others who produce specific restorative coatings.

Currently all the issues I observed were on the lower more horizontal areas subject to more rain flow and standing snow. The main body of the roof does have surface rust in various areas; however, this should be able to be treated and then coated with paint formulated for terne roofs.

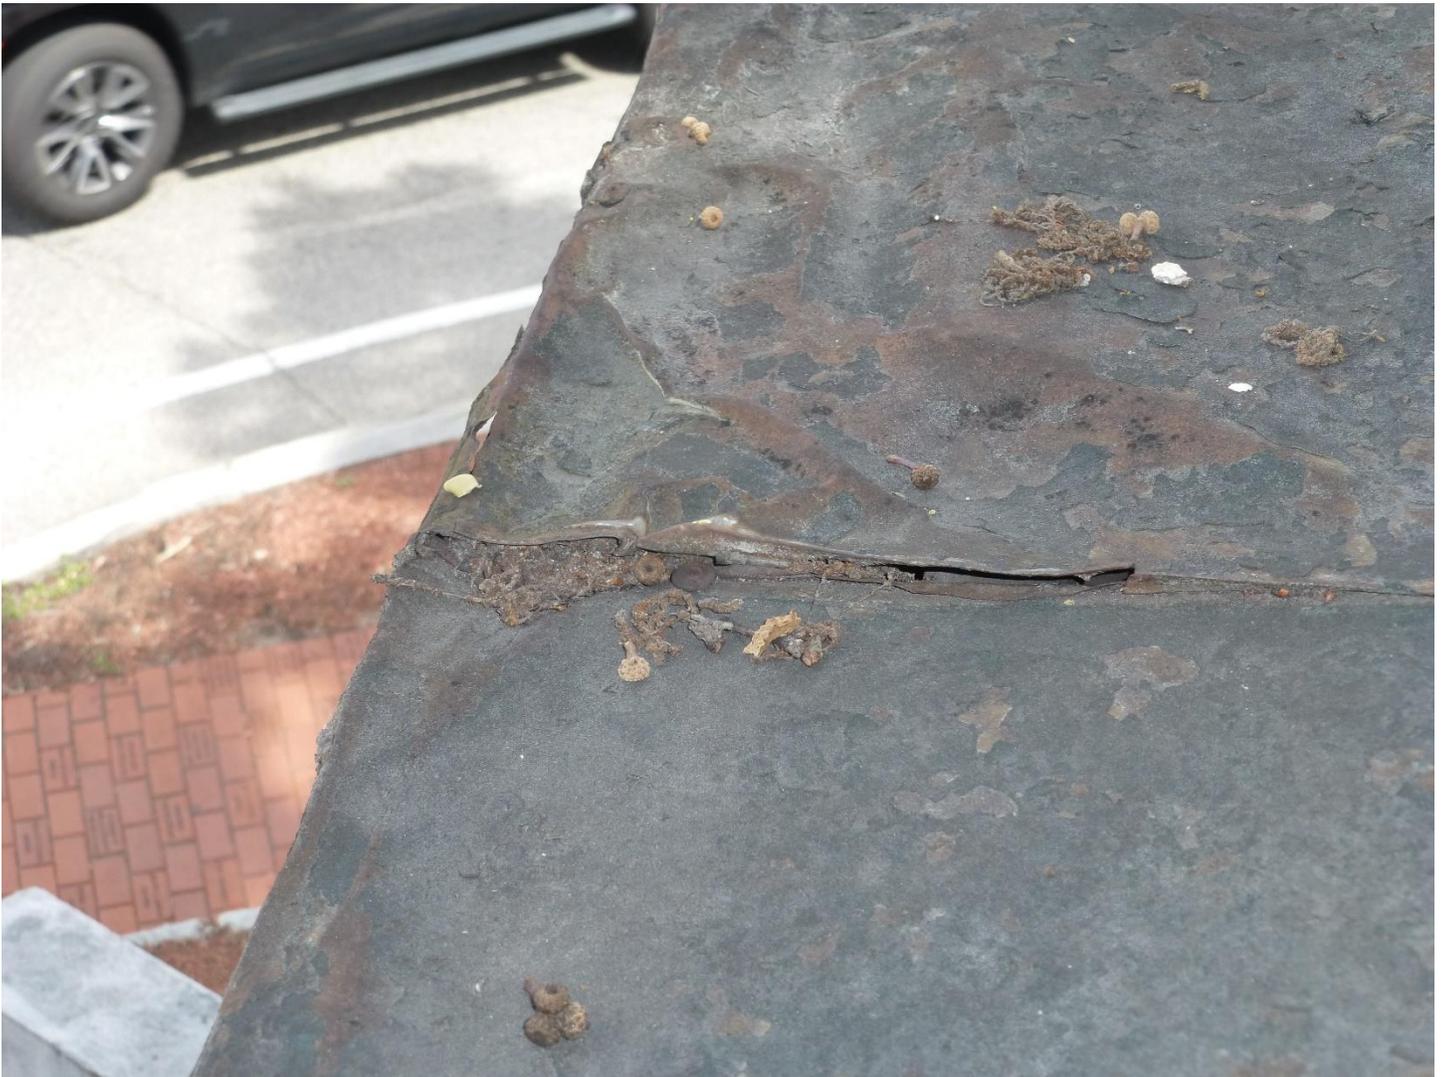
I did find a couple areas where the soldered seam has failed. This particular seam appears to have been damaged by some form of impact. I would then posit that perhaps the freeze-thaw cycles of ice on the lower areas of the roof slowly worked this area further apart over time. These areas should be able to be patched in utilizing an individual well versed in soldered seam metal roofing.

The lower damaged areas can be patched in, though one must find somebody who is familiar with the processes and preferably has an interest in historic roofing (and a decade or two of experience). Anybody that installs soldered seam copper would have the knowledge and respected skillset to complete these repairs. I have included sources for terne metal roofing on my reference page.

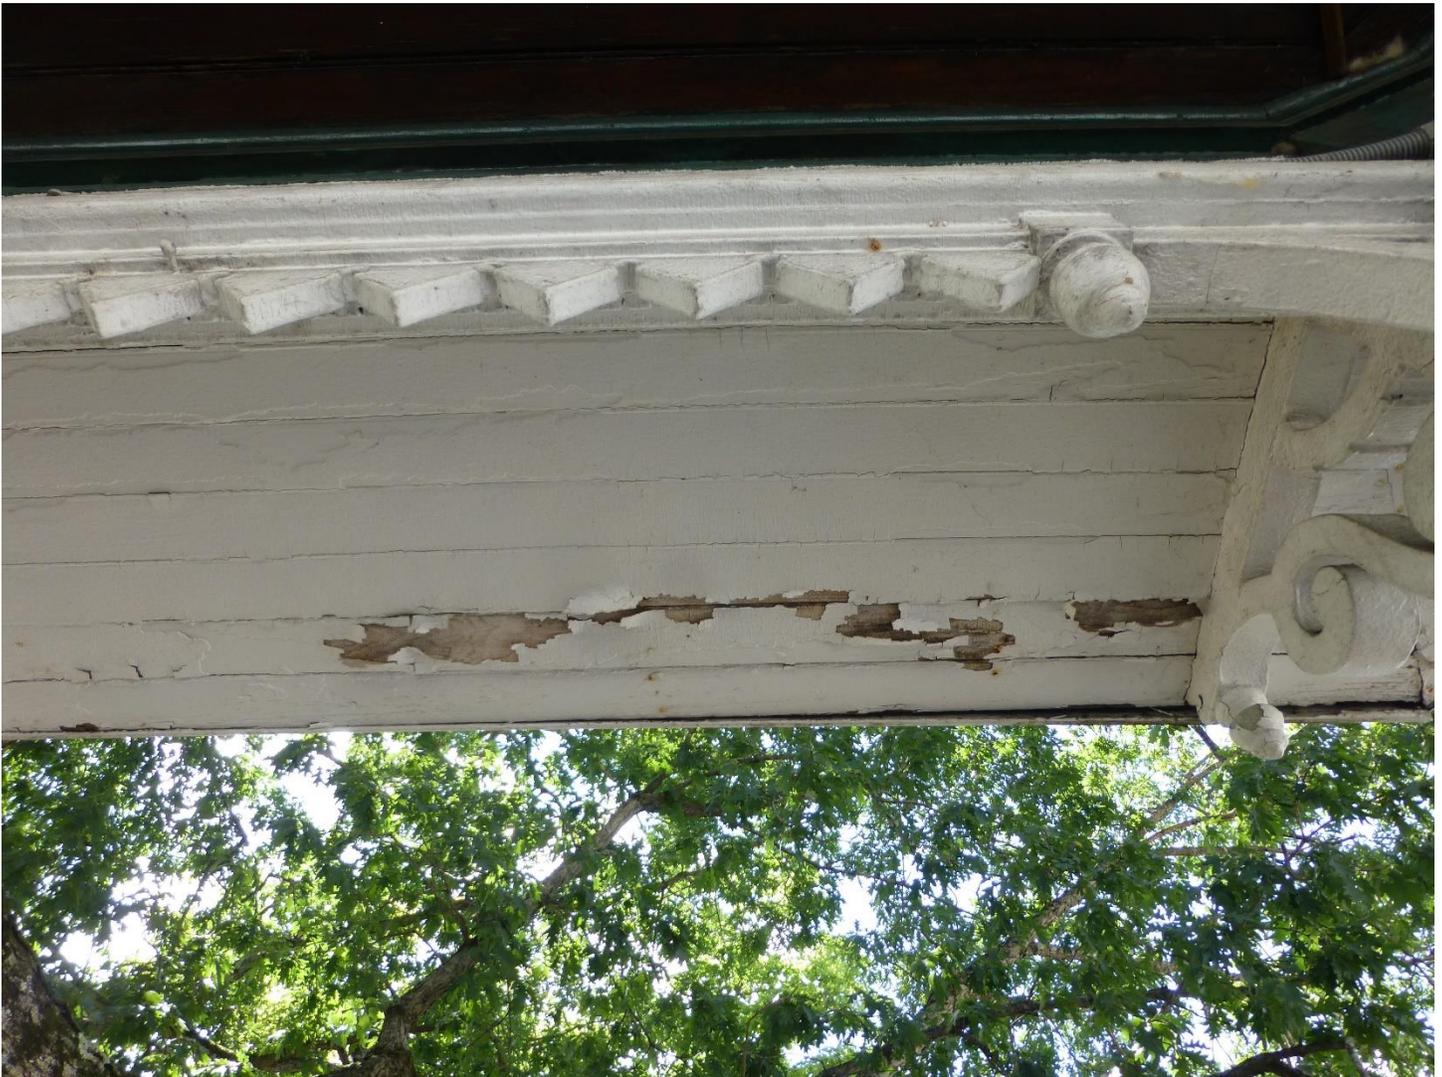
There are several areas of concern with regards to the soffit. Some are below the roof damage mentioned prior, other areas are taking on water due to the detached metal at the roof edge.

Due to the detached metal roofing along the roof edge and the inevitable windblown rain and snow, there are several areas of the original and replaced soffit that need attention. Again, epoxy is generally an easy approach to the repair of the original material that is failing. Though a more traditional approach is certainly available (and sometimes necessary) for this repair. This can be done by making up new edge-bead board that matches the original in species, (with good vertical grain) and a precise match to the complete profile (T&G, width, thickness and bead size). One can then cut out the damaged areas of the original edge-bead and fit and install the new material, typically with the help of a backer board set up and secured above the existing edged-bead. All the “new” edge-bead should be replaced with new stock that exactly matches the original as detailed above.

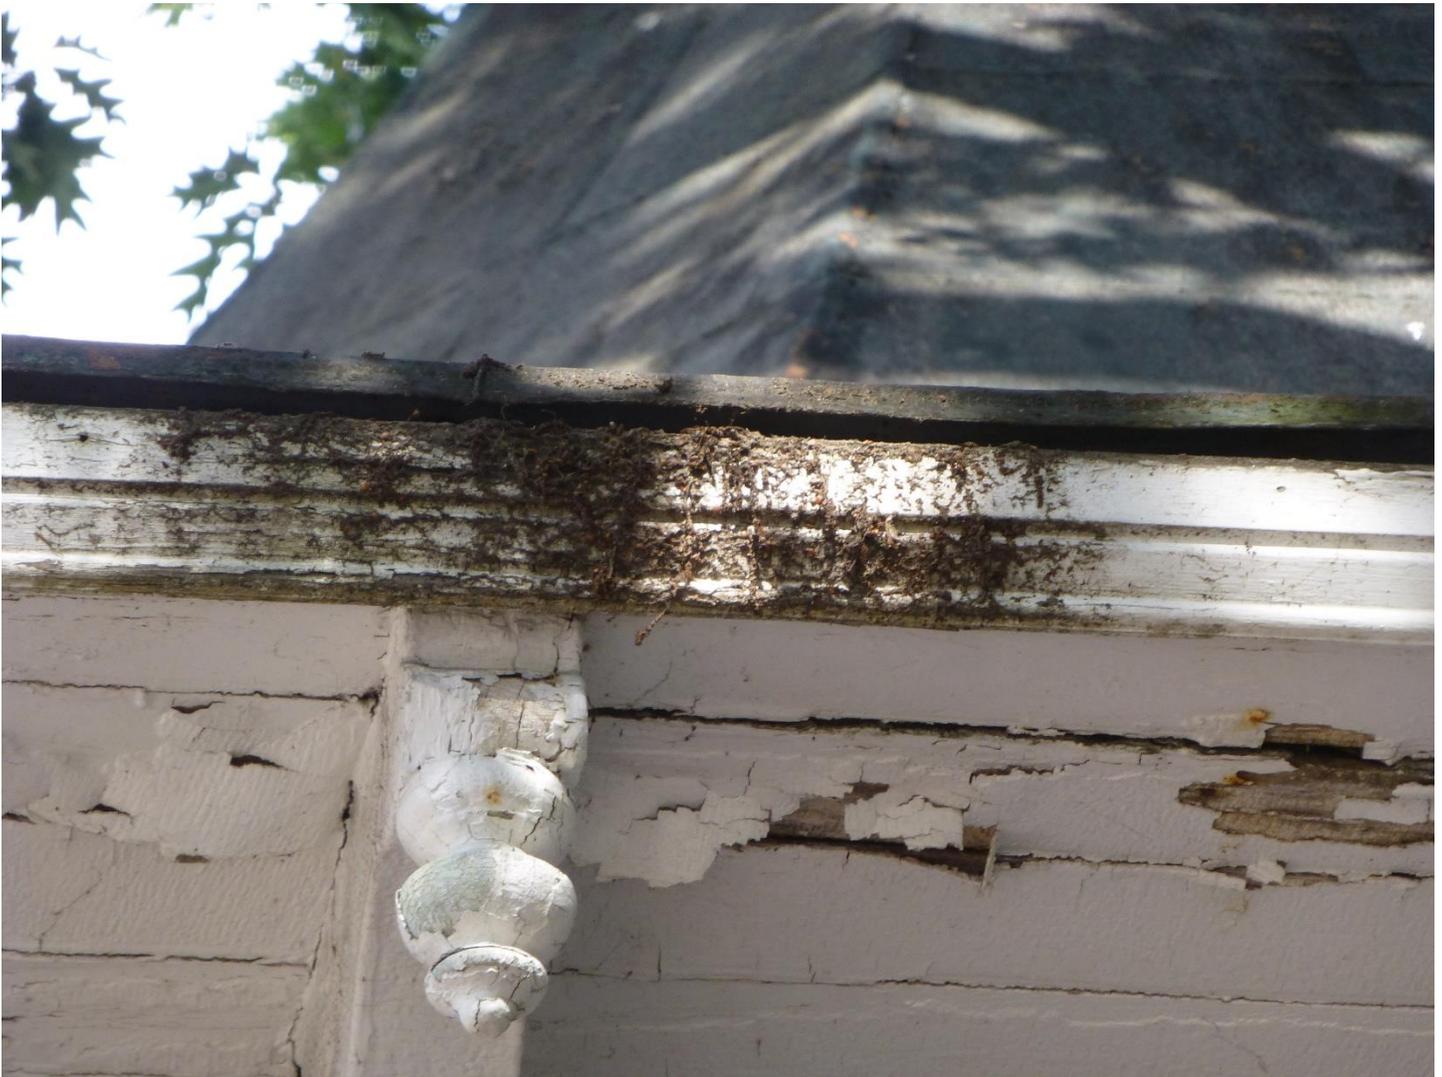
In this photo, the lip of the terne roof has separated from the profiled fascia allowing weather to take its toll on the fascia and the underlying beaded soffit. The terne roofing material and wood fascia have substantially different expansion and contraction coefficients. This combined with the relentless New England weather which over time will corrode most fasteners has led to the current situation in which much of the roof edge is no longer physically attached and many areas have separated upward from the fascia.

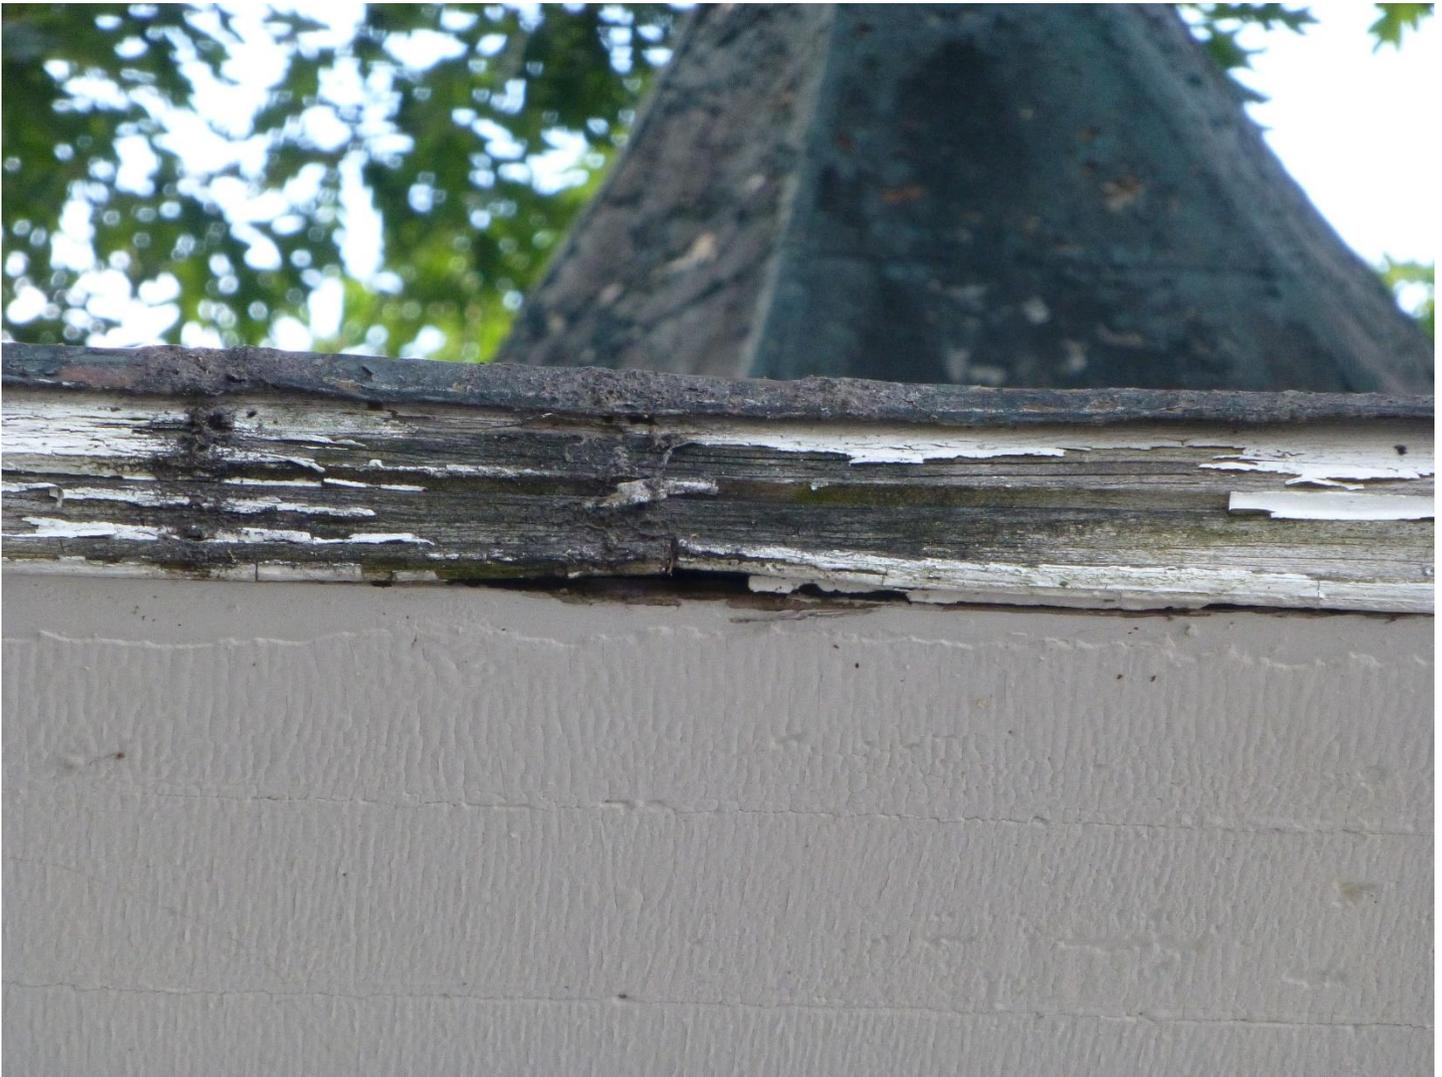
Here, the profiled fascia has taken on severe weathering and has started to deform. Though in a deteriorated state this section could probably be repaired utilizing epoxy consolidate and epoxy putty. This could be determined once the section is removed and more closely inspected. If not a candidate for epoxy repair, knives should be ground to precisely match the existing profile and new fascia made up utilizing the same species. In this particular case it would typically be Eastern White Pine. This should be clear vertical grain stock whenever possible. With narrow stock such as this it is typically fairly easy to find “quarter sawn” pieces by going through a pile of clear pine.

As noted in the photo section there are several decayed and/or damaged areas along the fascia and soffit. Some of the fascia may be repairable with epoxy, if not, a molding knife should be ground to match the existing profile and new fascia stock made up for replacement of the damaged areas. Again, keeping replacement to a minimum is the goal, thus keeping as much of the original fabric of the bandstand as possible.

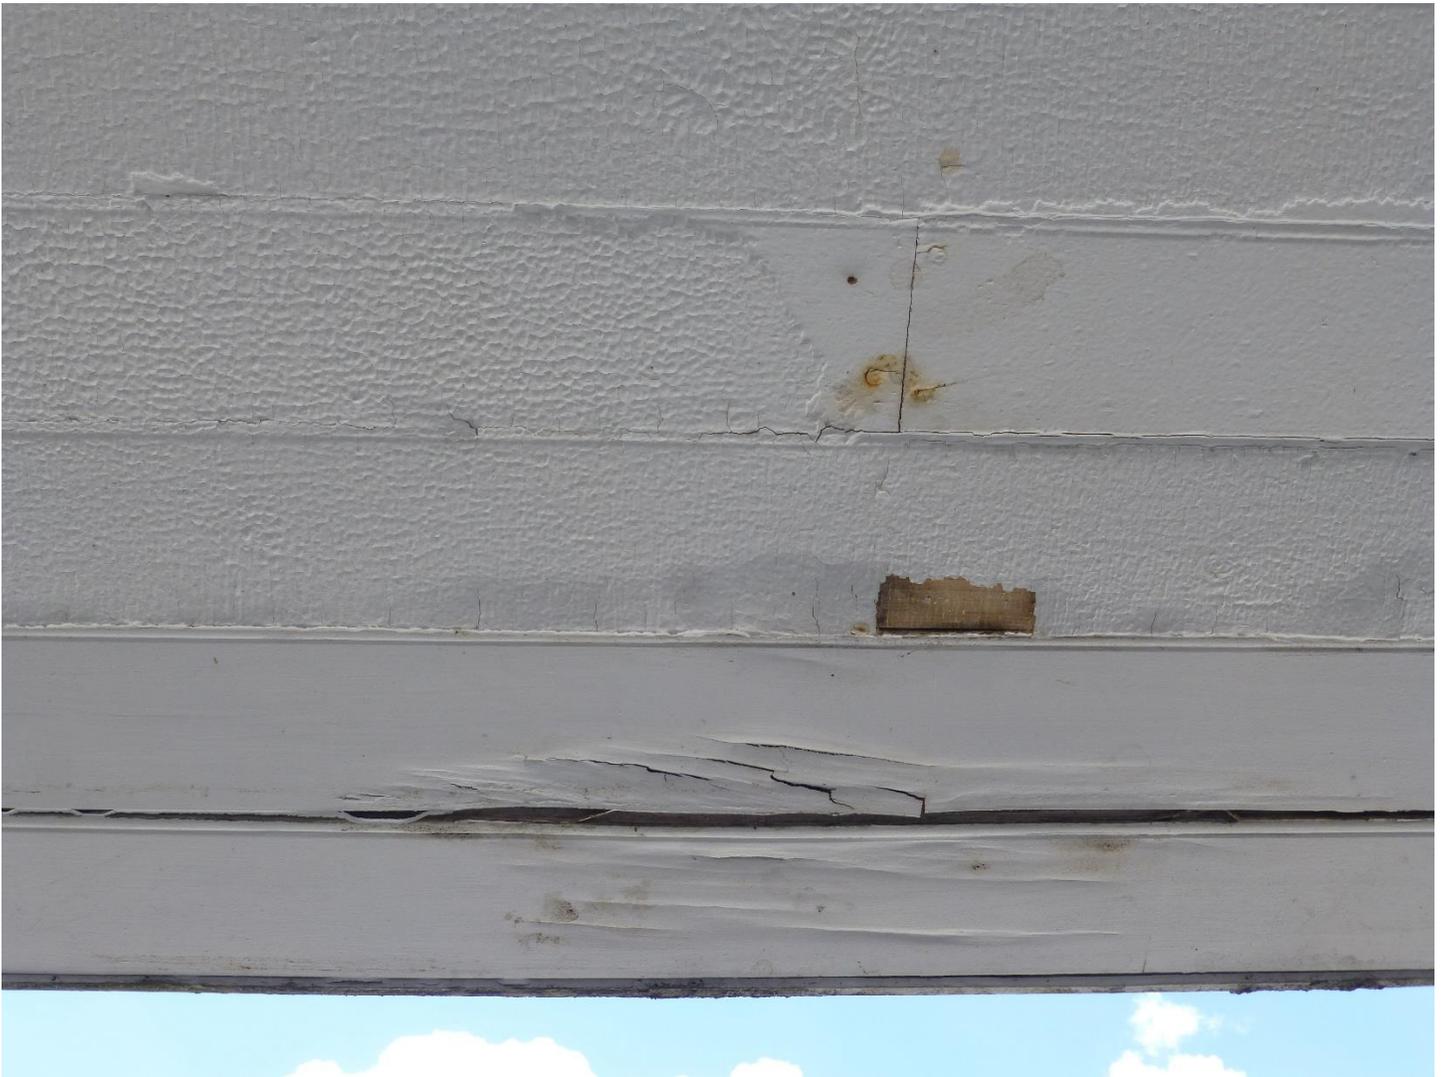
Apparently past soffit damage was repaired and the new repair has suffered the same fate. As mentioned prior much of the metal roofing lip has separated from the fascia allowing moisture of various sorts to enter. It's also important to note that care should be taken when matching existing materials and profiles, here (though hard to see in this photo) the edge bead size is noticeably different than the original. Best practice when completing preservation work is to match all profiles as precisely as possible, this respects the inherent architectural details of any particular historic property.

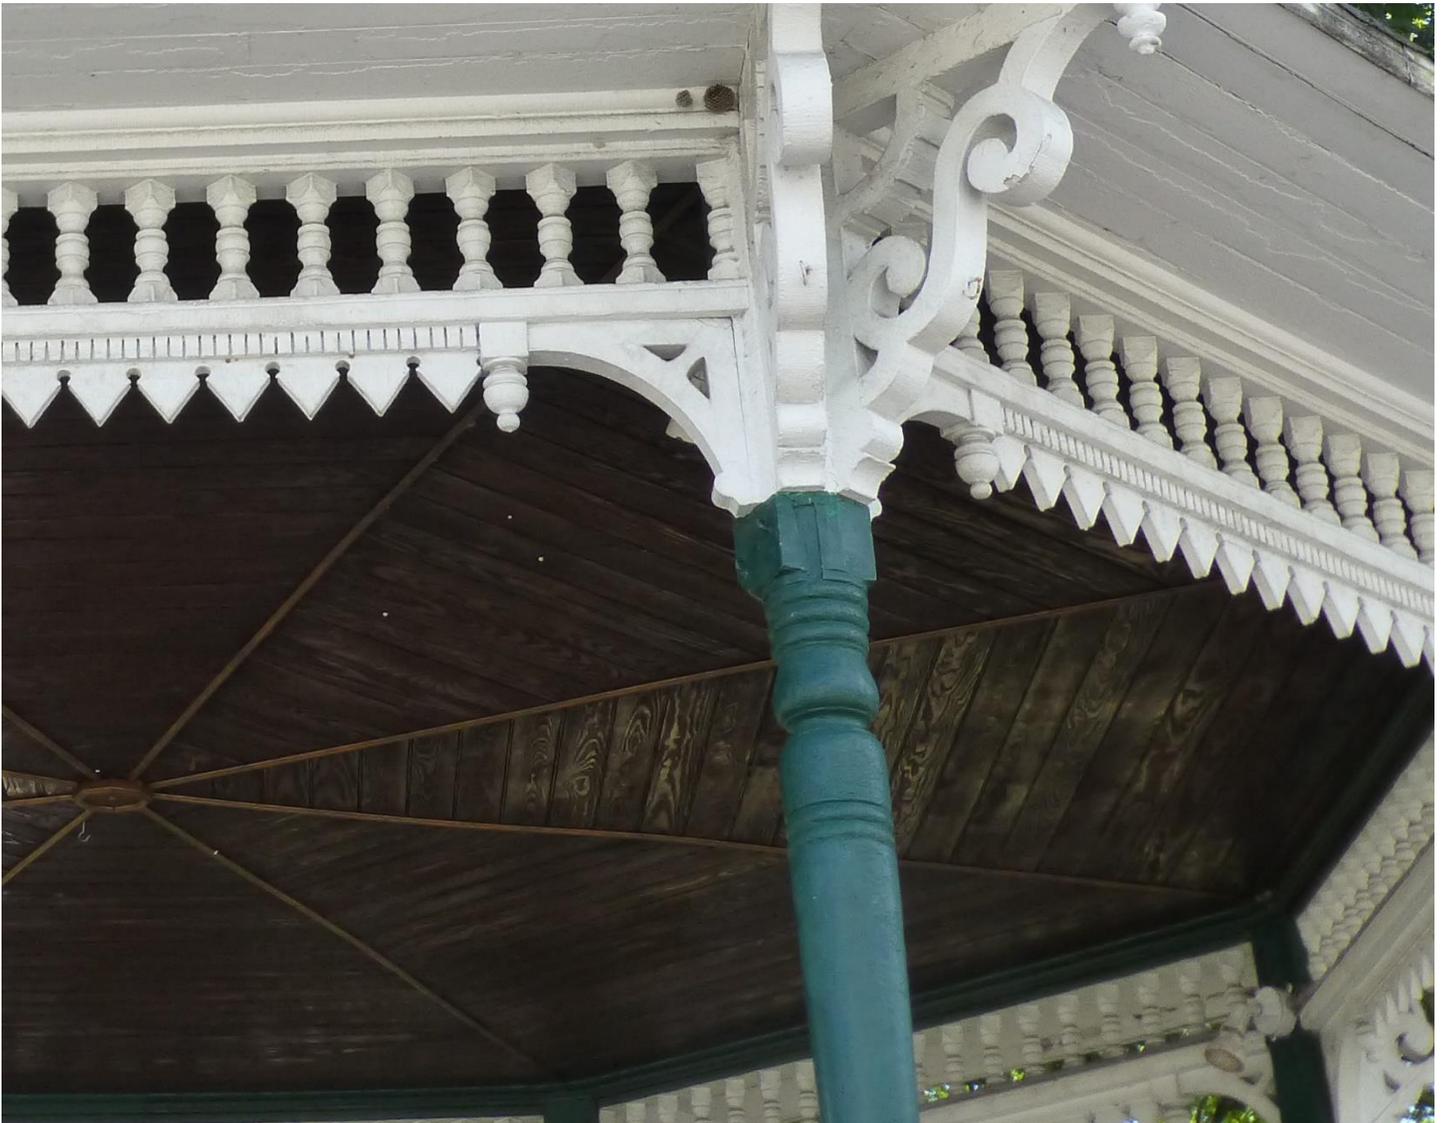
The area of concern here is the top of the post just above the decorative turned beads and below the bracketing. It would appear that the corner of the post has split off; perhaps at the annual growth rings though hard to tell, regardless, this can be easily repaired by scraping back all the paint in the affected area, drilling a number 1/4" holes (thereabouts) for a mechanical bond and either making up a new piece of material to match (and epoxying into place) or completing the repair with epoxy consolidate and putty. Once the epoxy is dry, carefully form the material to match the original profile. Typically posts of this period are turned from clear vertical grain Douglas Fir, however, whatever the species might be, one would want to match it.

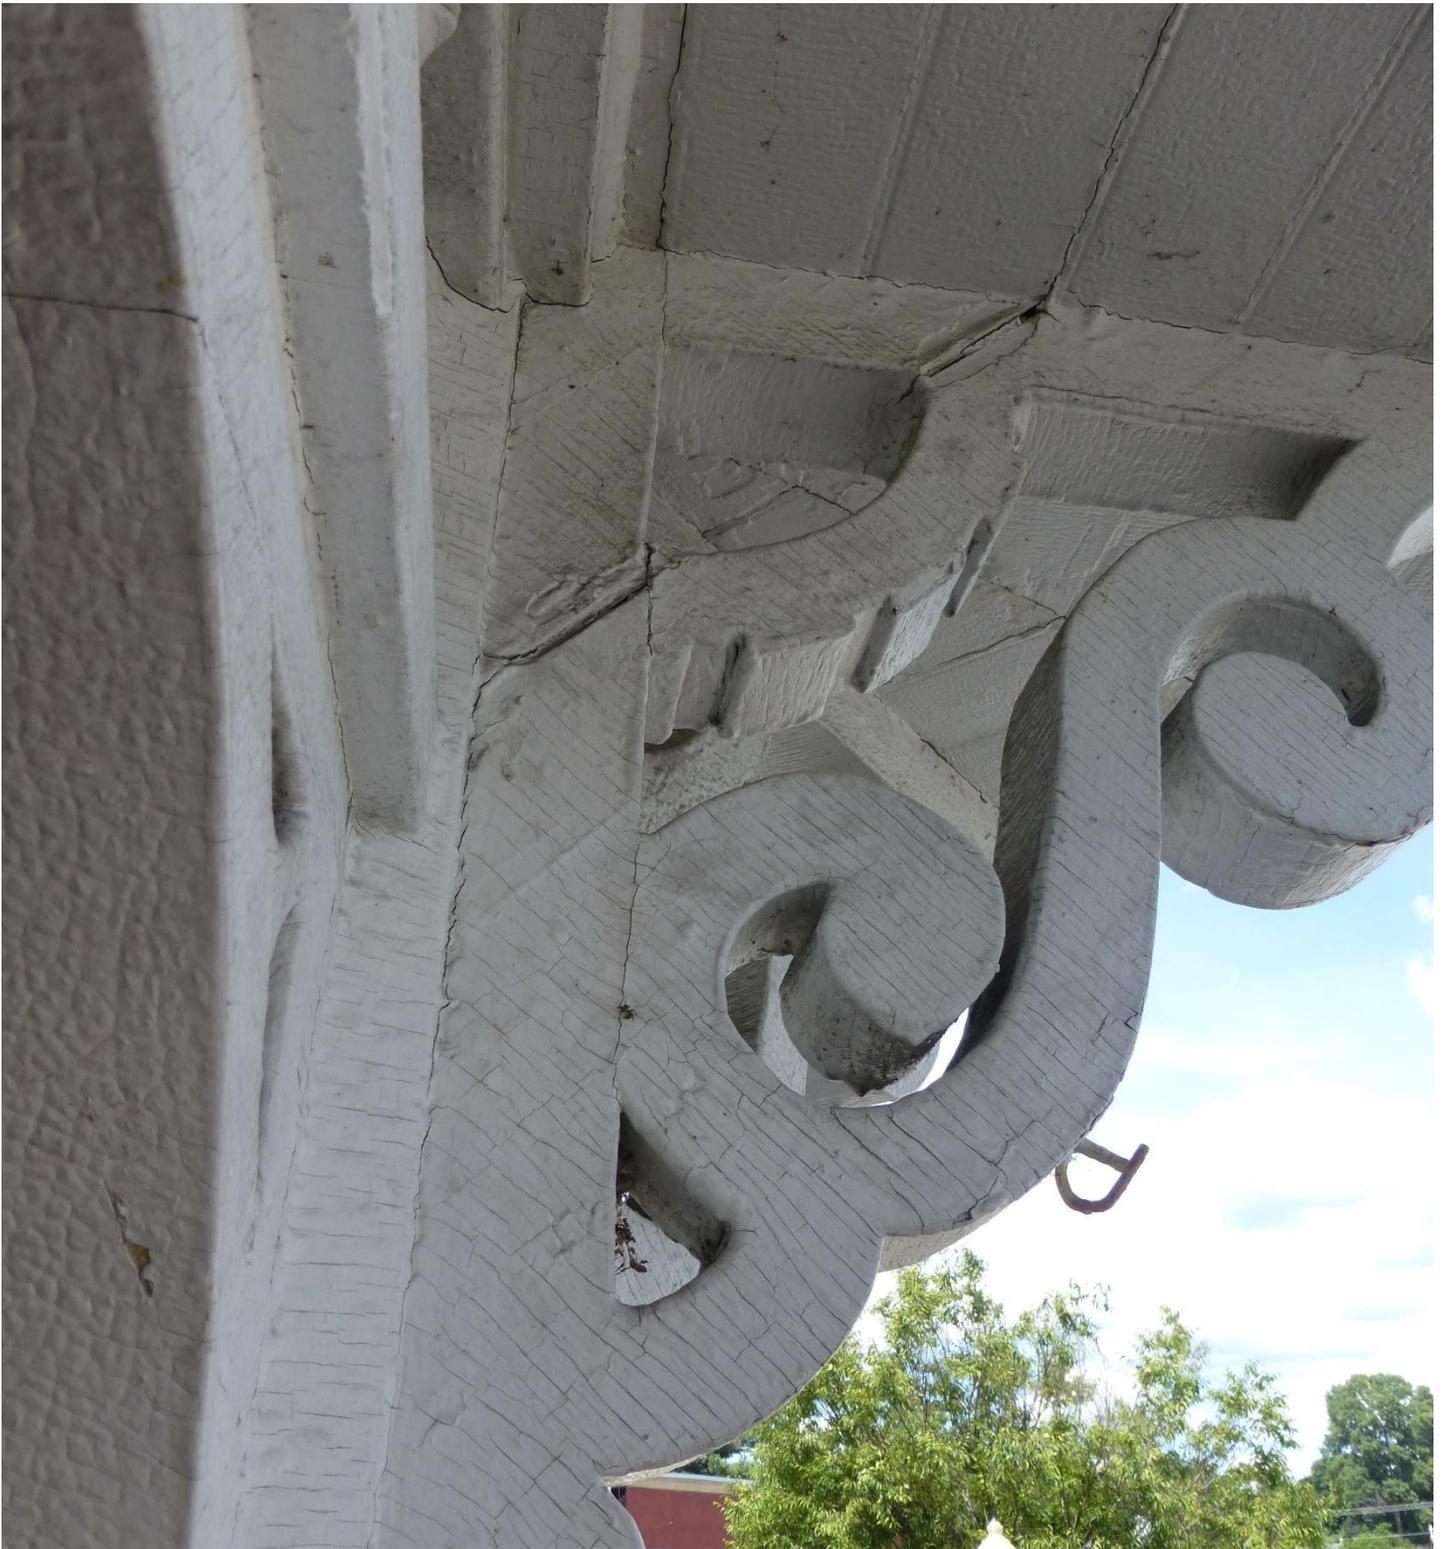
While the majority of the decorative brackets are in good condition a couple of them have cracks that need attending to. Here the upper corner has opened up a bit, another good candidate for epoxy repair.

The majority of the decorative brackets are in good condition, though a couple of them have cracks or splits that need attending to. All of them are good candidates for epoxy repair. The repairs would be completed in a similar way to the post repairs, though I would refer back to the photo section for the specifics on each particular bracket. Once the epoxy has fully dried, I
