IRONWOOD RESTORATION, LLC

The Pillsbury Bandstand

August 20, 2022

Within the following pages of this brief report, I have done my best to document and encompass the existing conditions of the Milford, NH bandstand in hopes that it will encourage and allow for the future restoration and preservation of this unique historic structure.

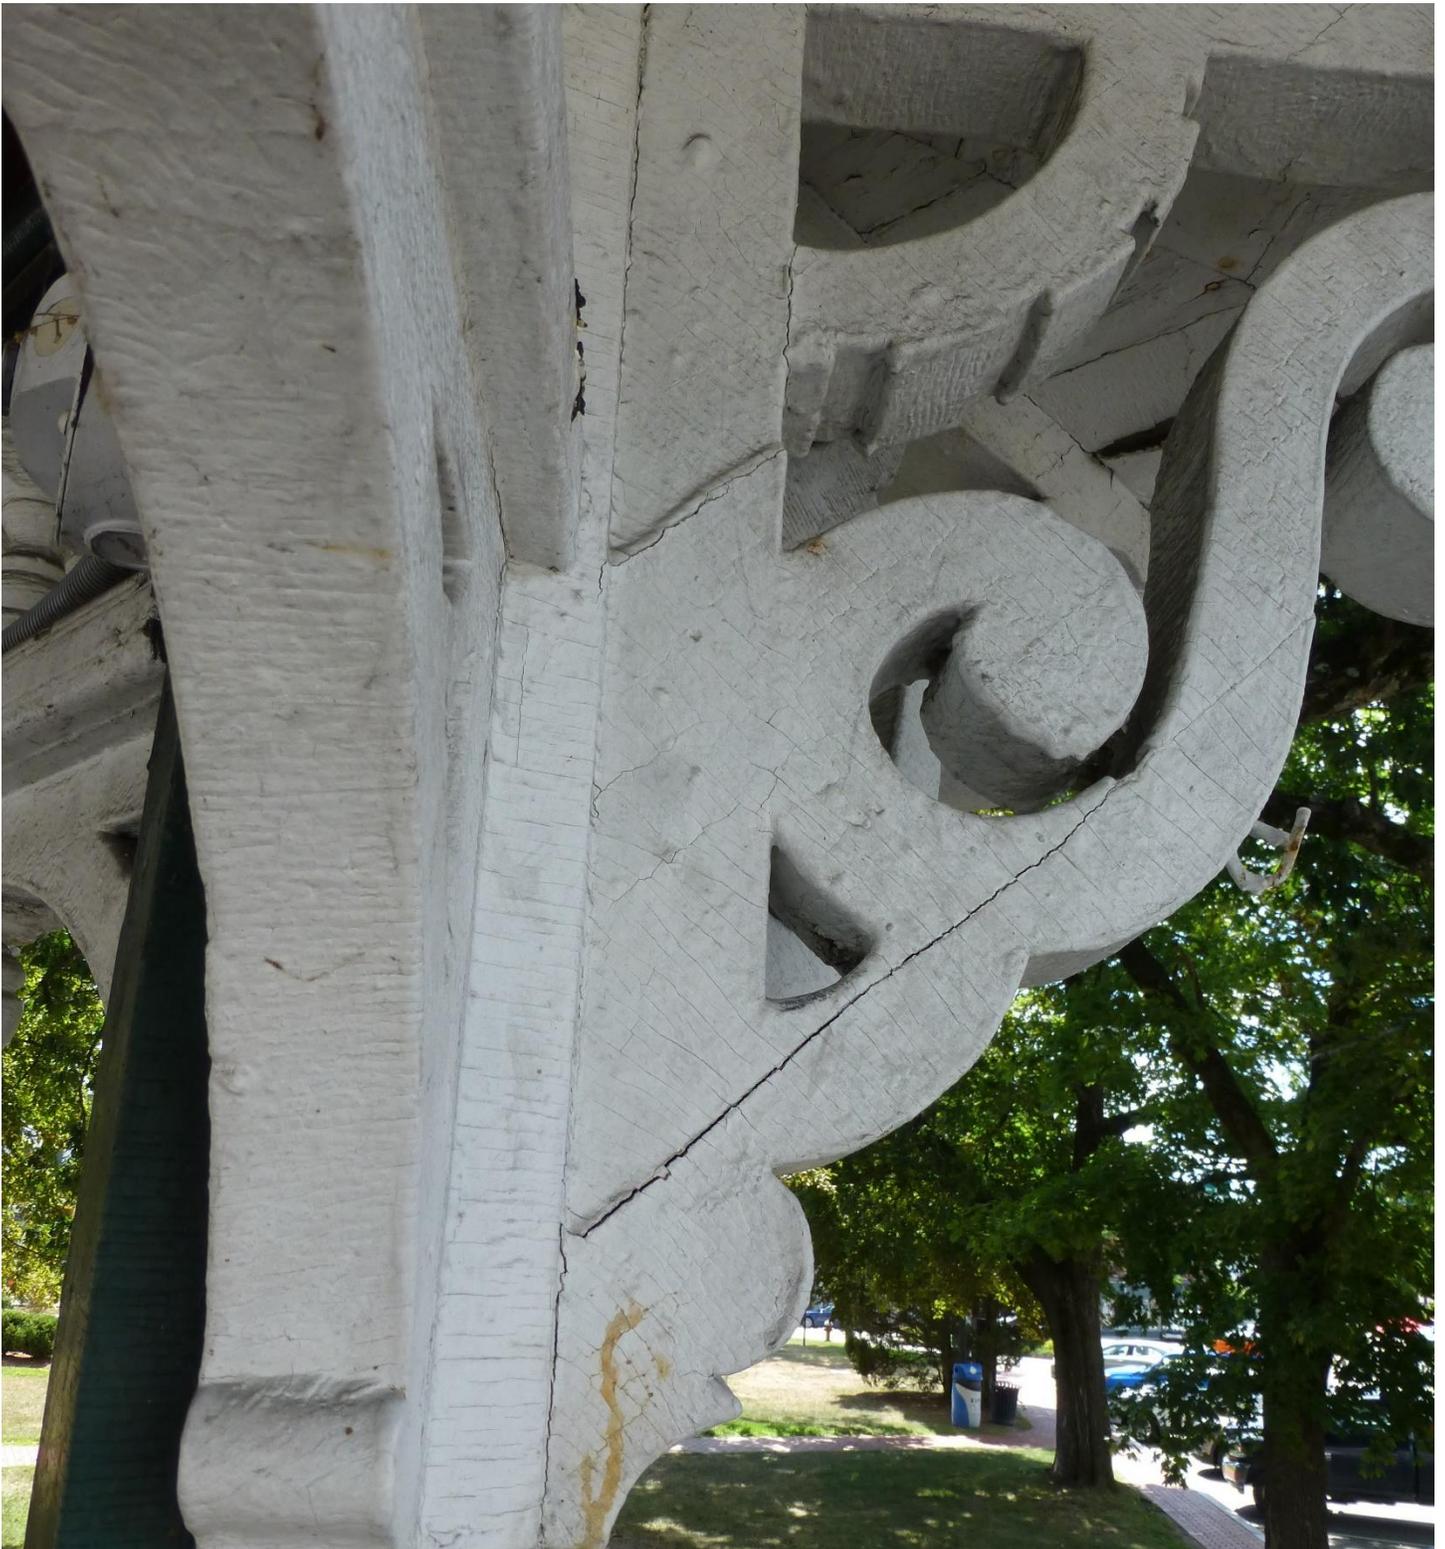
This bracket has a couple areas in need of repair. The upper crack has caused the plane of the bracket to offset, this should be cleaned out, re-set and epoxied into place. The lower crack appears to be split through; hence this piece would be removed cleaned up, hollowed out in the center leaving the original edges, consolidated and epoxied back into place. The hollowing process allows for the epoxy to build in thickness which allows for a much stronger connection.

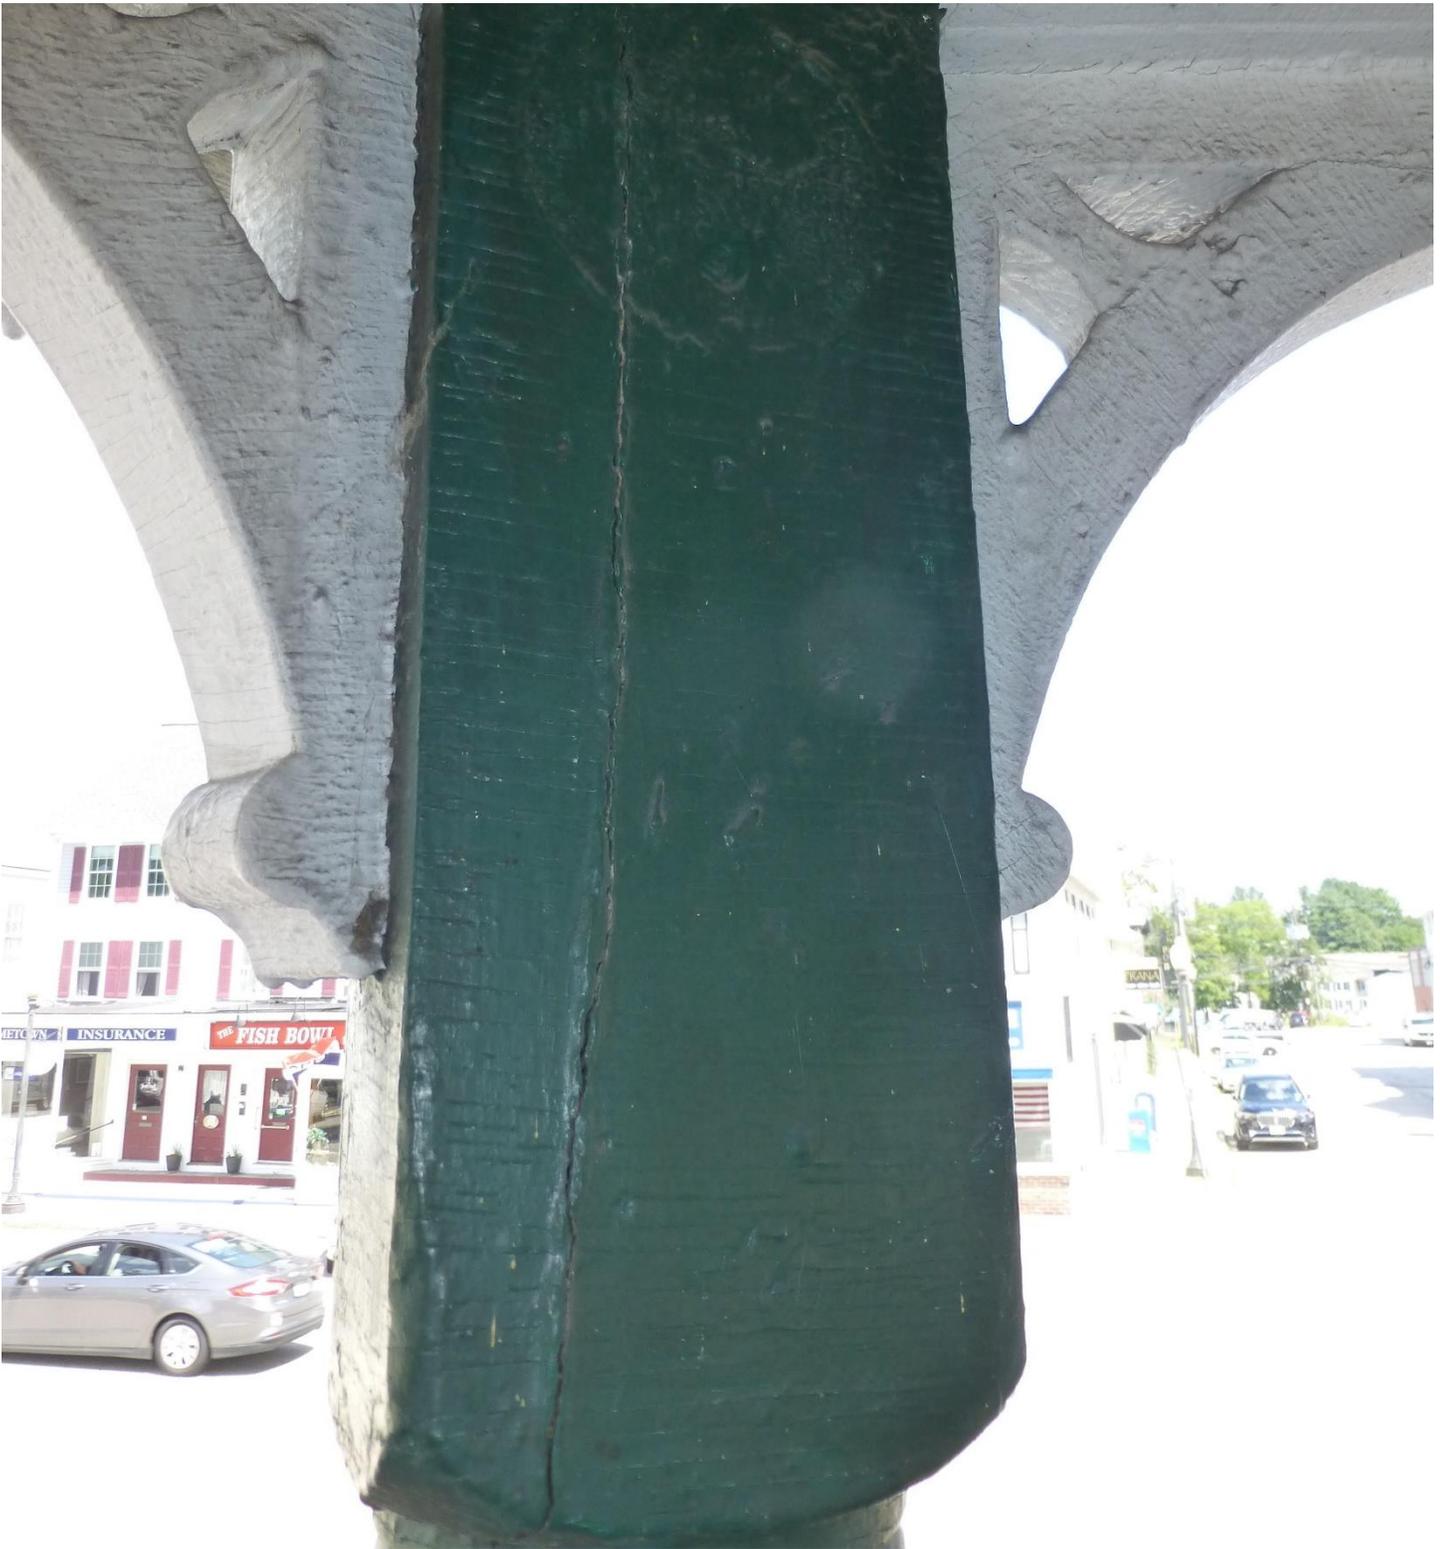
The posts are the structural and decorative element that ties the bandstand together. Hence it is critical that a crack such as shown here be properly repaired. This can be done by taking a teardrop scraper and v-ing out the crack to a depth of $\frac{3}{8}$ " or so, then drill a series of $\frac{5}{16}$ " holes to a depth of about $\frac{3}{4}$ the depth of the crack or more (drill holes at slight downward angle) and vacuum well. Mix epoxy consolidate, saturate with two coats, followed with epoxy putty.

It is critical that large and/or deep cracks be properly repaired. This can be done by taking a teardrop scraper and v-ing out the crack to a depth of 3/8" or so, then drill a series of 5/16" holes to a depth of about 3/4 the depth of the crack or more (drill holes at slight downward angle) and vacuum well. On a straight run, holes should be approximately 1"-1-1/2" apart, where there are more contours, hole placement should be planned to produce the greatest potential for deep epoxy consolidate saturation. Mix epoxy consolidate, saturate with two coats, followed with epoxy putty. Allow to thoroughly dry and form to surrounding contours.

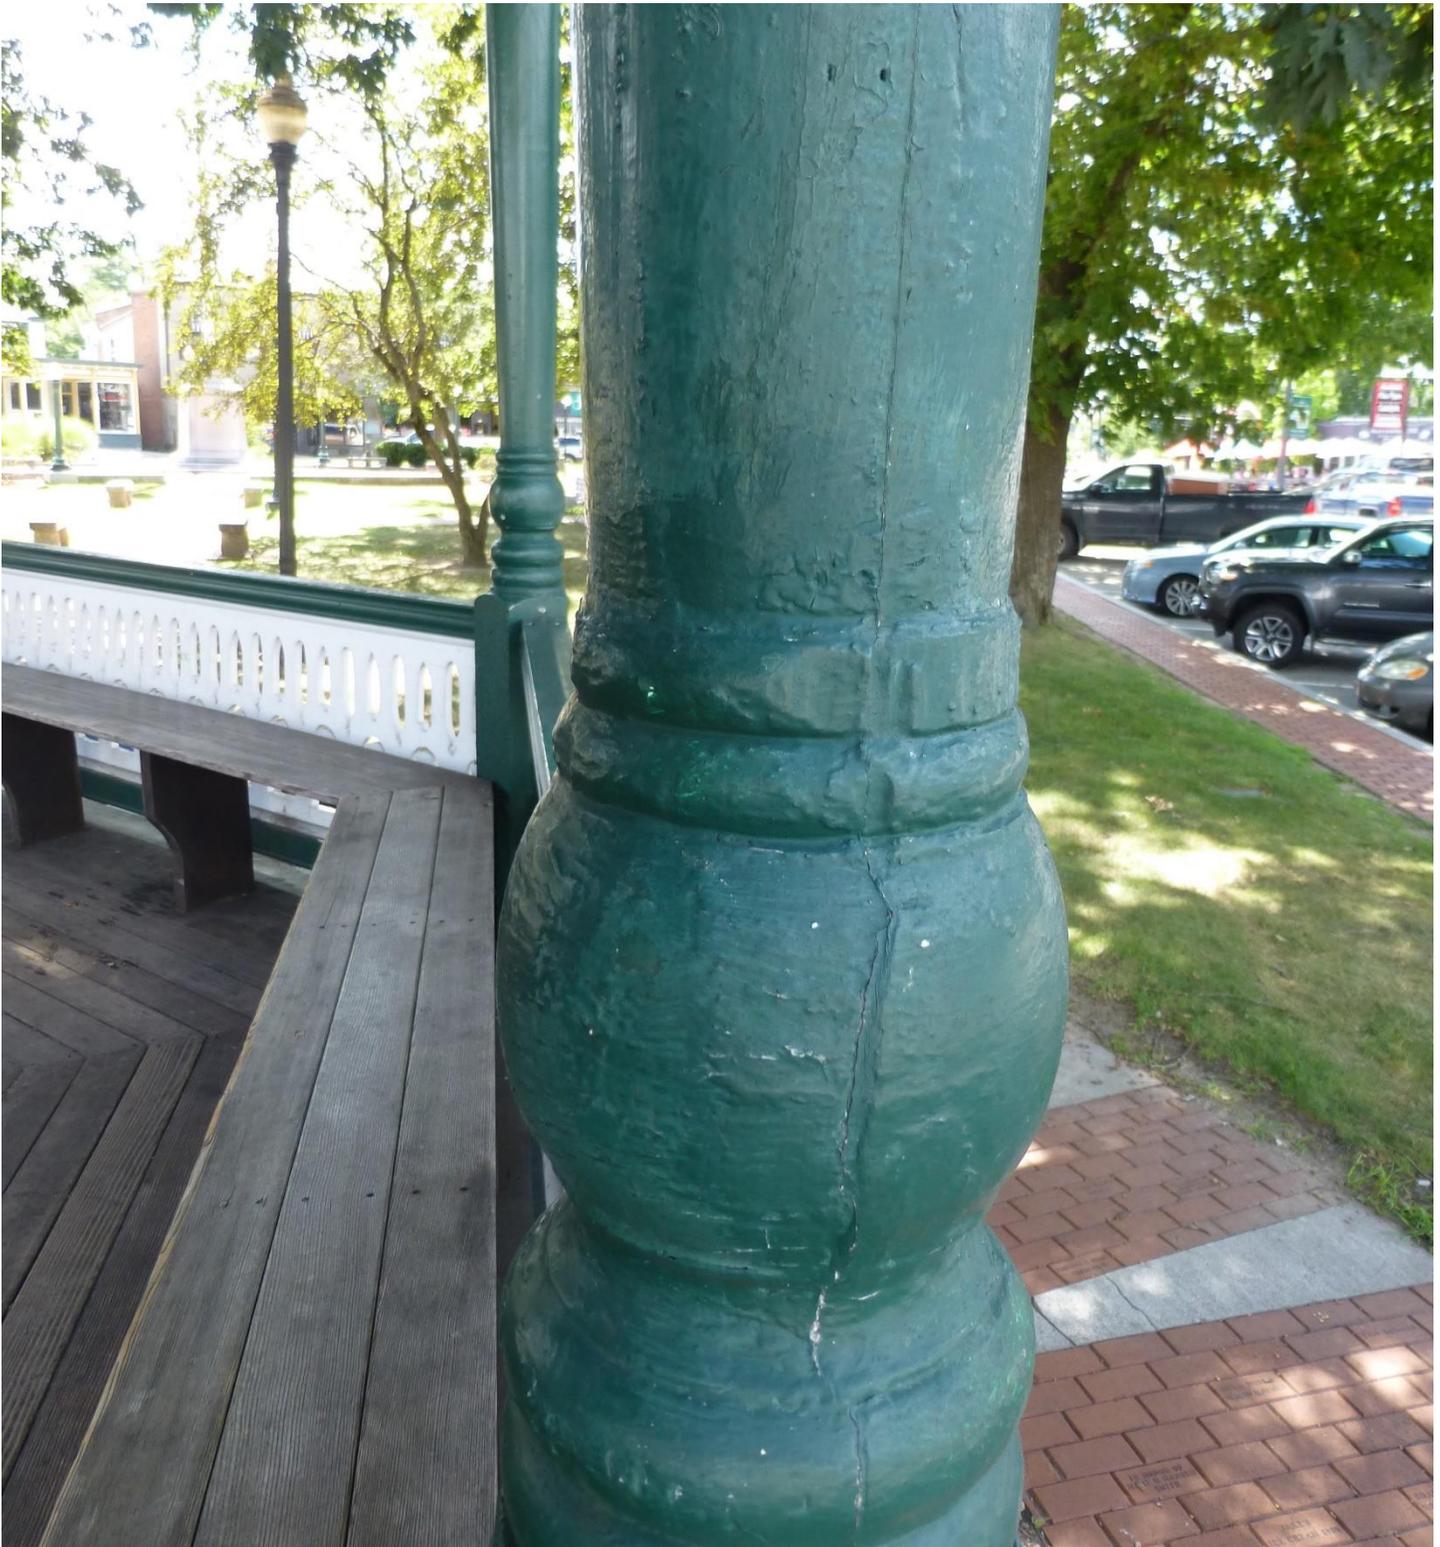
Another critical post crack repair, with the same procedure utilized here as previously mentioned adding additional epoxy as needed to rebuild the damaged decorative elements of this post. Once the epoxy has dried a full 24 hours (I prefer two days), clean up the epoxy and form to surrounding contours and prime.

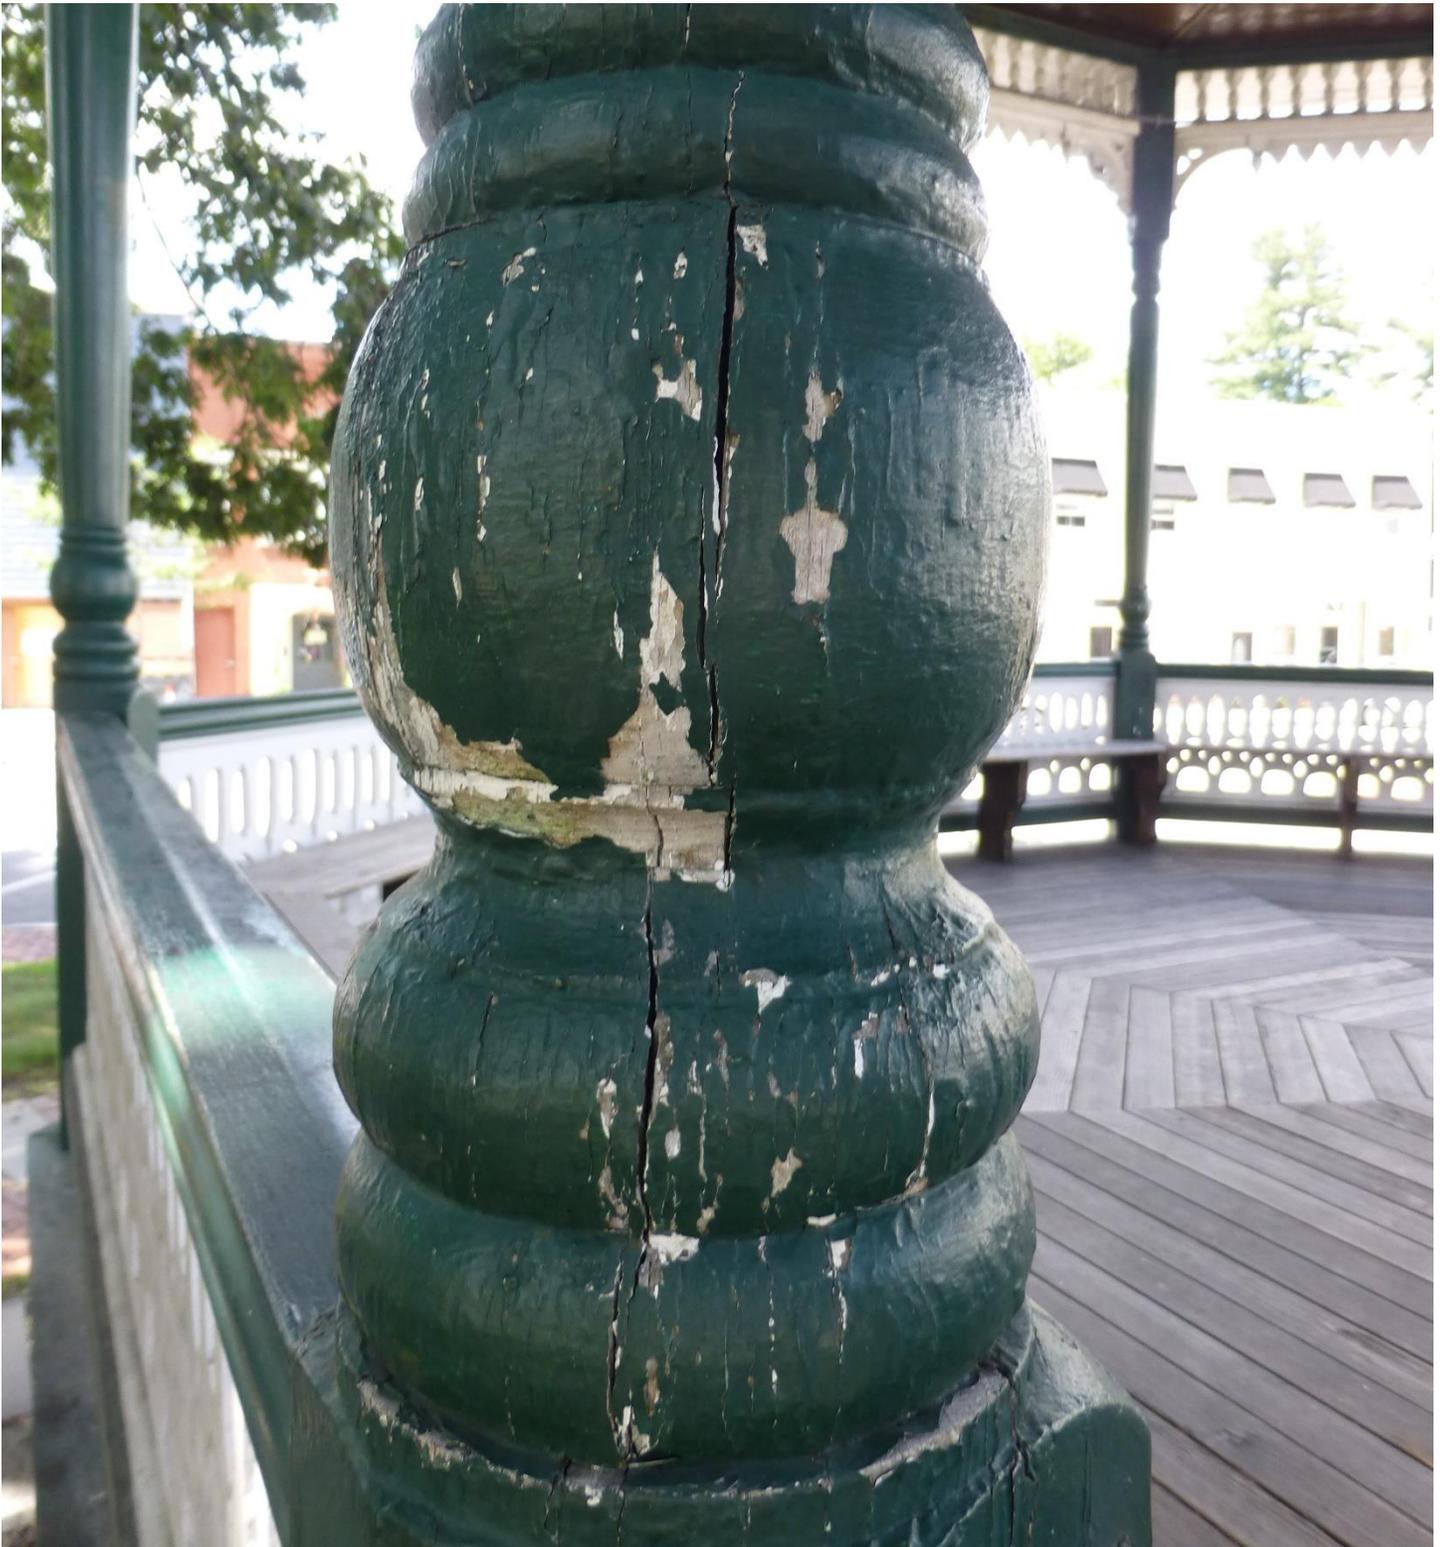
This crack runs right through the decorative post turnings; however, the same repair procedure applies. V it out, drill downward angled holes, saturated with at least two coats of consolidate, mix epoxy putty and fill. On a straight run, holes should be approximately 1"-1-1/2" apart and $\frac{3}{4}$ the depth of the crack where feasible. Here, where there are more contours, hole placement should be planned to produce the greatest potential for deep epoxy consolidate saturation.

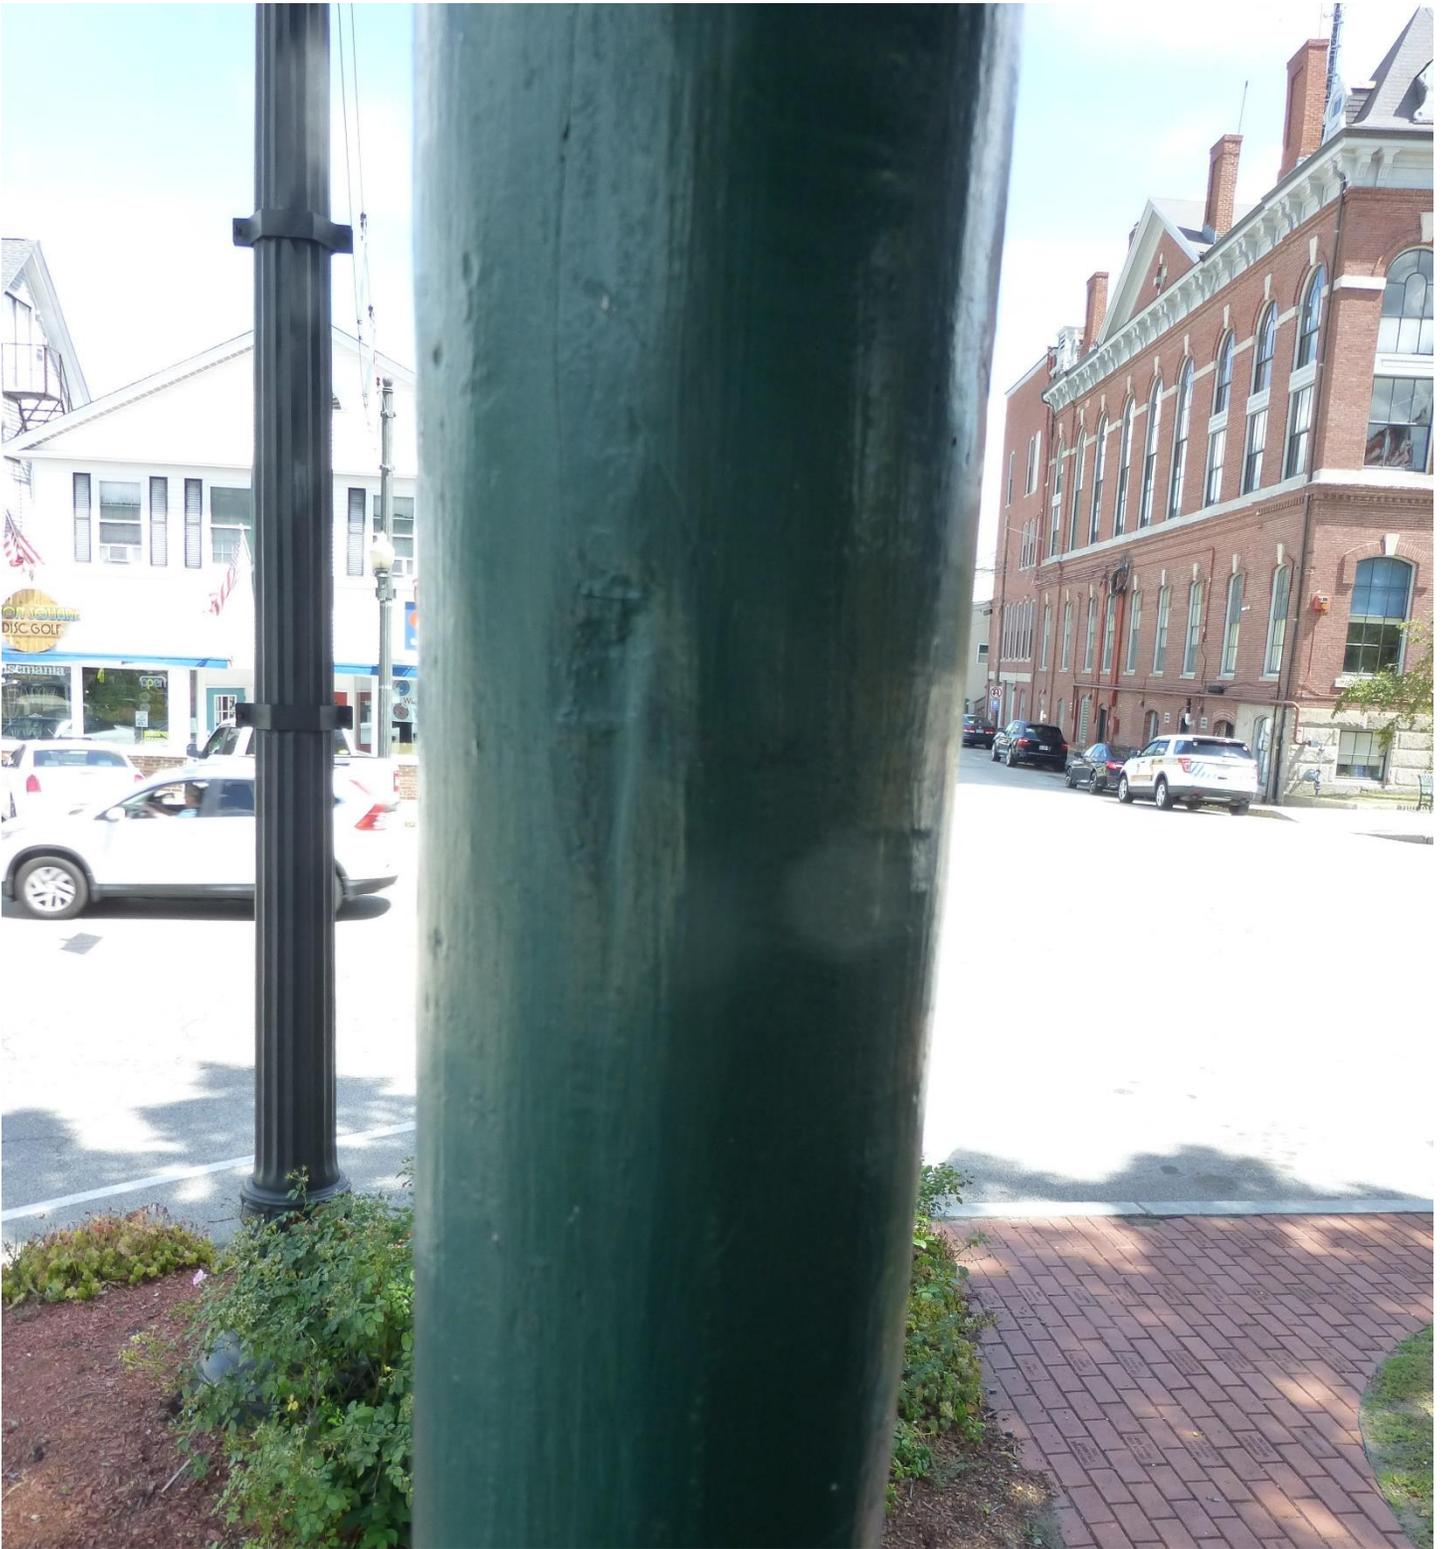
Another candidate for epoxy repair, remove paint from affected area, rough up contact area for mechanical bond, apply epoxy consolidate and putty, after drying form to match contours.

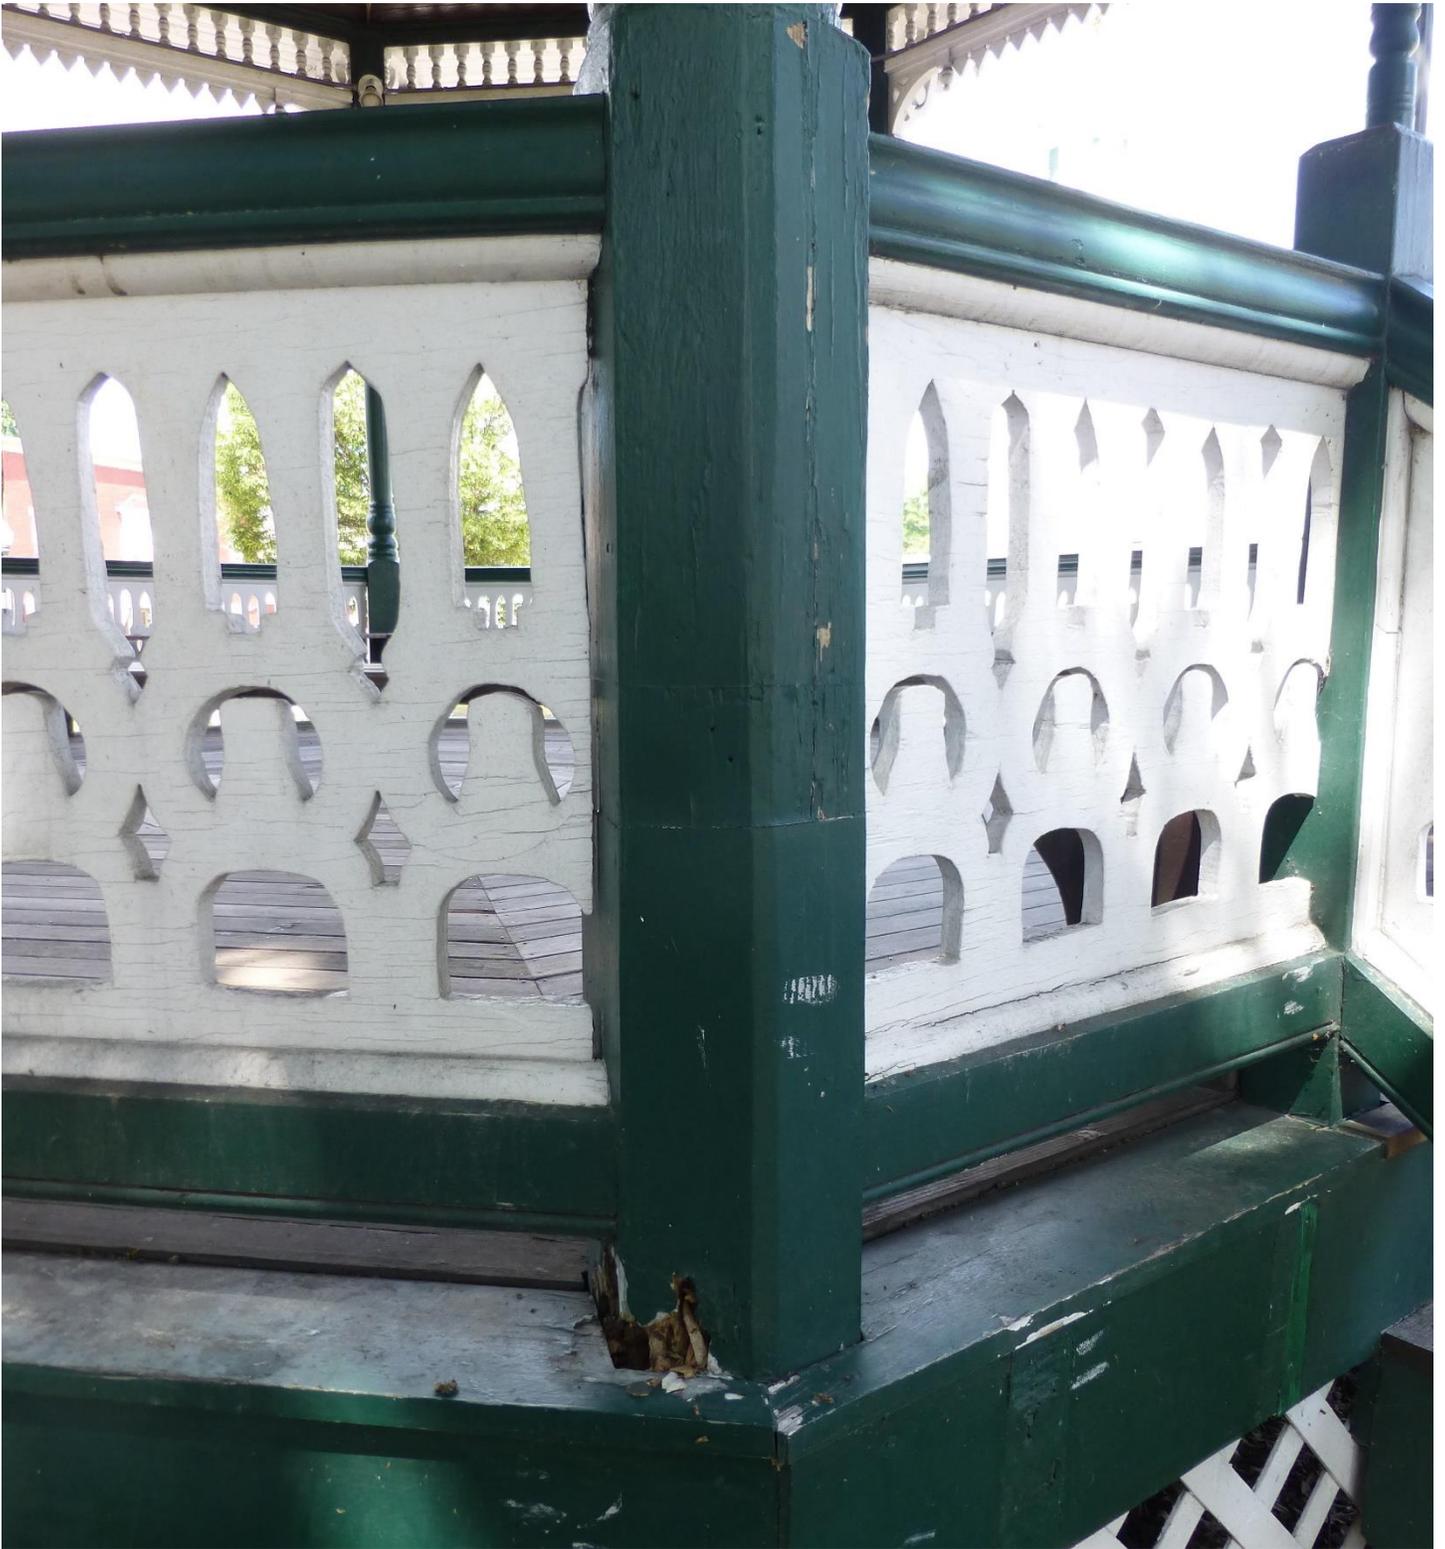
One of at least six post bottoms that need attention. It is apparent that some repairs were completed on this post the last time the bandstand was worked on.

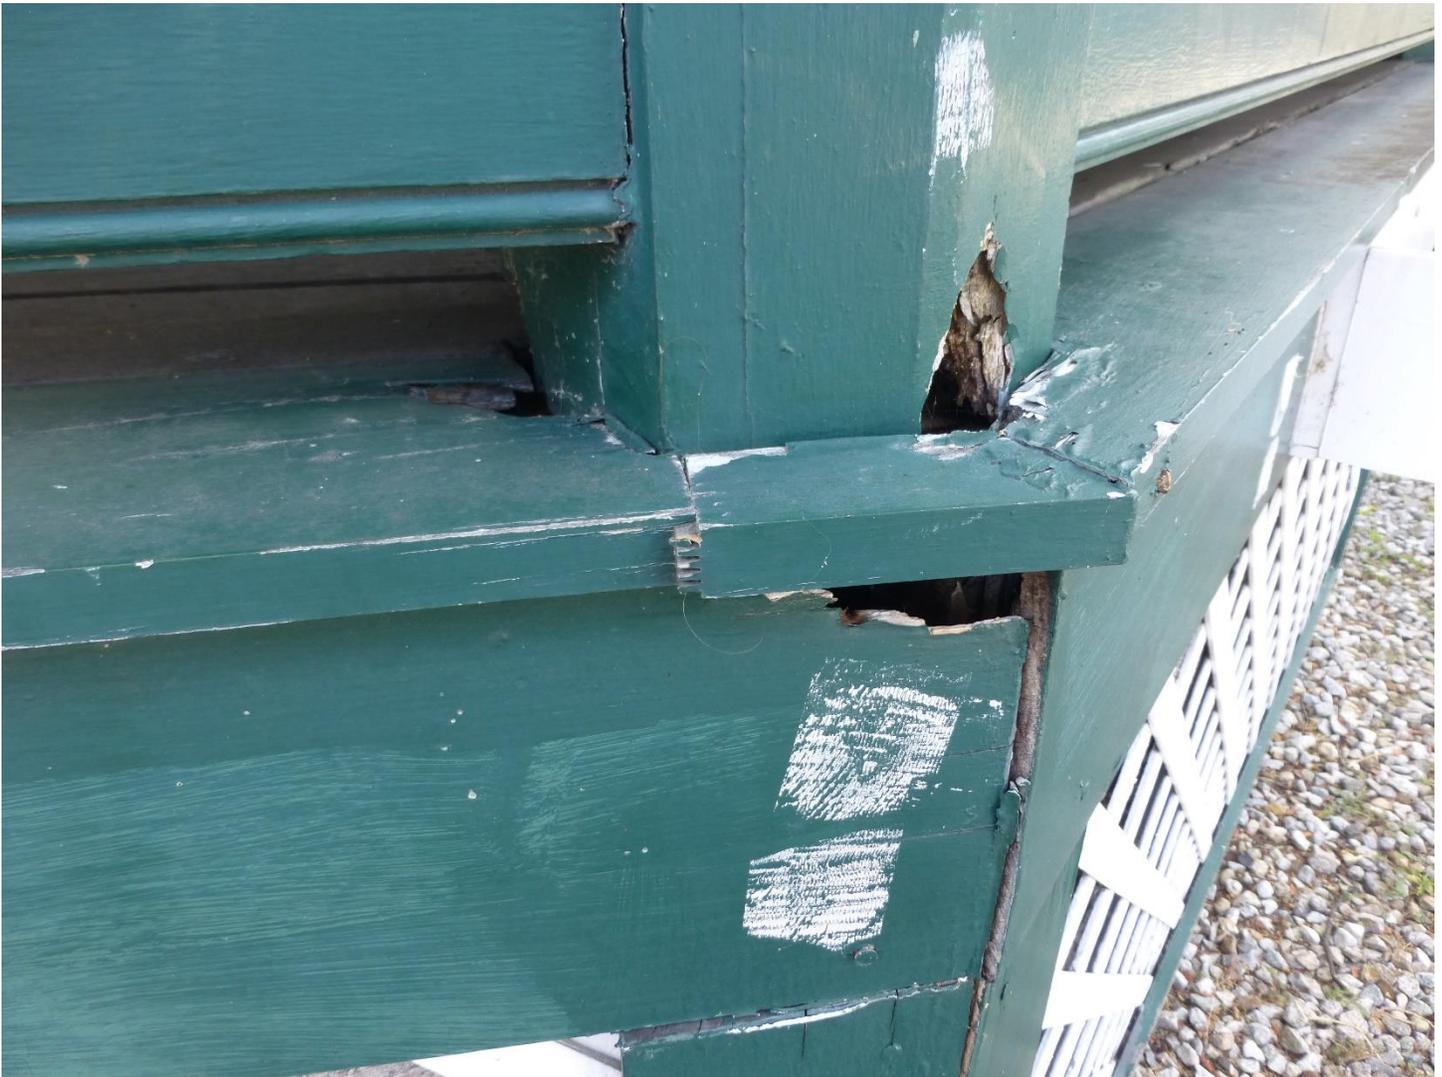
Another post bottom that has badly deteriorated along with a peek into the decayed sill below the post, which is hidden behind the horizontal trim. All post bottoms that have been repaired should be replaced with new material (assuming to be CVG Douglas Fir) to match the existing species. Best practices are to utilize a mortise and tenon joint, bladed scarf joint or epoxy embedded fiberglass rods.

Utilizing a mortise and tenon joint with the tenon on the new post bottom and the mortise cut into solid material on the existing post, if well executed this can be glued with Titebond III. More commonly the joint can be fit to allow a 1/8" space on the mortise and tenon to allow for epoxy. Epoxy needs some thickness for strength. Either way, pegs or stainless-steel screws should be installed as a second lock to the joint, both being sunk below the surface and filled.

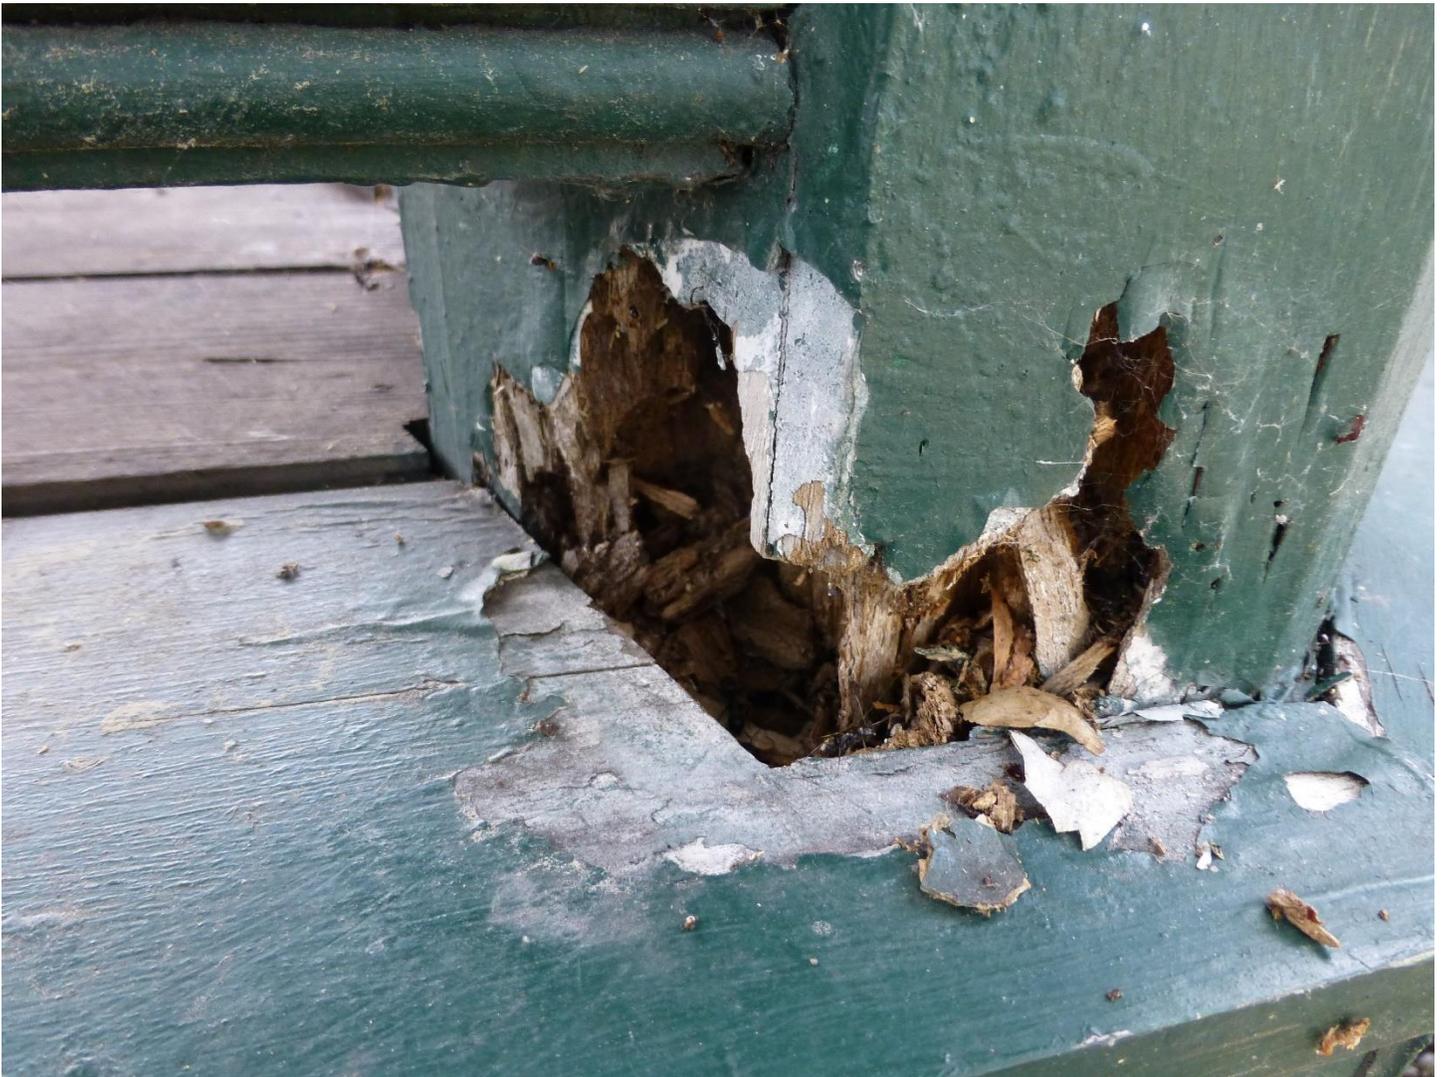
Quite severe deterioration on this post bottom, I believe this is the replaced material and not the original. If it were original material, it would be possible to splice in new material with epoxy. As mentioned prior, this should be repaired by splicing a new post bottom to the original post.

If utilizing fiberglass rods, a straight horizontal cut can be made, then four $5/8''$ - $3/4''$ vertical holes can be drilled up into the post and down into the new post bottom approximately 6'' deep in preparation for $1/2''$ fiberglass rods and epoxy. All meeting surfaces must be fully saturated with epoxy consolidate and certain epoxy putties must be thinned (with consolidate) to lower the viscosity, this allows for the rods to be pushed in and displace the epoxy, fully filling the void around the fiberglass rod. Best to complete testing prior to actual assembly.

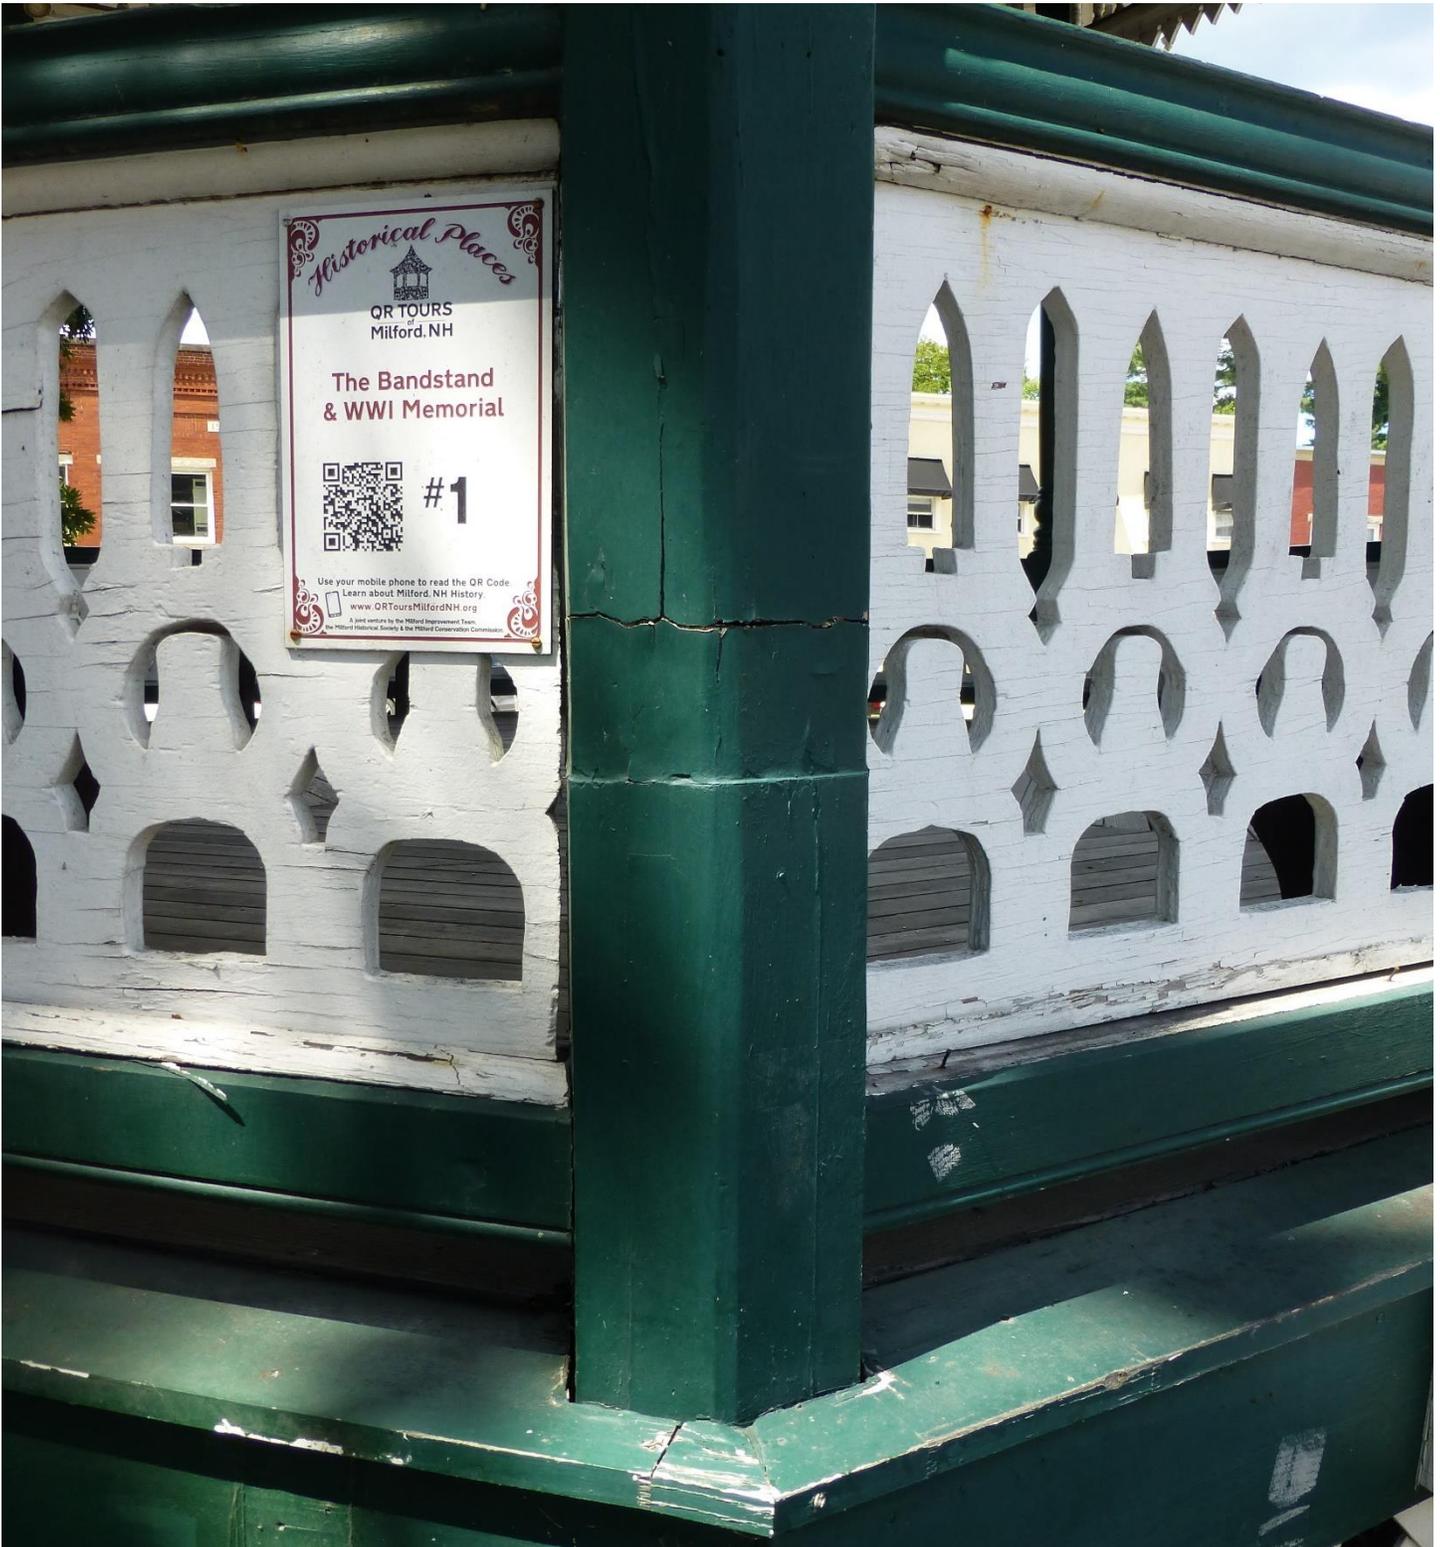
A good view of an existing post bottom, it's not clear to me how this post bottom was joined to the original nor what the horizontal channel's purpose is, this would fully be understood once repair work begins. Regardless a new post bottom should be spliced to the original post by one of the forementioned methodologies.

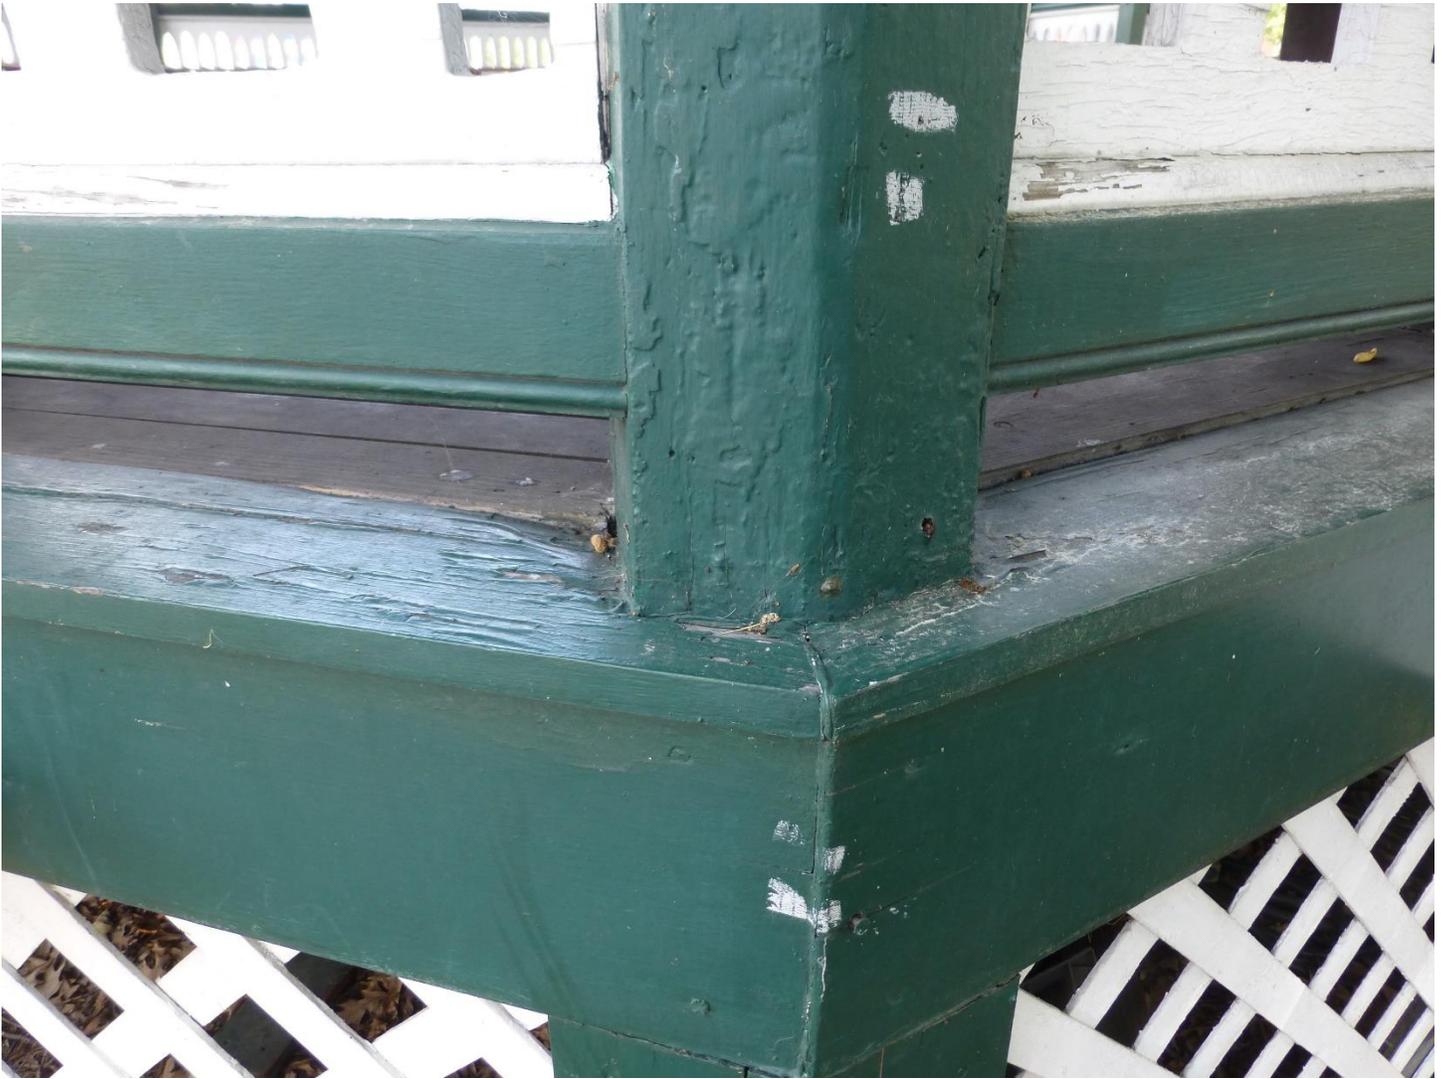
It is not all that clear in this photo, however, if you look closely one can see nail heads protruding from the face of this original post bottom. This fastening method has so far securely held the posts to the floor framing system. While a fairly strong assembly if nailed correctly on all sides, these fasteners have been there for decades and are failing. Where new post bottoms have been added in the past and are now decaying, we have a similar situation with regards to the fasteners.

Once the new post bottoms are in place and all other repair work is completed, new fasteners should be installed which would consist of either, A: Utilizing a more traditional approach, 12d-16d common galvanized nails or B: A more modern approach 3"- 4" GRK (or equivalent structural screw). Both approaches call for the pre-drilling and countersinking of the fastener through the new (or original) post bottom and if the fastener is being driven into an epoxy repair to the sill below, the epoxy should be piloted to help receive the fastener.
