IRONWOOD RESTORATION, LLC

The Pillsbury Bandstand

August 20, 2022

Within the following pages of this brief report, I have done my best to document and encompass the existing conditions of the Milford, NH bandstand in hopes that it will encourage and allow for the future restoration and preservation of this unique historic structure.

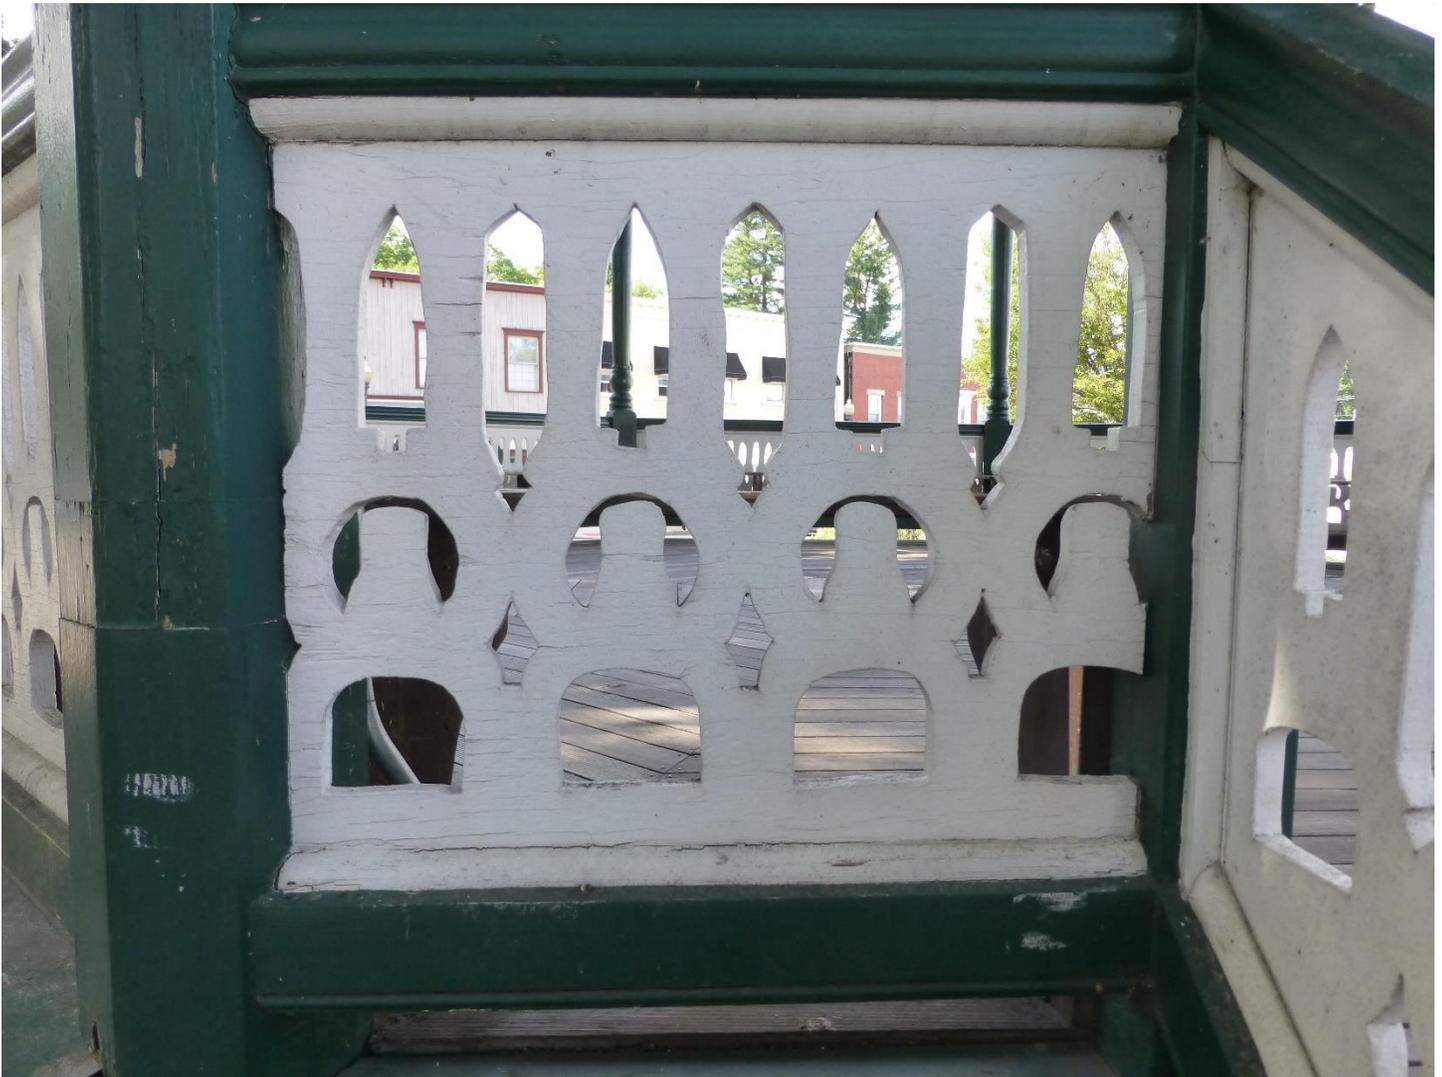
Shown here is a typical section of the existing rail scrollwork which has been cut out of a 3/4" plywood sheet; just a bit of a variation from the traditional baluster approach! New balusters should be cut from cedar or eastern white pine. Though today, cedar, particularly red cedar can be cost prohibitive. The original balusters were most likely EWP so utilizing eastern white pine as a replacement is certainly a viable choice. However, the original balusters would have been cut from first growth pine or the trailing edge of it, either way a superior product to what we generally have today. To counter this I typically dig through piles of lumber in search of "quarter sawn" pieces to utilize for projects such as this. Any straight log when flat sawn produces several pieces of "quarter sawn" lumber, however as mentioned one must look for it. Though originally such scrollwork on a structure such as this would have been cut out by hand utilizing a bowsaw (though certain patterns were available from manufacturers at this time) and you can carefully cut these out with a modern powered jig saw, the most efficient method that I have found is to make up an accurate template and cut them with a guide bushing and router. It is also sometimes possible to find a woodworking shop that can complete this work utilizing this method or a pin router.

The existing scrollwork which has been cut out from $\frac{3}{4}$ " plywood, has begun to fail and should be replaced with traditional individual balusters as were the originals. Time and care should be taken to average out the measurements of the existing scrollwork in hopes that one will arrive as close to the original patterns as possible. Once a pattern and template have been established, the most efficient way that I have found to cut them out is typically with a router, finishing up details with wood rasps and sandpaper.

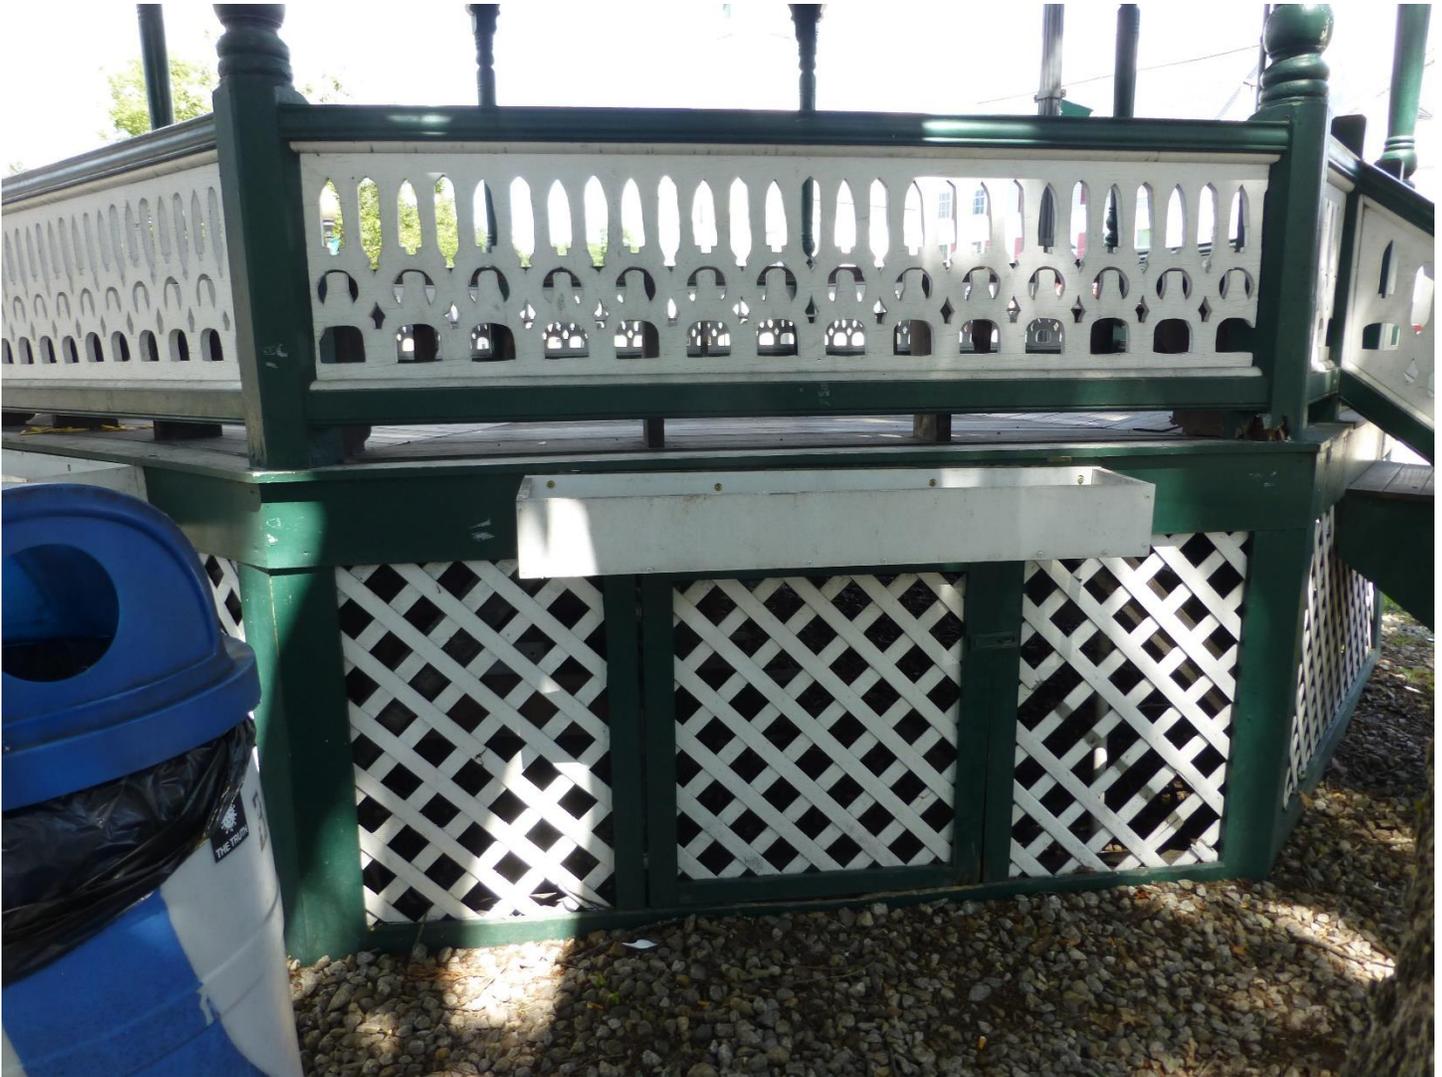
Despite my best efforts I was unable to find any clear photos of the railing assemblies. As mention prior, I am hopeful that the current rails match the original profiles as close as possible. I had alluded to the observation that the beading on the rails seems to match the beading on the spindle rails. Being that I have no other information to refer to and the existing rails appear to be in good shape, I would recommend re-using them in the restoration efforts. Another observation is that the quarter round molding used to hold the scrollwork in place does seem a bit large to me, however again I have no reference to the original, nor do I know whether this is the original railing assembly design.

It is assumed that the flower boxes are used throughout the year. Being that they will be removed during the restoration process, best practice would be to re-install them with metal L-brackets using $\frac{3}{4}$ " spacers (at the screw locations) between the vertical leg of the bracket and the horizontal trim, this allows for plenty of air circulation and prevents moisture retention which can lead to decay over time.

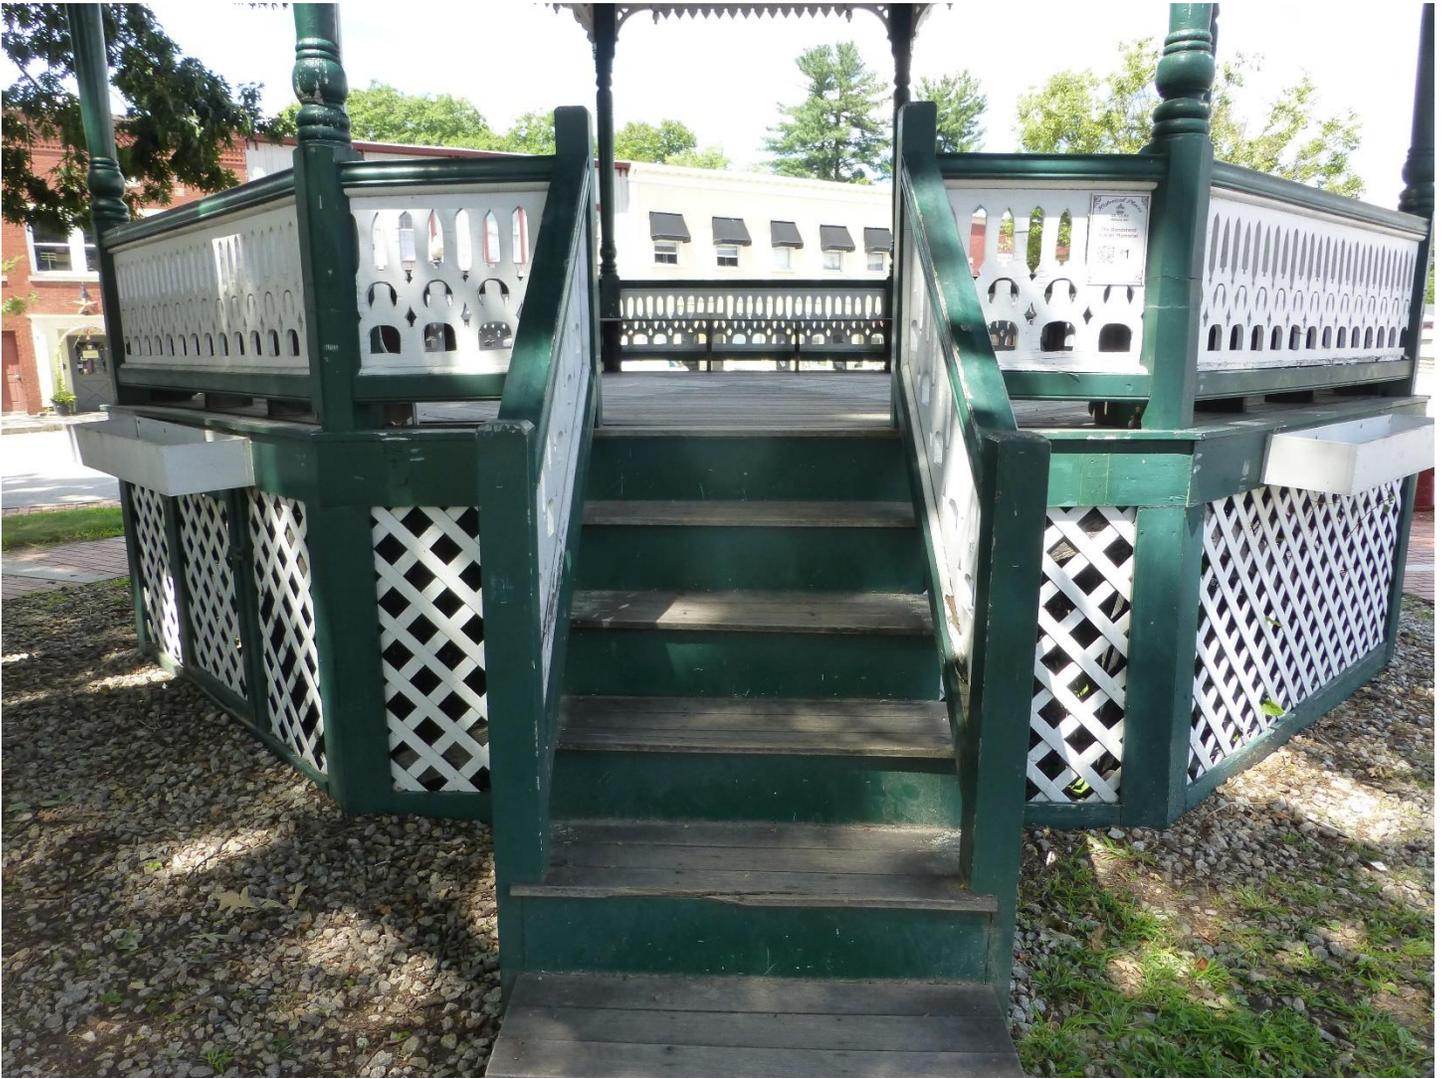
Stair entrance is in pretty good shape though will need some tread repair.

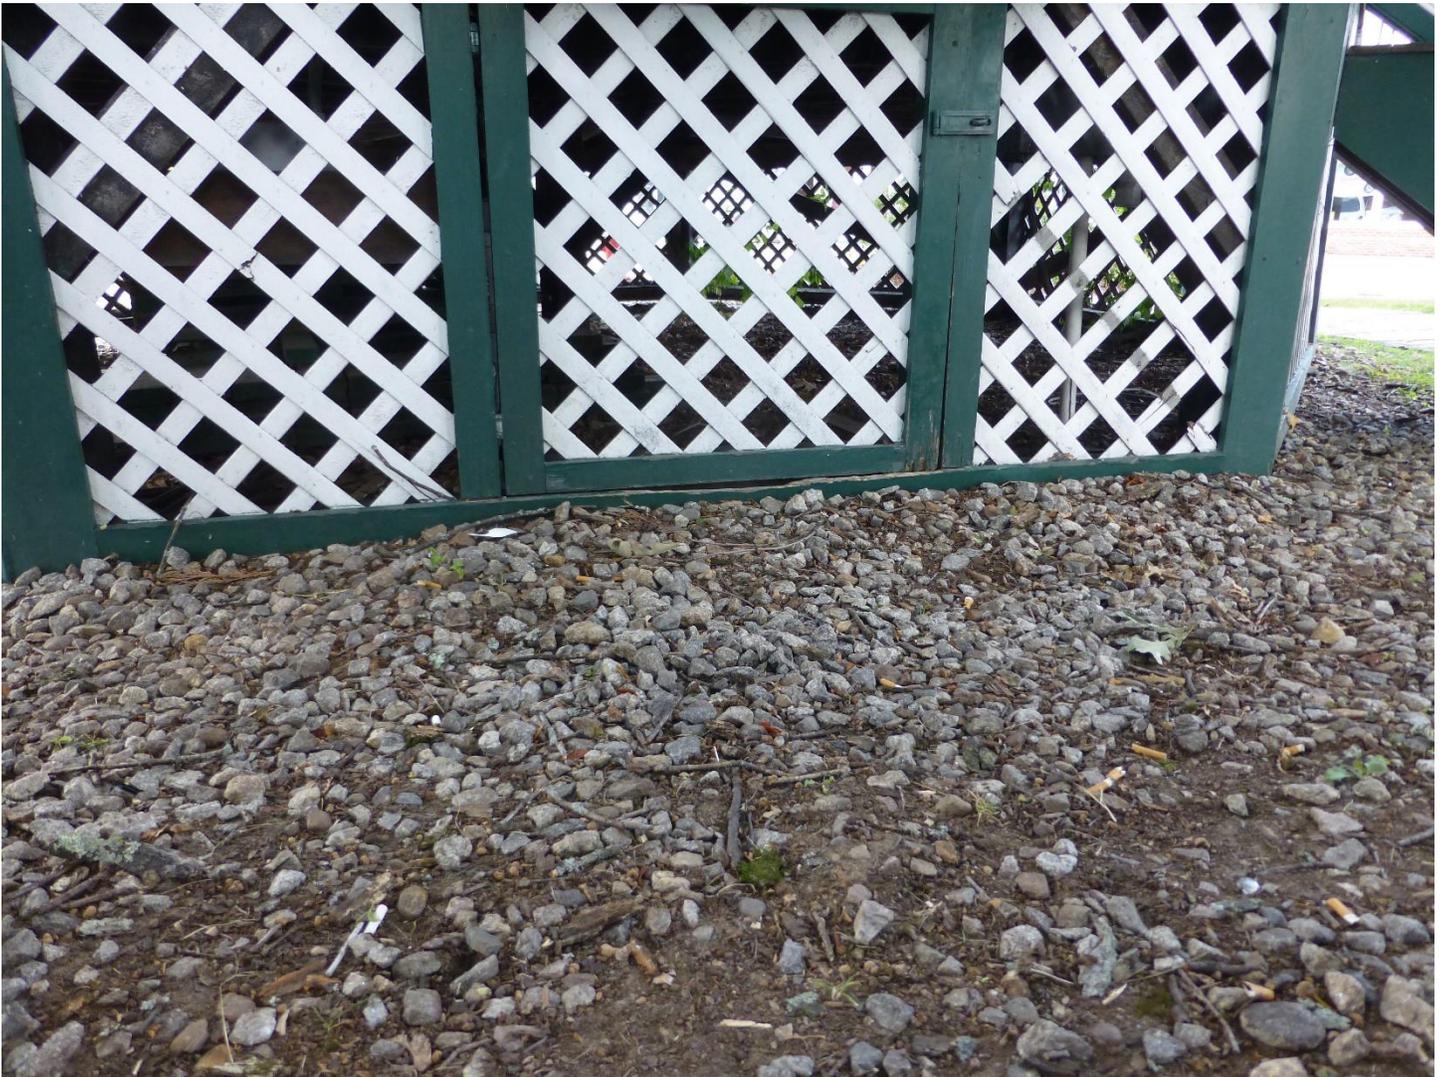
I wanted to point out the grade level here, as one can imagine any wood in contact with the ground is subject to more rapid decay. Grade should be altered if possible; if existing topography does not allow for this, then the new trim should be installed a couple inches above existing grade level.

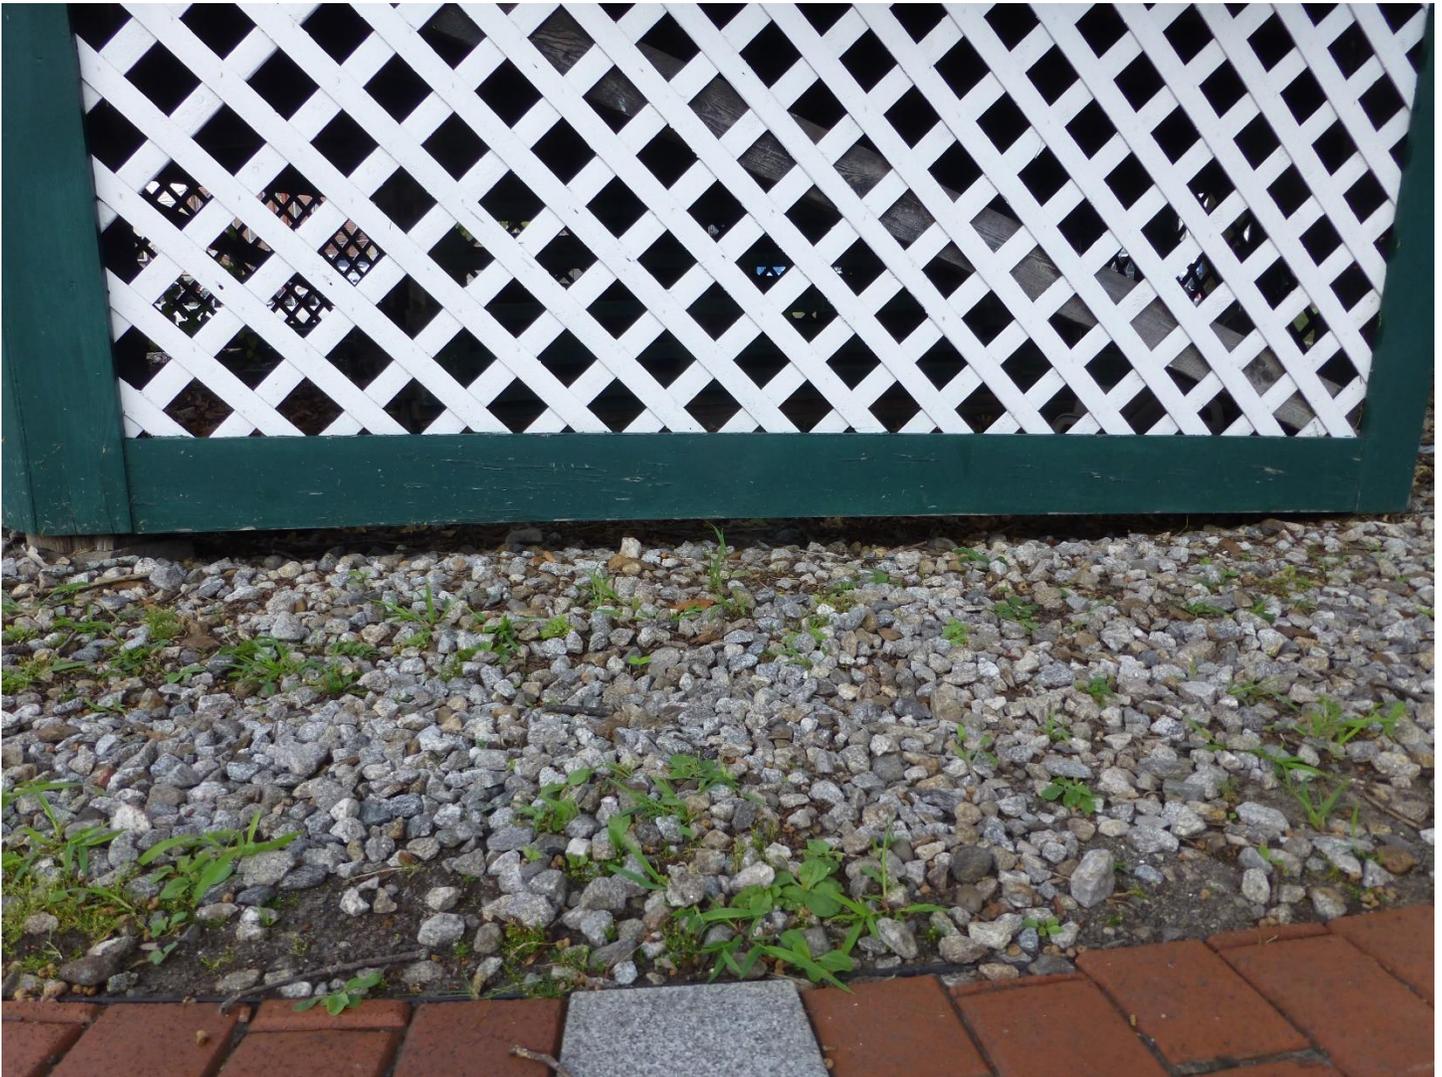
This particular side of the bandstand has a more appropriate clearance above grade.

While the original lattice was diagonal, it had a tighter weave, hence the existing lattice work should be replaced with something that more closely matches the original. I would propose this to be somewhere around 1-1/2" – 1-5/8" slats with the diagonal spacing matching the slat width.

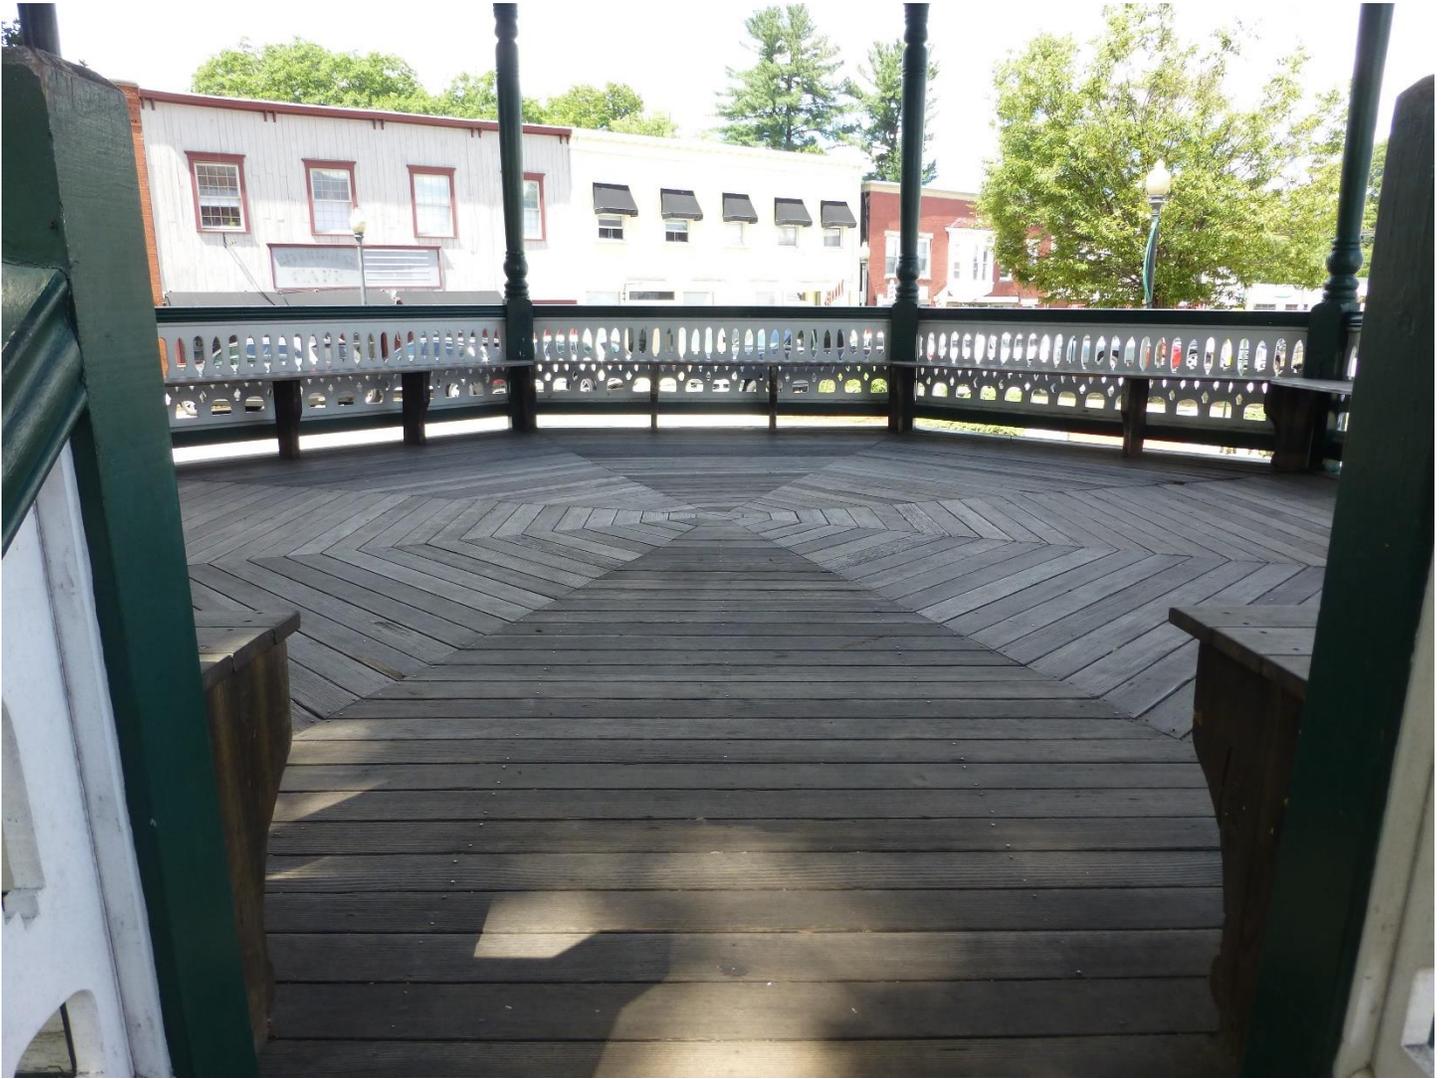
The flooring appears to be in relatively good shape; I am not sure when this floor was installed or whether the original flooring was tongue and groove douglas fir or not. Though T&G would have been more typical for that period of time. T&G does have the advantage of forming a complete barrier to the framing below, provided it is well maintained with paint or sealer.

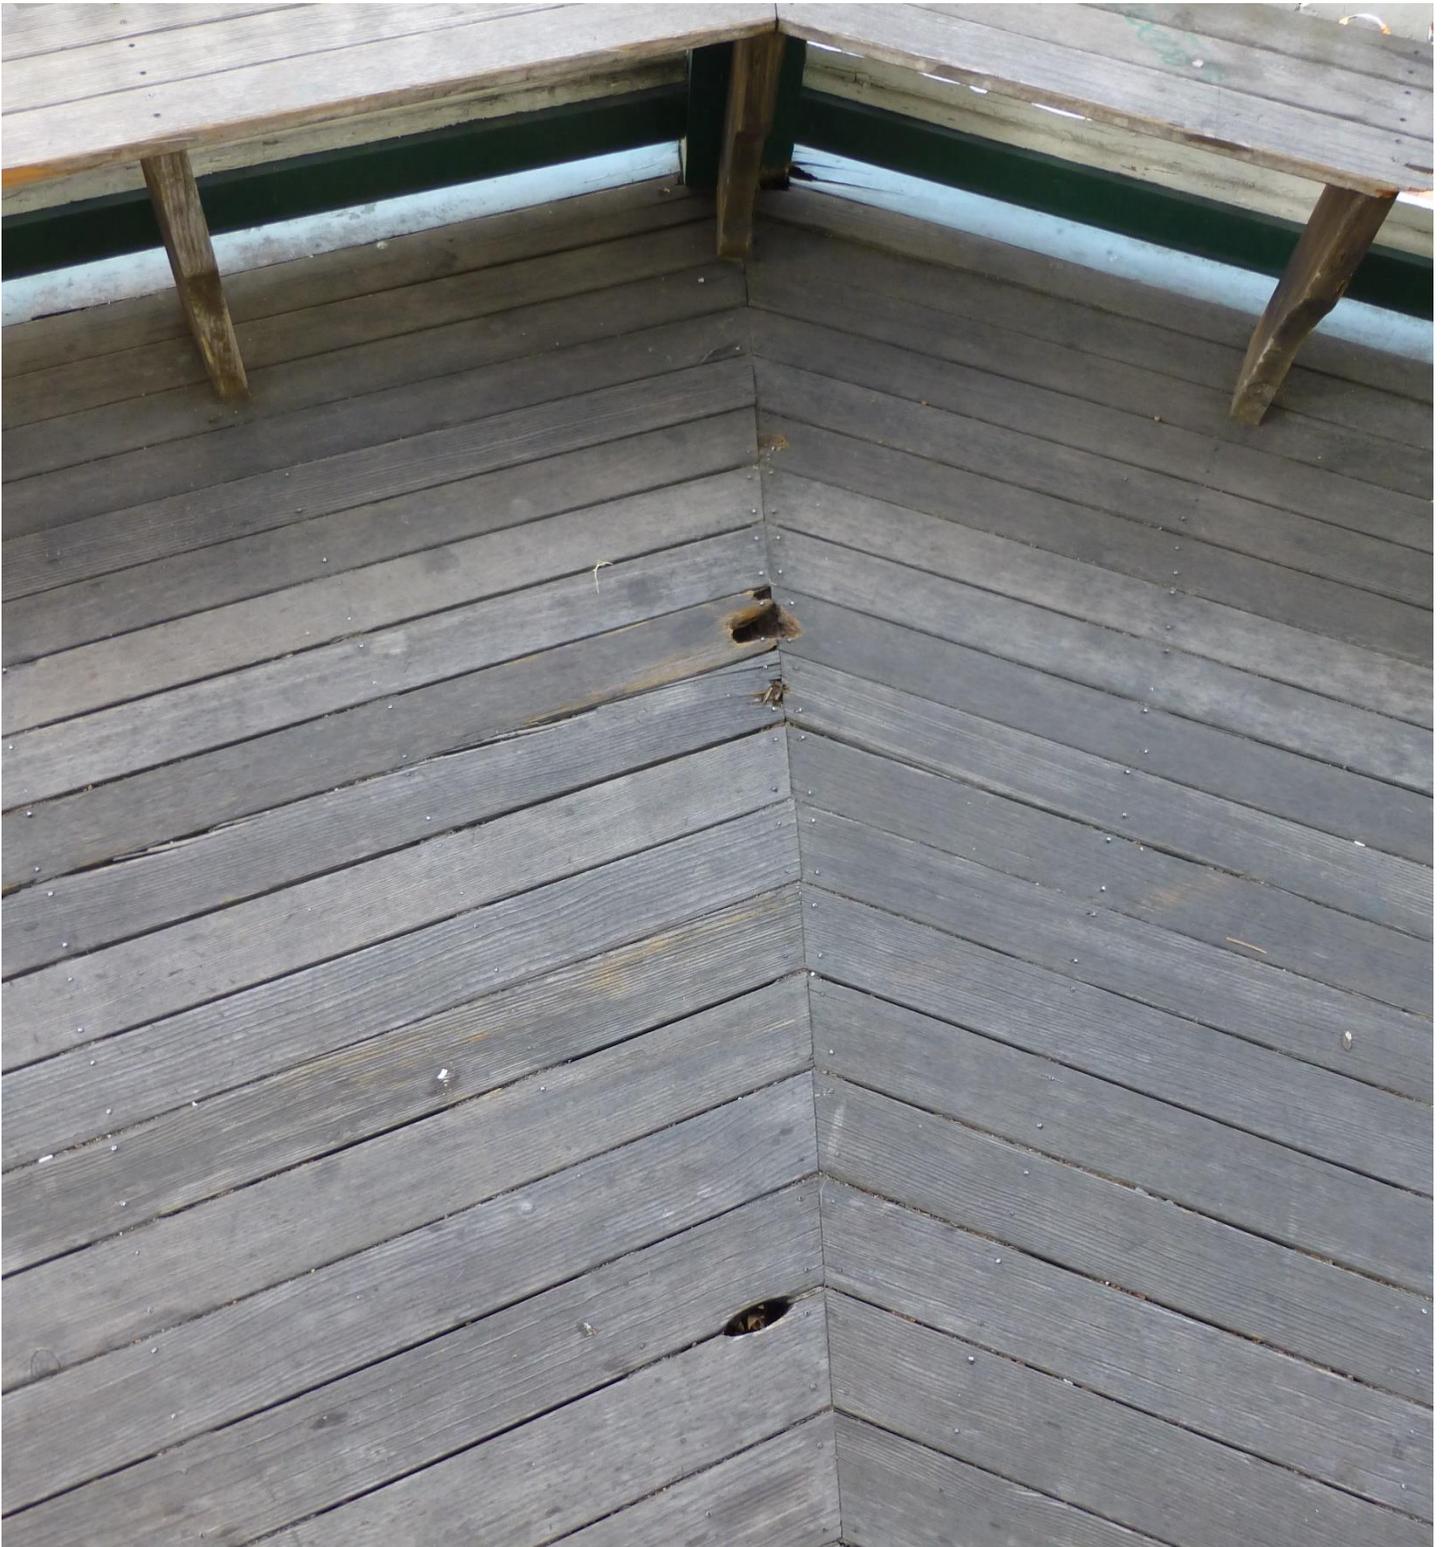
There are a few damaged areas that should be repaired with the same 5/4" x 4" (1" x 3-7/16" nominal) clear vertical grain douglas fir flooring.

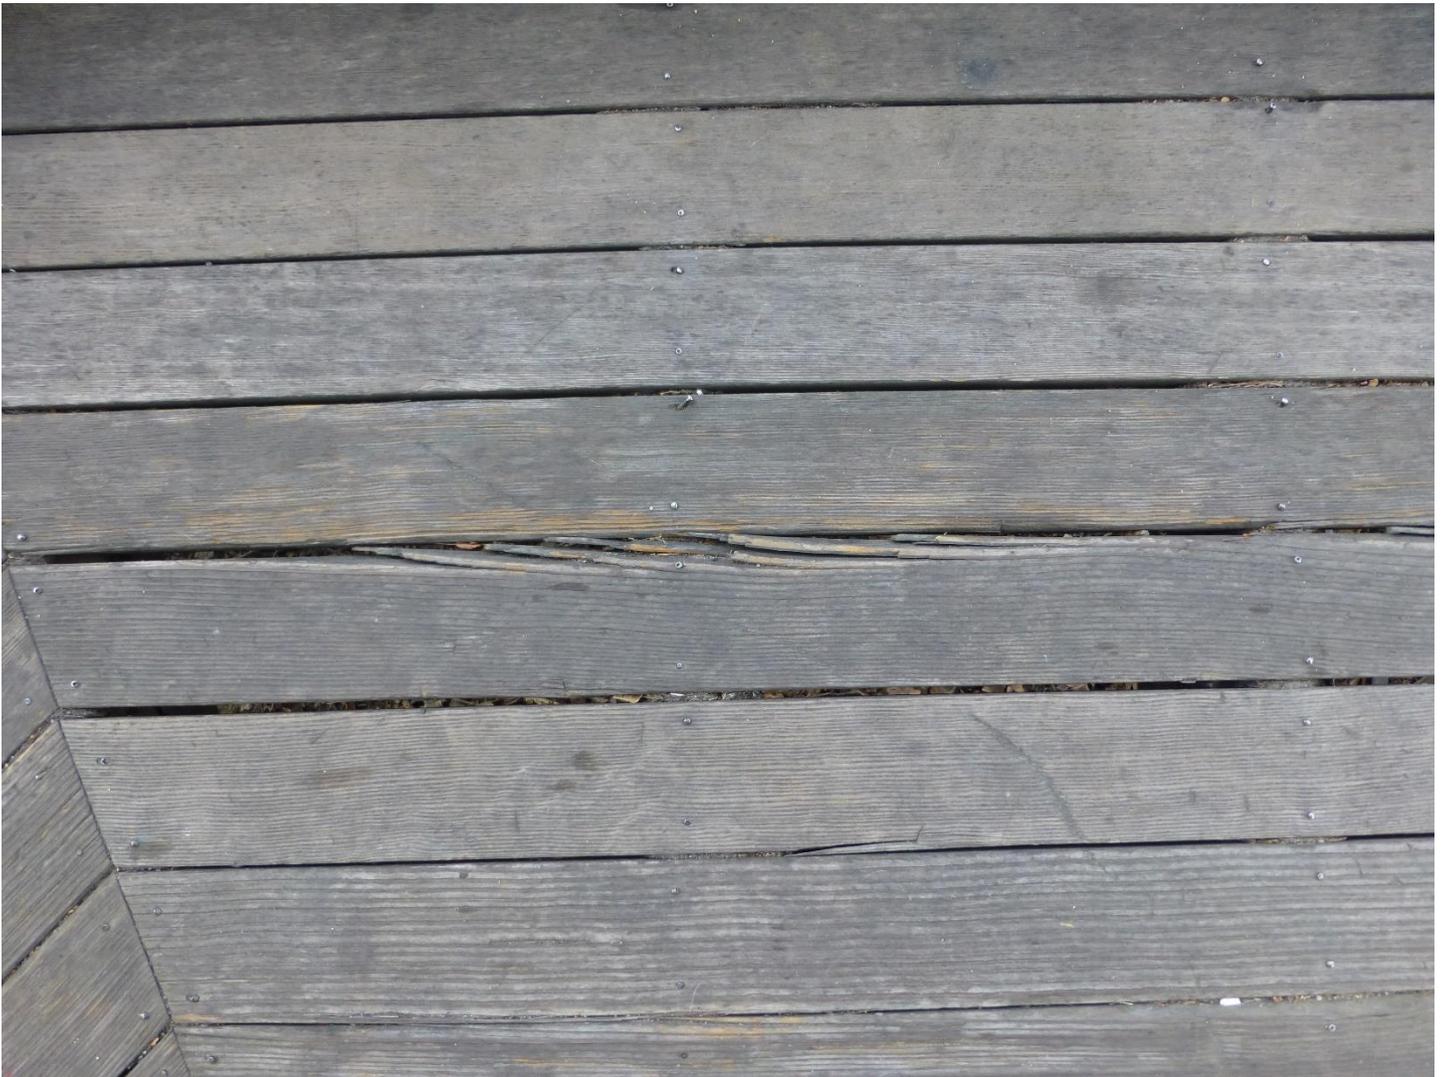
Good idea to inspect the floor thoroughly and replace any damaged material. Also, being that it is square edge stock (though tedious) it is a good idea to clean out any debris in the crevasses. Once completed, it is important to check for any decay in the floor joists below, this is typically where it begins.

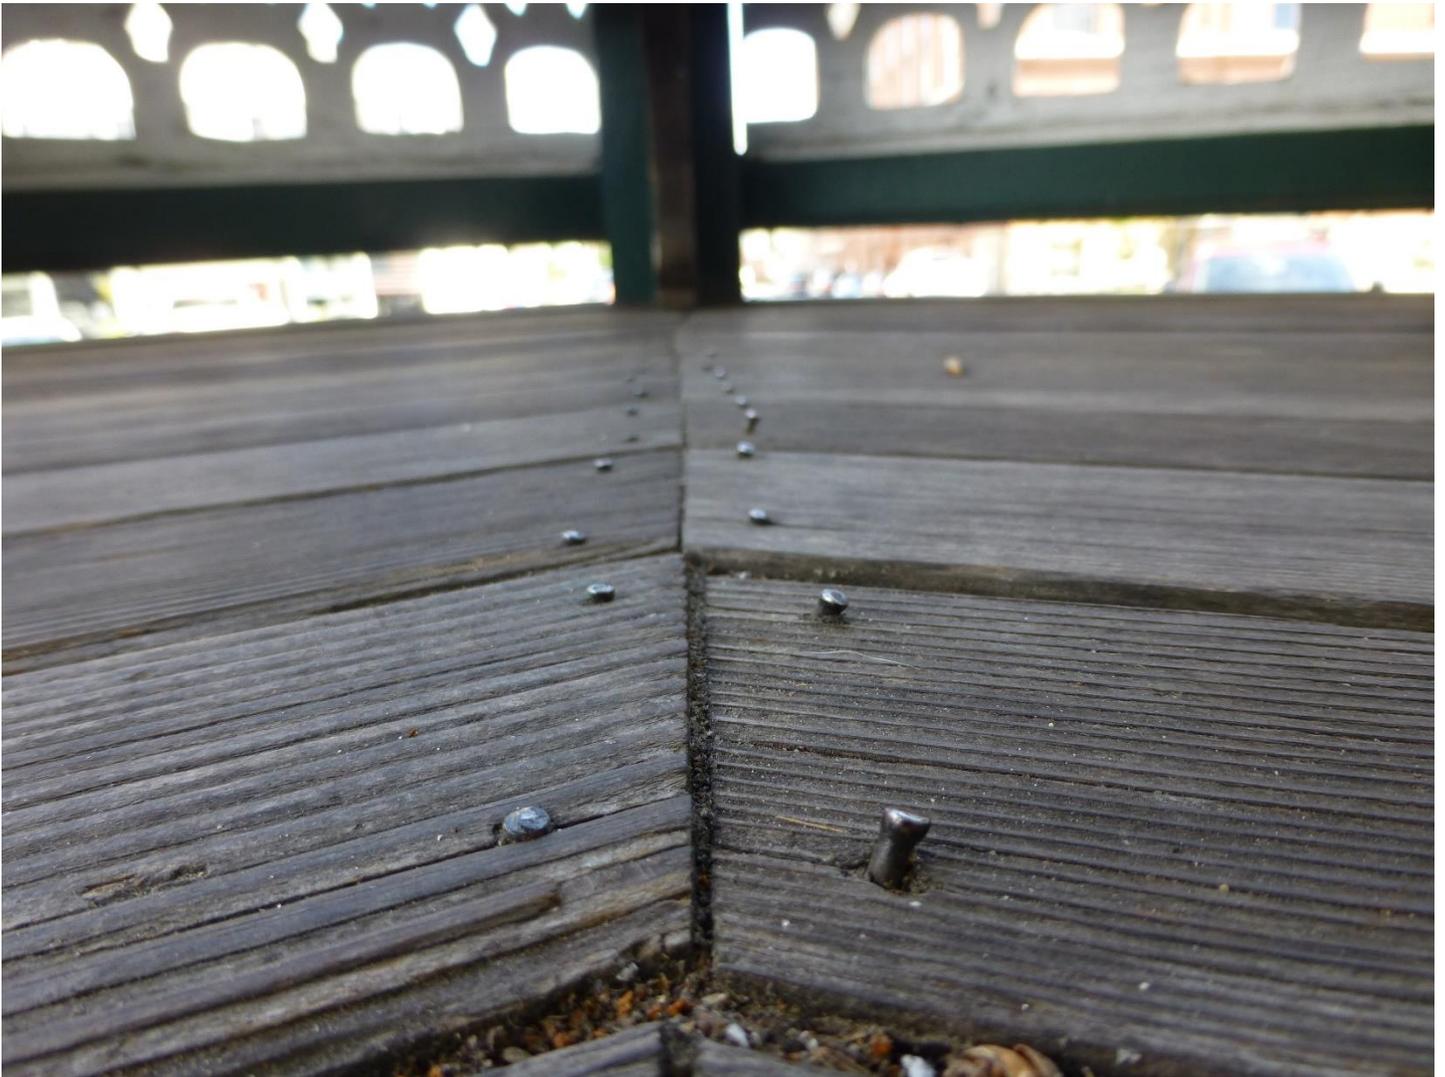
One thing that was quite obvious is that many of the nails have popped up, these should all be re-set below the surface

The existing floor seems to be in fairly good shape excepting a few damaged floor boards and protruding nail heads. I am hopeful that the nail heads can simply be re-set below the surface, if this is not possible, one can try removing the nails and re-fastening the floor boards with a small headed ring shank nail utilizing the same nail hole. All damaged flooring should be removed and replaced with matching CVG Douglas Fir. In addition, new CVG Douglas Fir perimeter boards (wider stock with a nosing profile) should be installed (once work progress permits) around the outside edge of the bandstand with a 1" overhang past the new skirt board and a 3/4" x 5/8" scotia molding installed underneath. I would then recommend that the floor be sanded and coated with either 3 coats of spar varnish or painted with 3 coats of a high-quality oil-based floor enamel. Another approach is to apply a form of deck stain which does not afford as much protection, however prep and re-coat is a bit easier. All the above applications must be maintained on a regular basis.

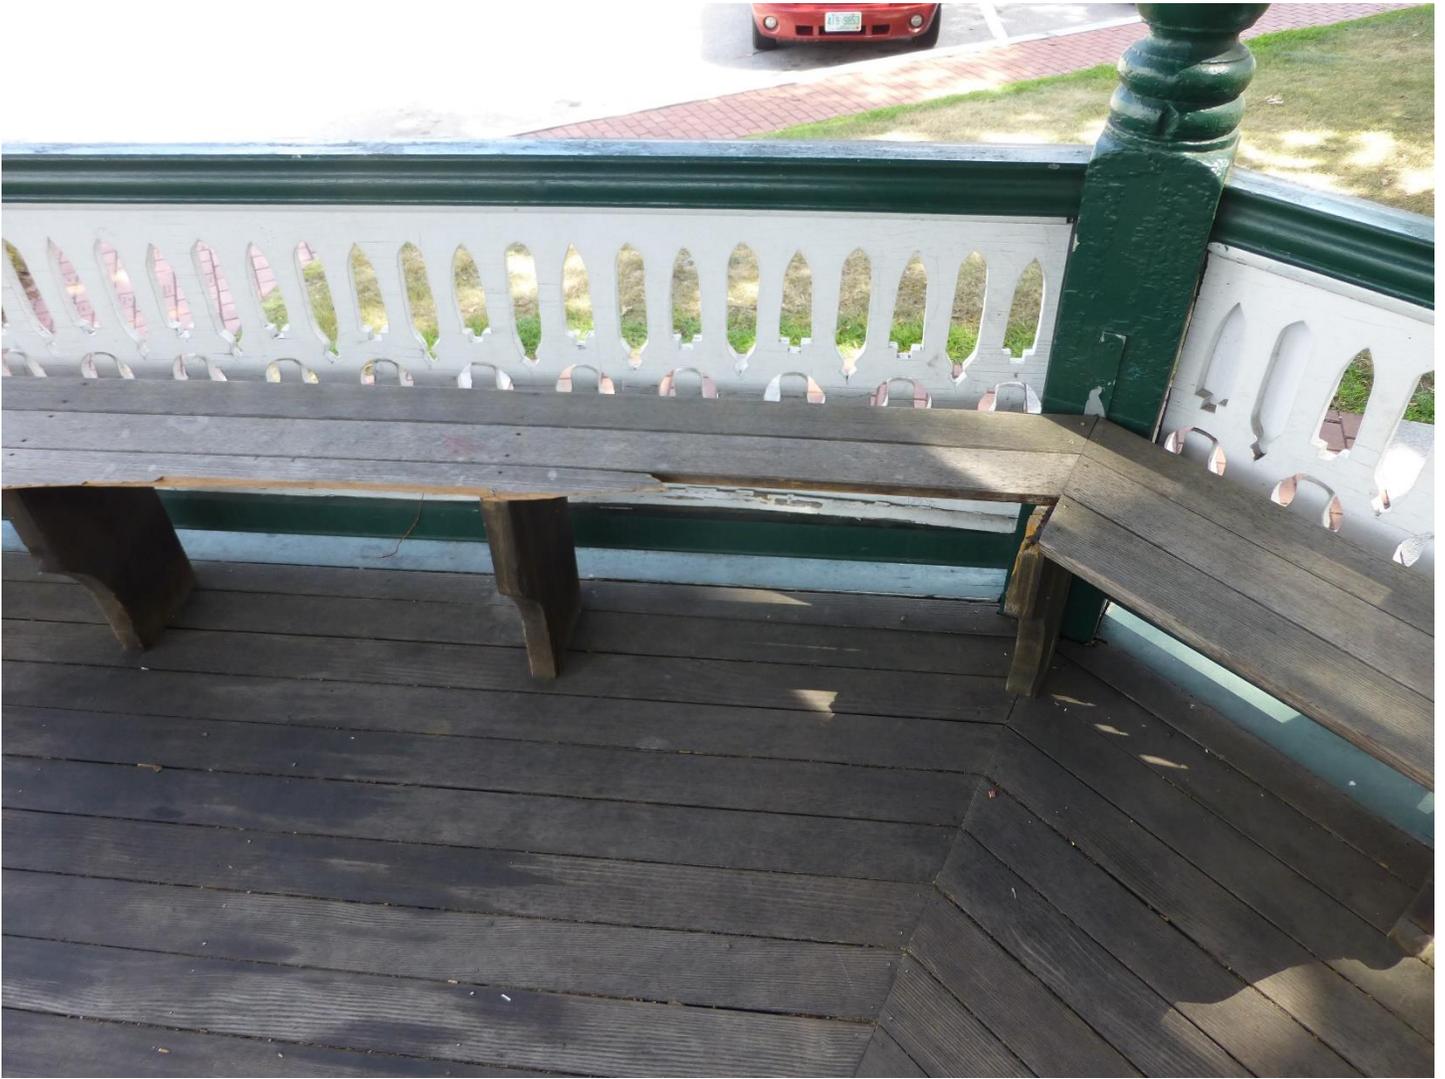
I believe this is the only damaged bench, fairly simple fix.

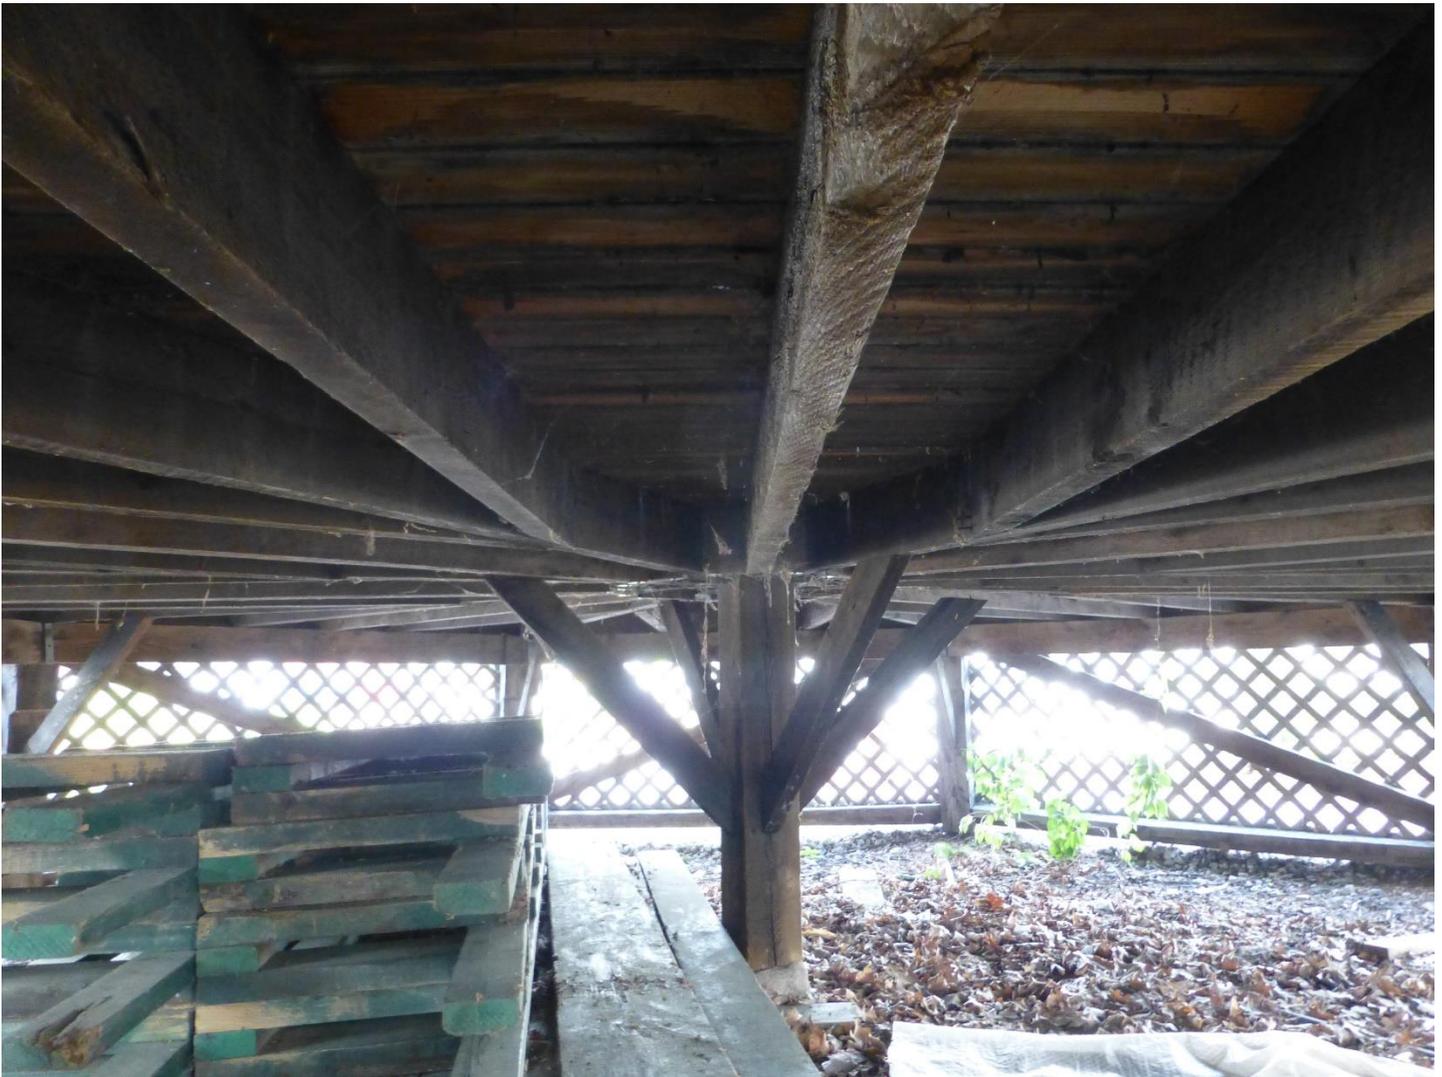
A general view of the floor framing, my best guess is that the floor system was rebuilt in the 1950s-1960s. It is comprised of what appears to be rough circular sawn Hemlock and from what is visible the inner framing and joists appear to be in very good condition.

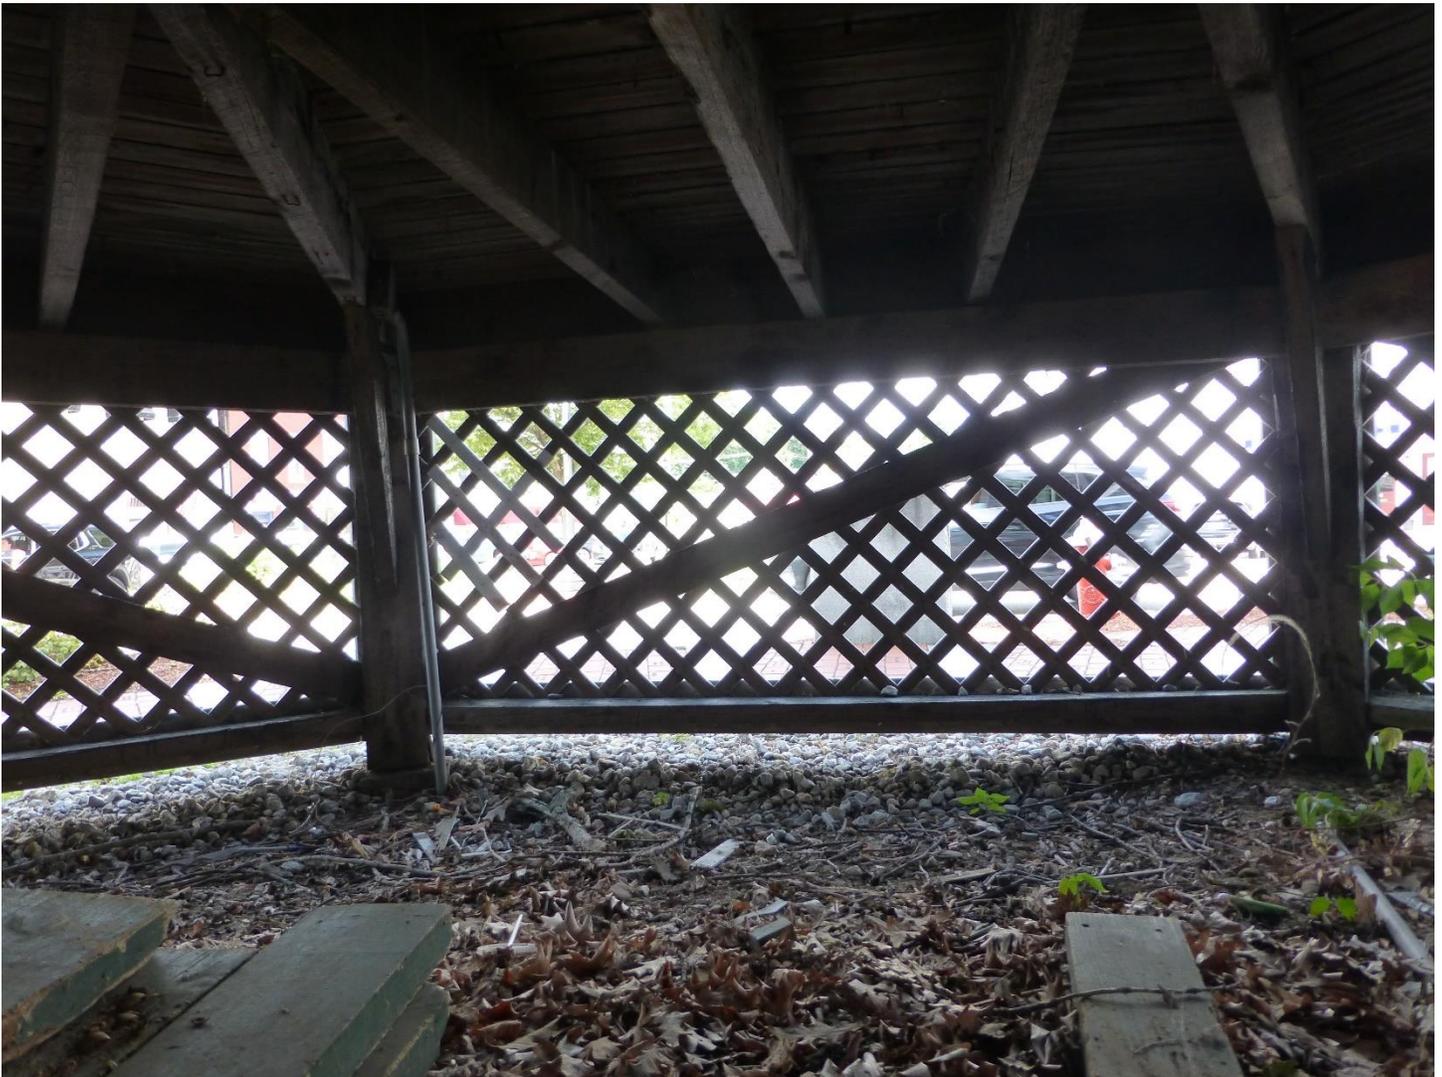
All lower framing appears to be sound, however, no doubt one could find the beginnings of decay where any framing member is in contact with the ground and where the post bottoms contact the granite piers. Any framing decay found during the repair process should be replaced or repaired, post bottoms should be checked for decay and I would recommend treating all with consolidate if any decay is found. This can help eliminate any future moisture wicking issues via the post bottom end grain.

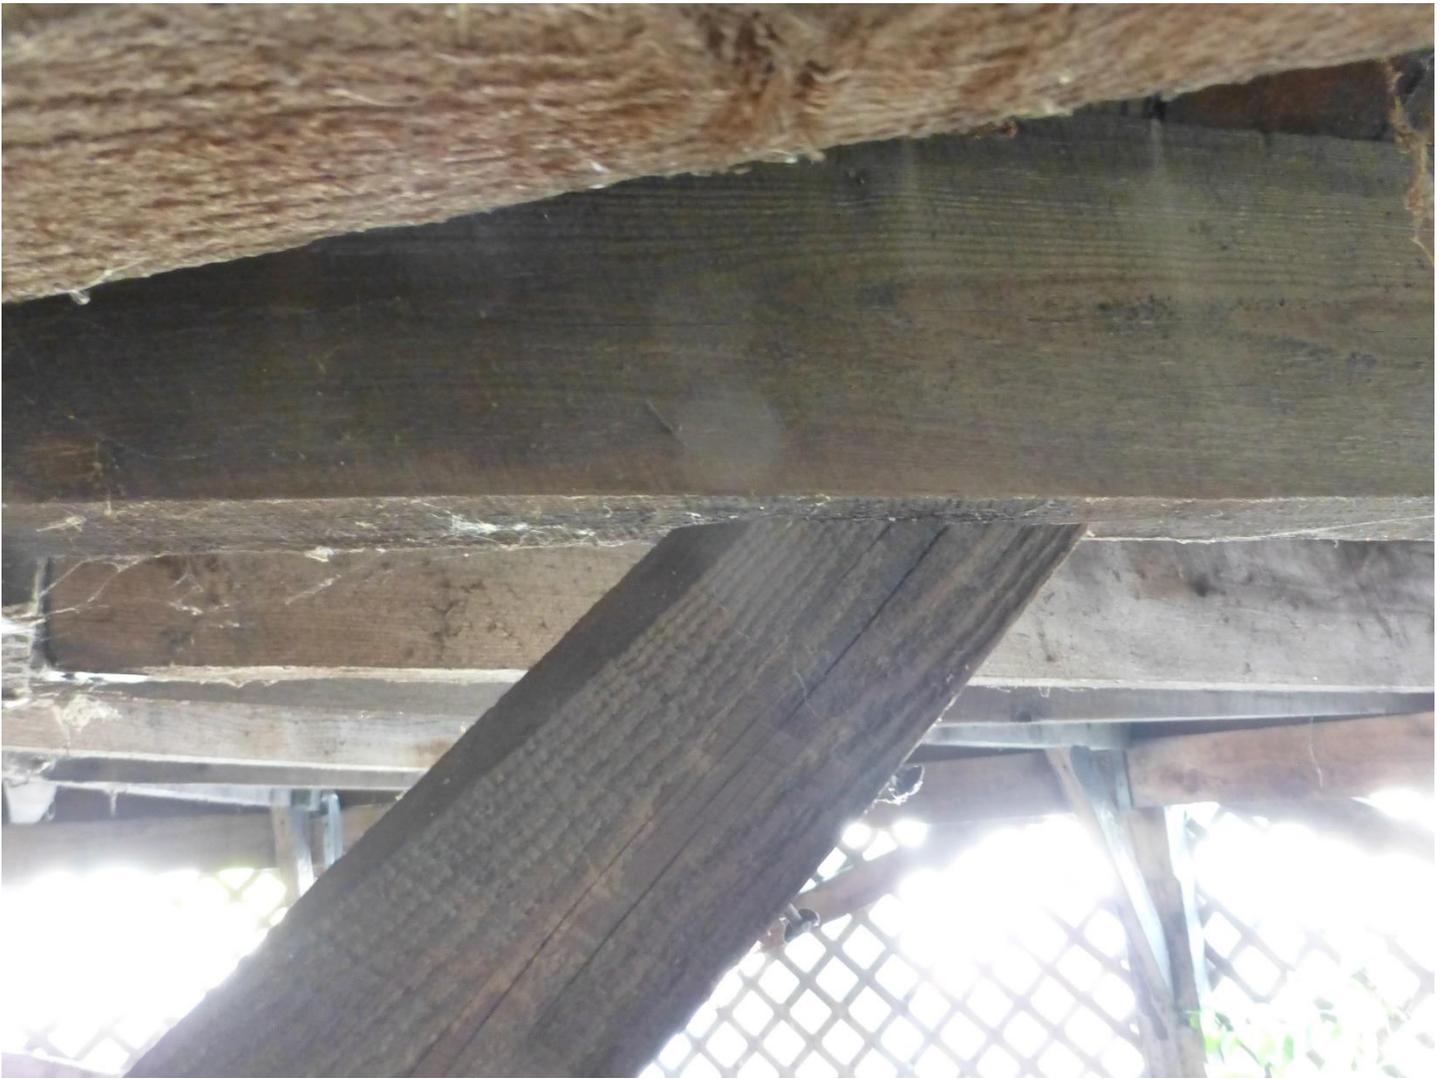
Although the framing material does appear to be in very good shape, I did notice some fasteners failing. All connections should be inspected, best practice would be to re-nail (pre-drill & hand nail) all connections with galvanized common nails, while structural screws such as GRK work well, nails are more in keeping with the history and integrity of the bandstand.
