IRONWOOD RESTORATION, LLC

The Pillsbury Bandstand

August 20, 2022

Within the following pages of this brief report, I have done my best to document and encompass the existing conditions of the Milford, NH bandstand in hopes that it will encourage and allow for the future restoration and preservation of this unique historic structure.

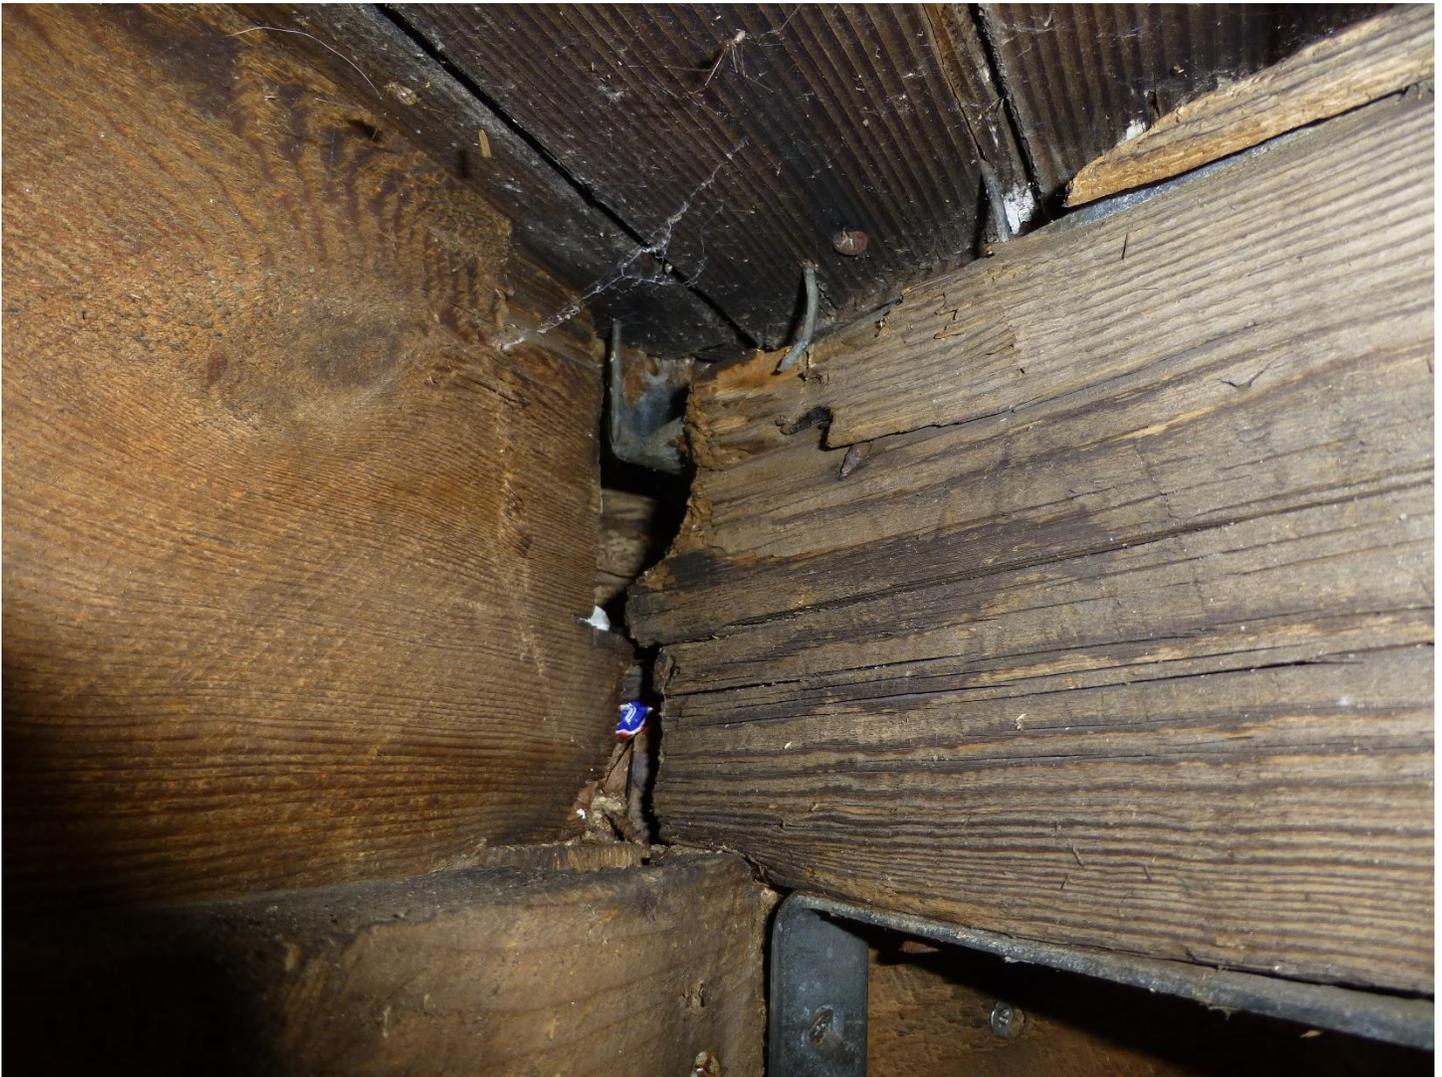
As is typical, most of the problematic areas of decay reside below the bandstand posts. Here we have a view of the inside sill corner and floor joist intersection. In this particular corner, it appears that there is substantial decay to the sill corner and one can see that the joist tenon has completely rotted away. It is possible to repaired the decayed joist end with epoxy and fiberglass rods. Any replacement material should match the existing species, dimensions and texture, hence floor framing would be rough sawn Hemlock matching same dimensions as existing frame and should be dry.

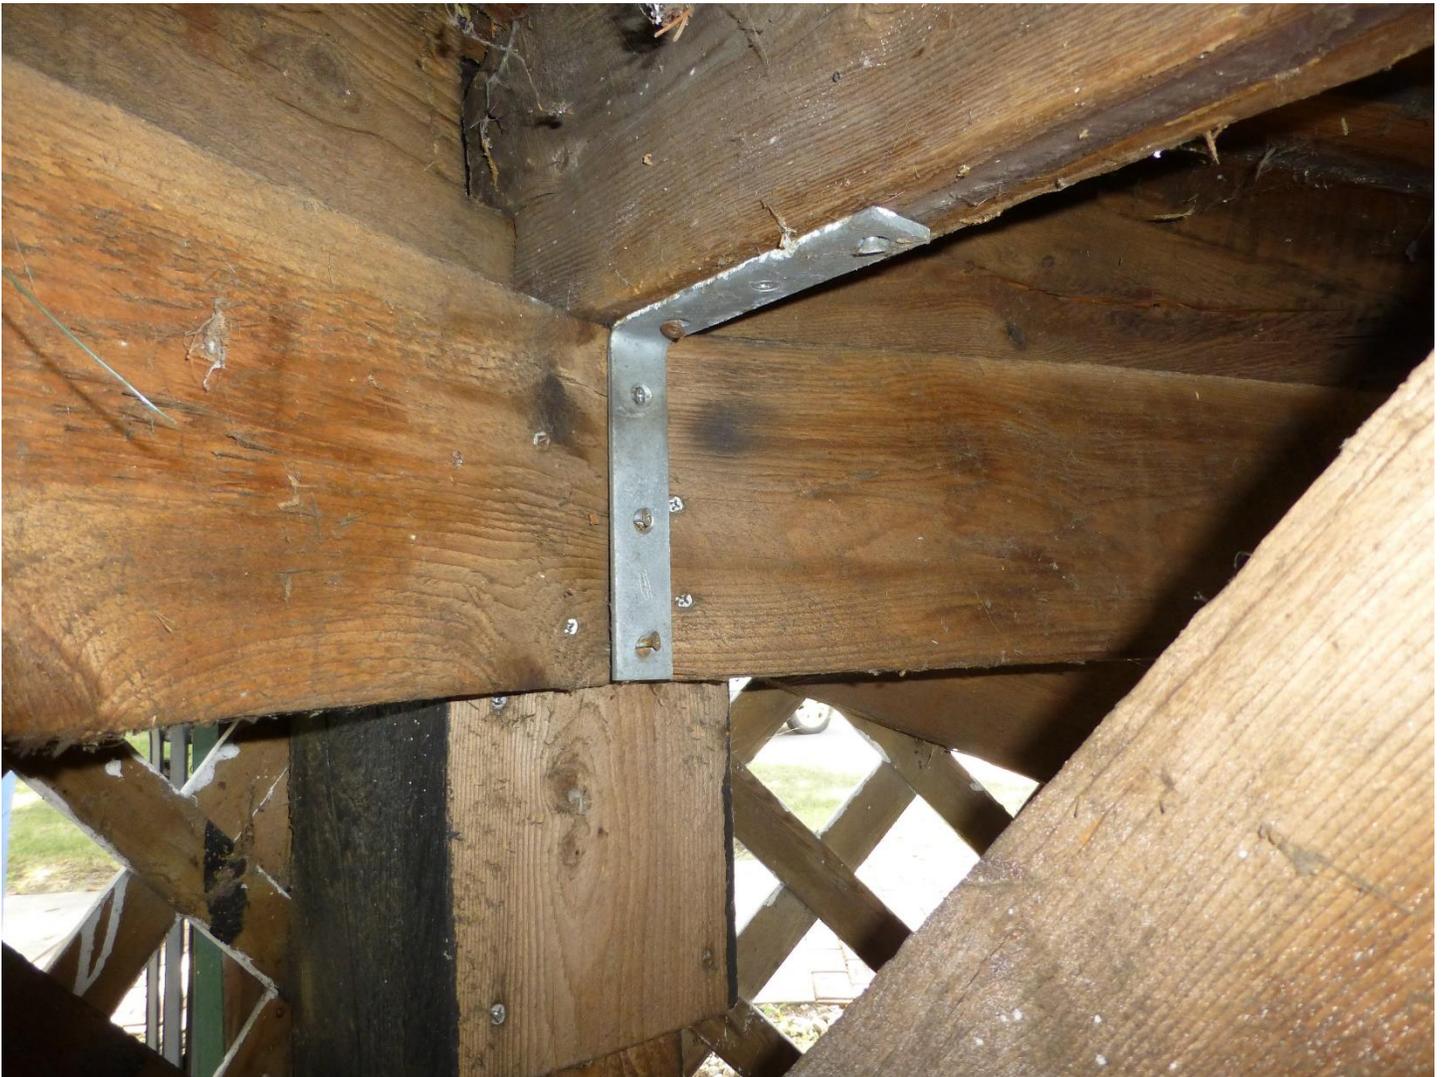
The ledger board and L-brackets have been added to help compensate for areas of the structure that are failing. This can all be removed once repairs are complete.

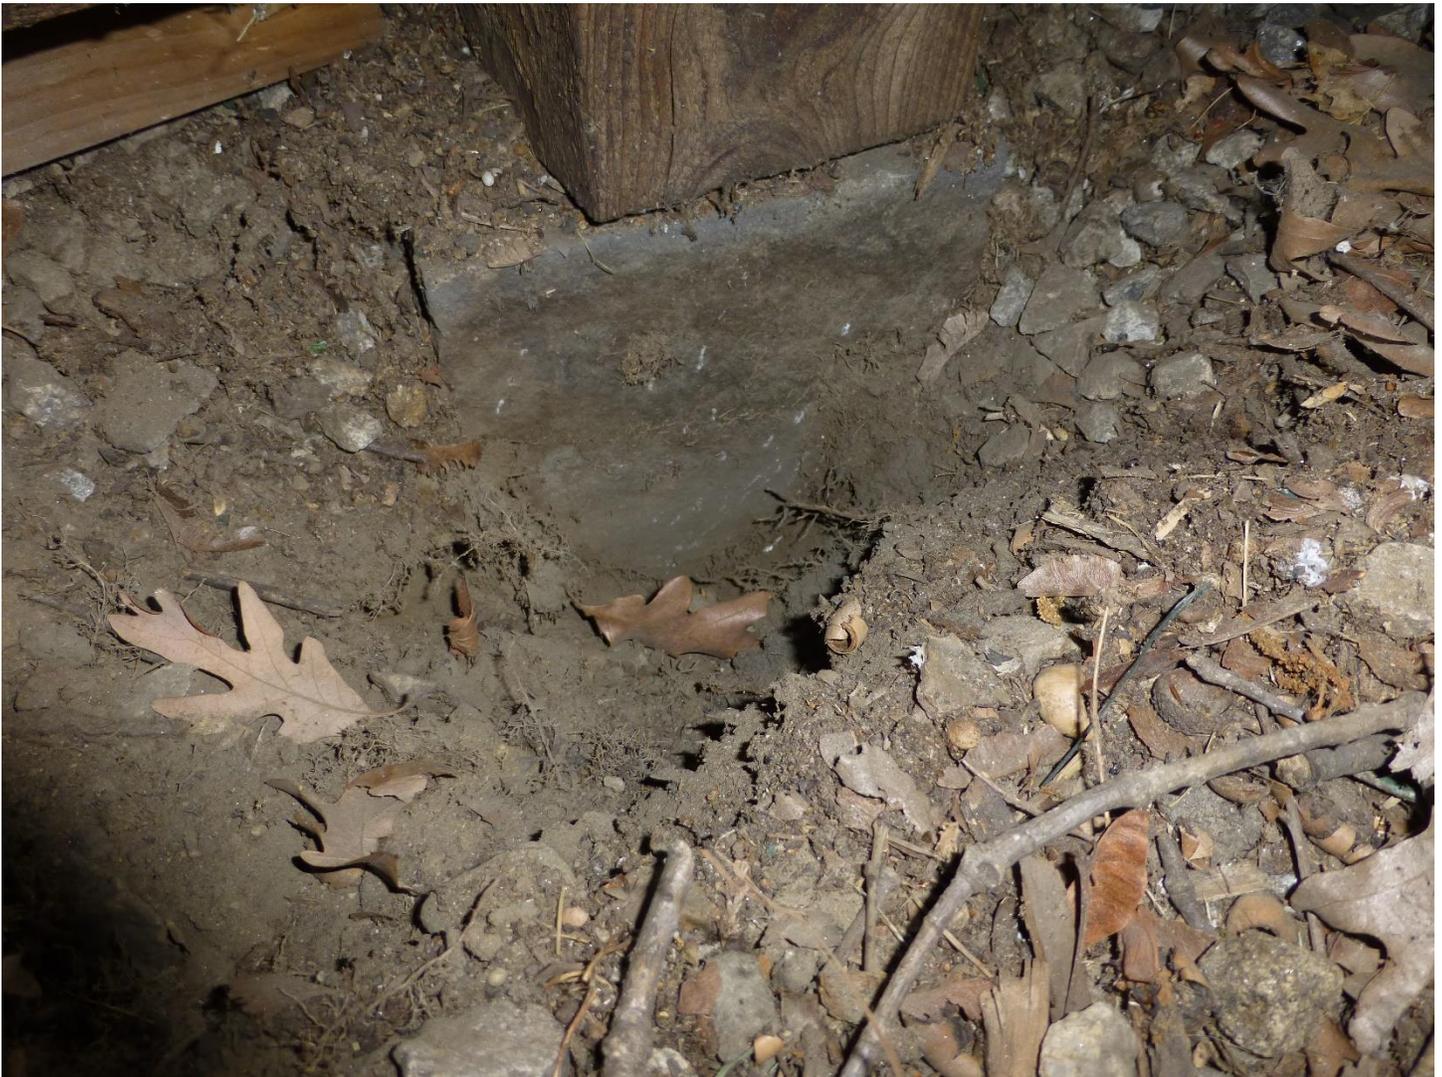
The original granite piers appear to be sound; I don't see any need for a new foundation with regards to any current structural issue. If a firmer storage area is wanted it would be possible to excavate the necessary material, fill the excavated area with 8 inches of 1 inch stone and top with hard pack, this would produce a firm usable surface while still maintaining excellent drainage and most importantly preserving the original foundation stones.

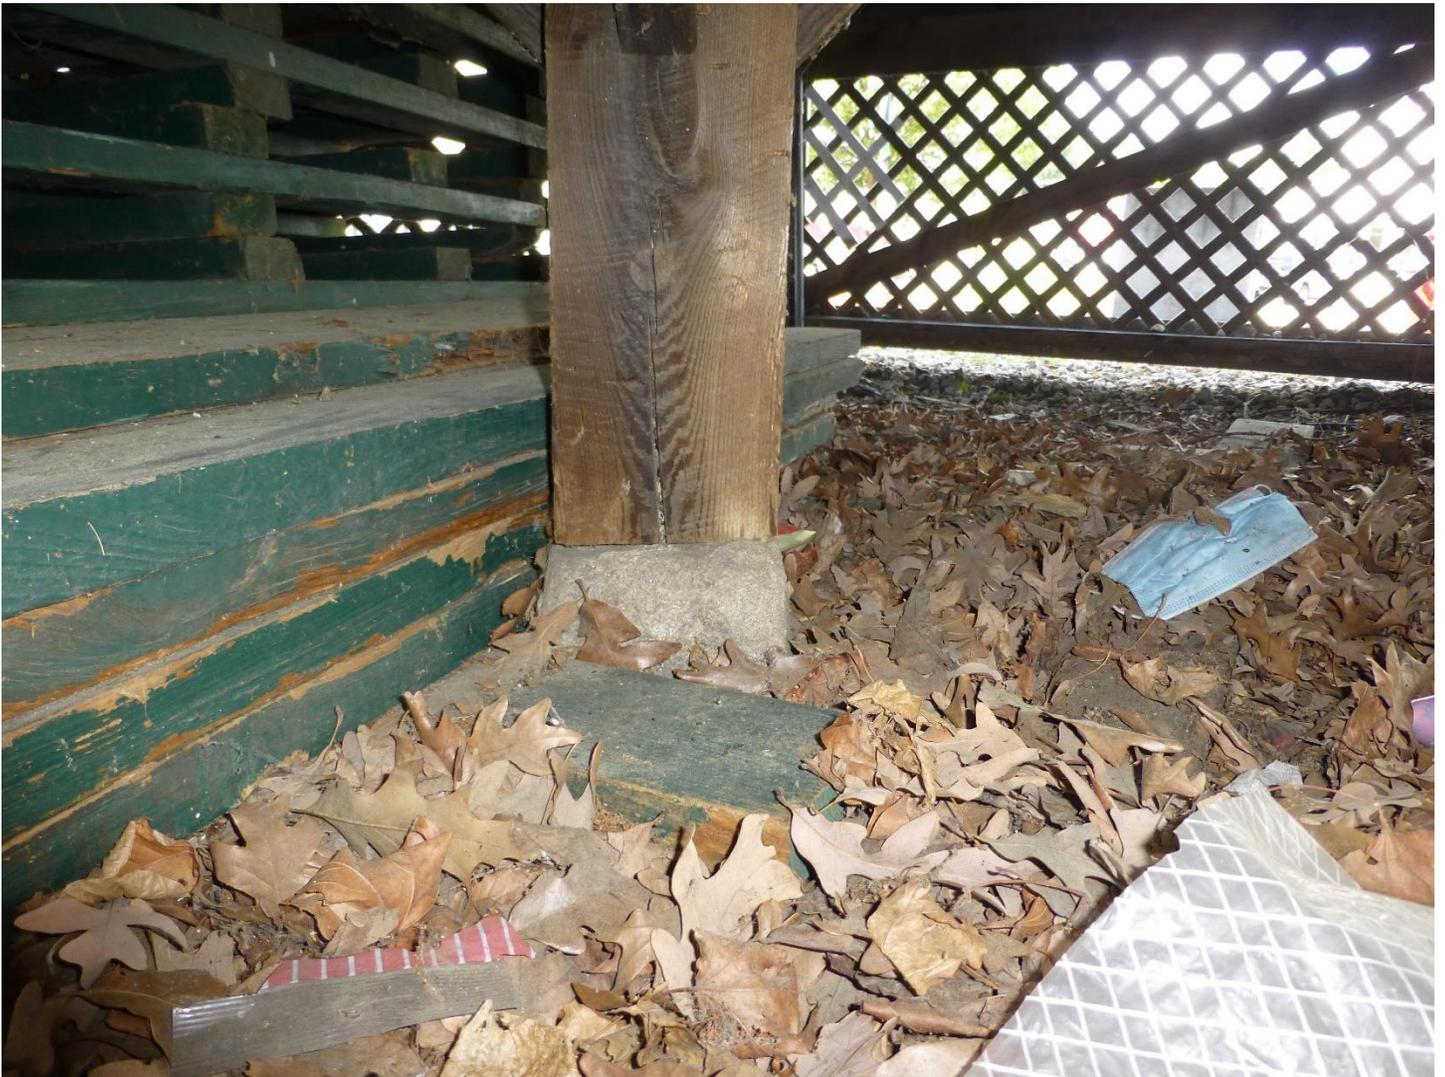
Center post and foundation stone, both appear to be in excellent condition.
