IRONWOOD RESTORATION, LLC

The Pillsbury Bandstand

August 20, 2022

Within the following pages of this brief report, I have done my best to document and encompass the existing conditions of the Milford, NH bandstand in hopes that it will encourage and allow for the future restoration and preservation of this unique historic structure.

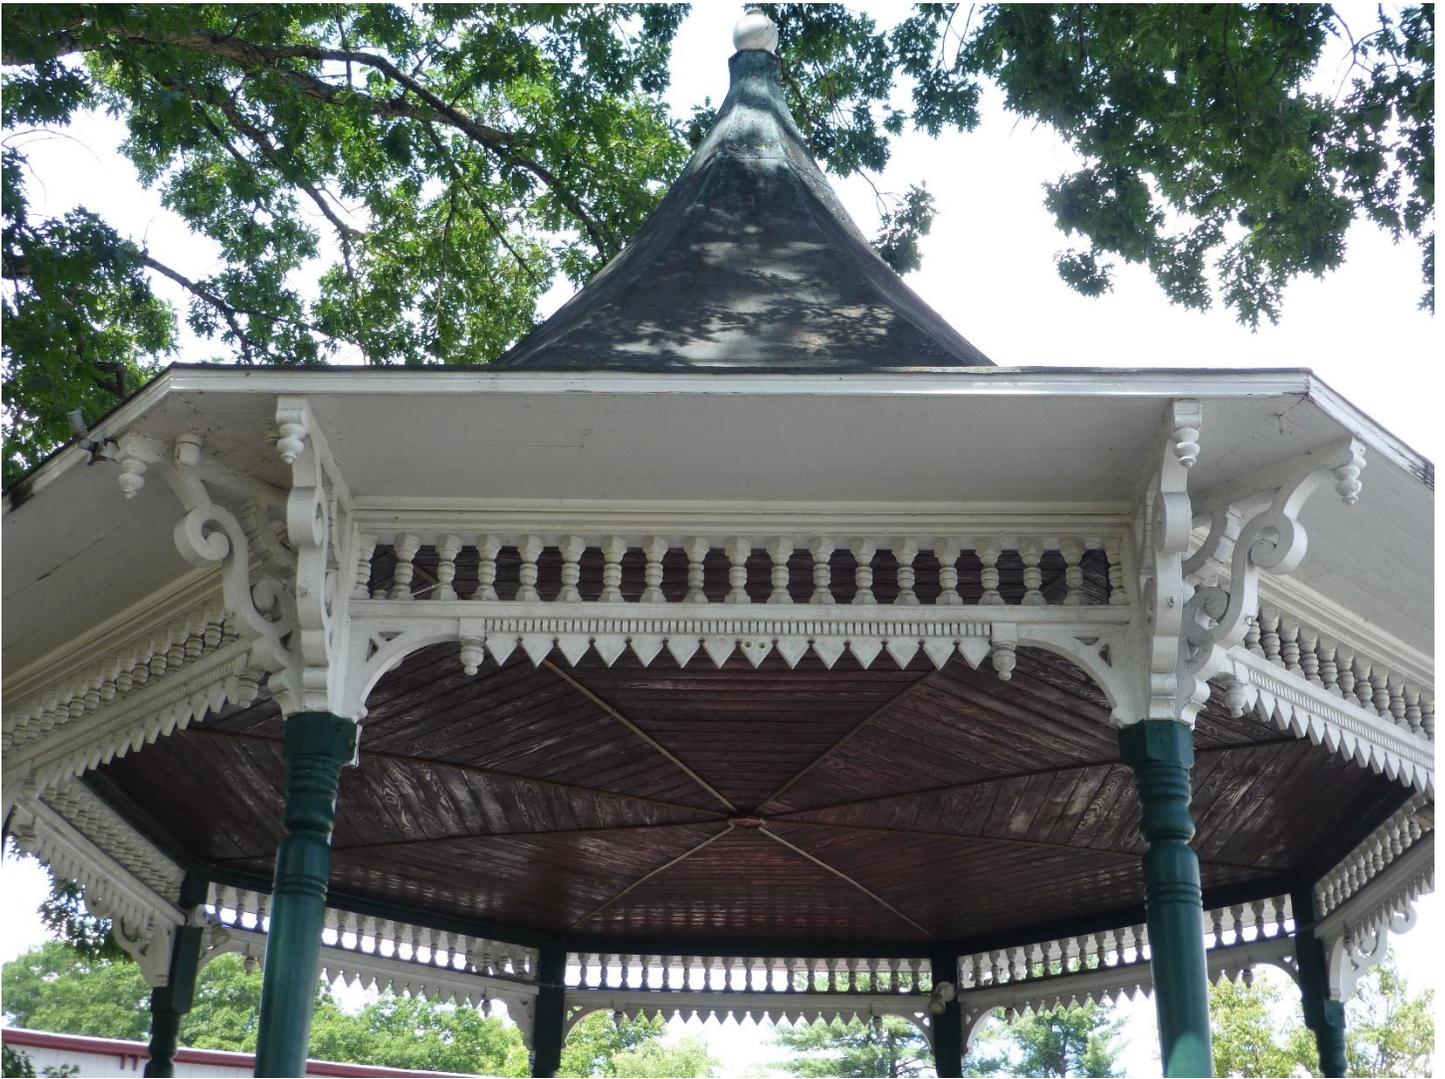
The spindle work is well balanced with the triangular motifs hinting at Eastlake style and the decorative bracketing tying the inverted posts to the upper structure.

While somewhat difficult to see in this photo, the ceiling is inverted, sloping down toward the center. I have found this to be evident with several bandstands in NH with the thought that this provides acoustical enhancement by splaying the sound down and outwards.

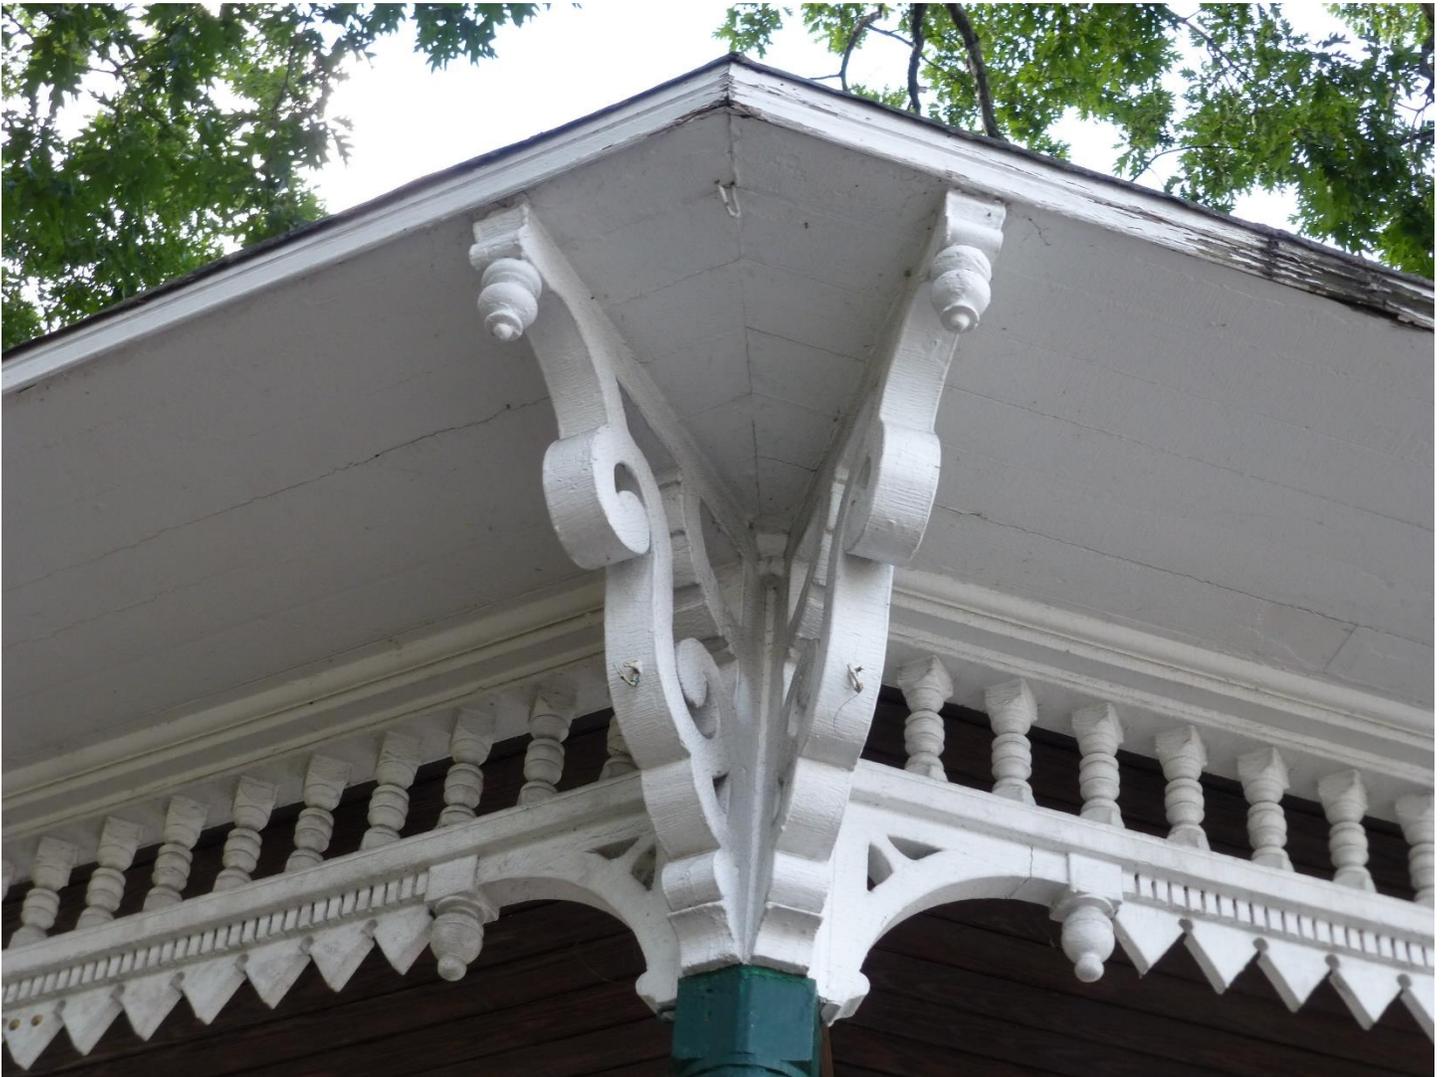
Where everything comes together on the outside corners, well balanced and pleasing to the eye!

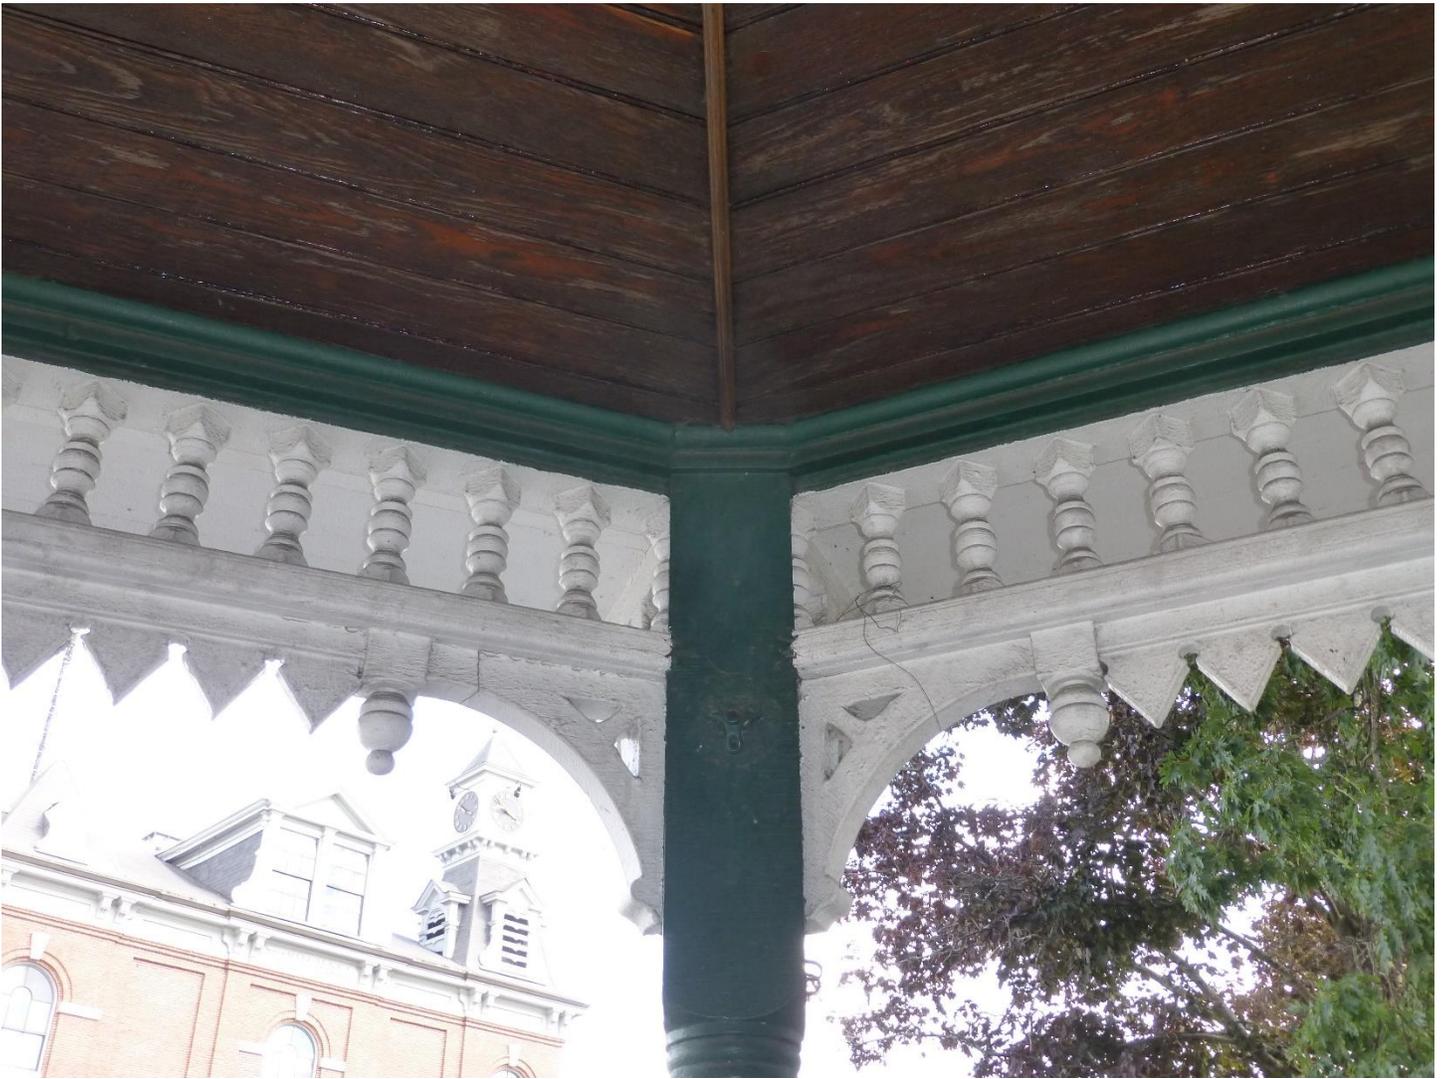
Again, inside corners with well executed workmanship, everything looks like it belongs there.

Another thing to note here is the edge bead (top edge) on the bottom rail of the spindle work, this does seem to correlate with the beading present on the bandstand railings. This gives hope that the existing railings (which appear to be replacements) might match the original profiles.

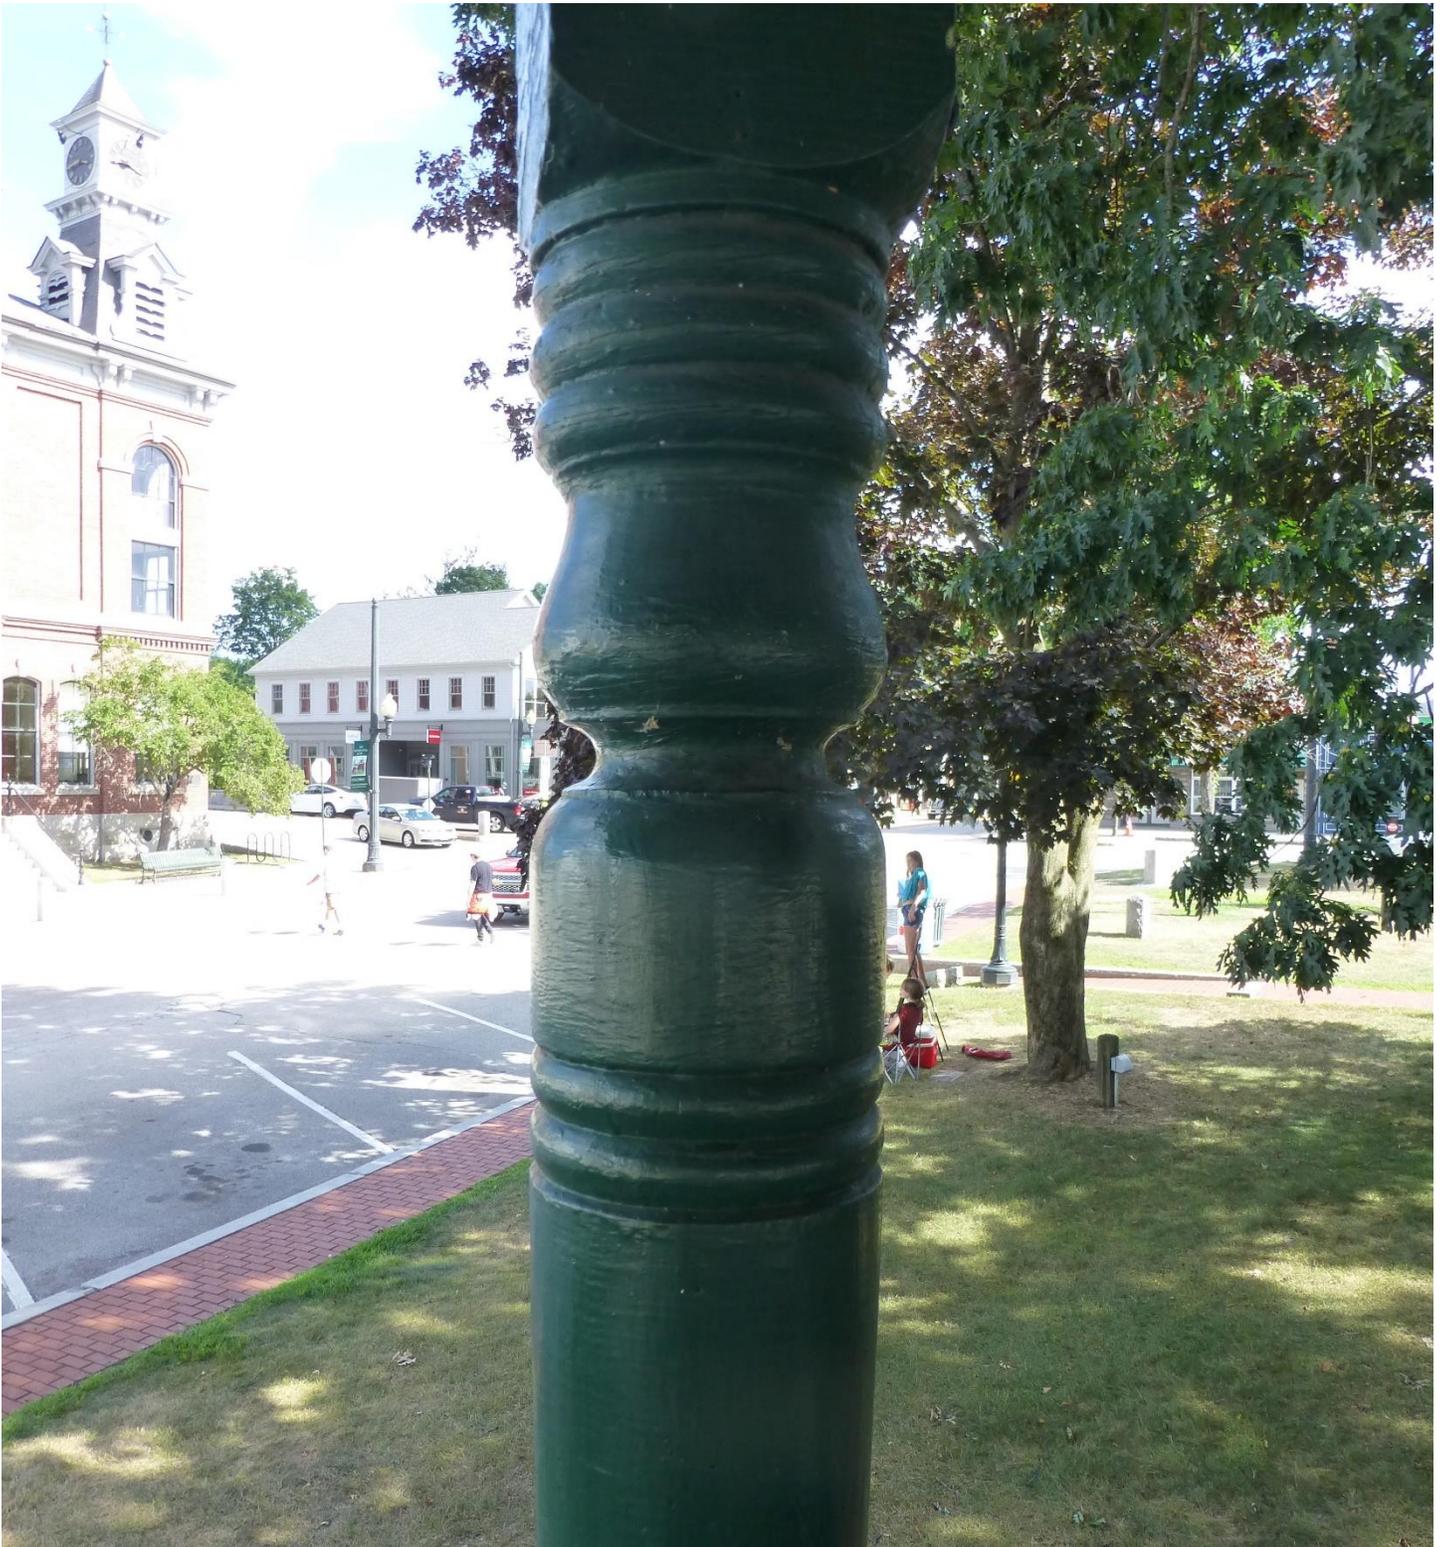
Well balanced turned details on the inverted posts, tying the upper cornice to the floor assembly.

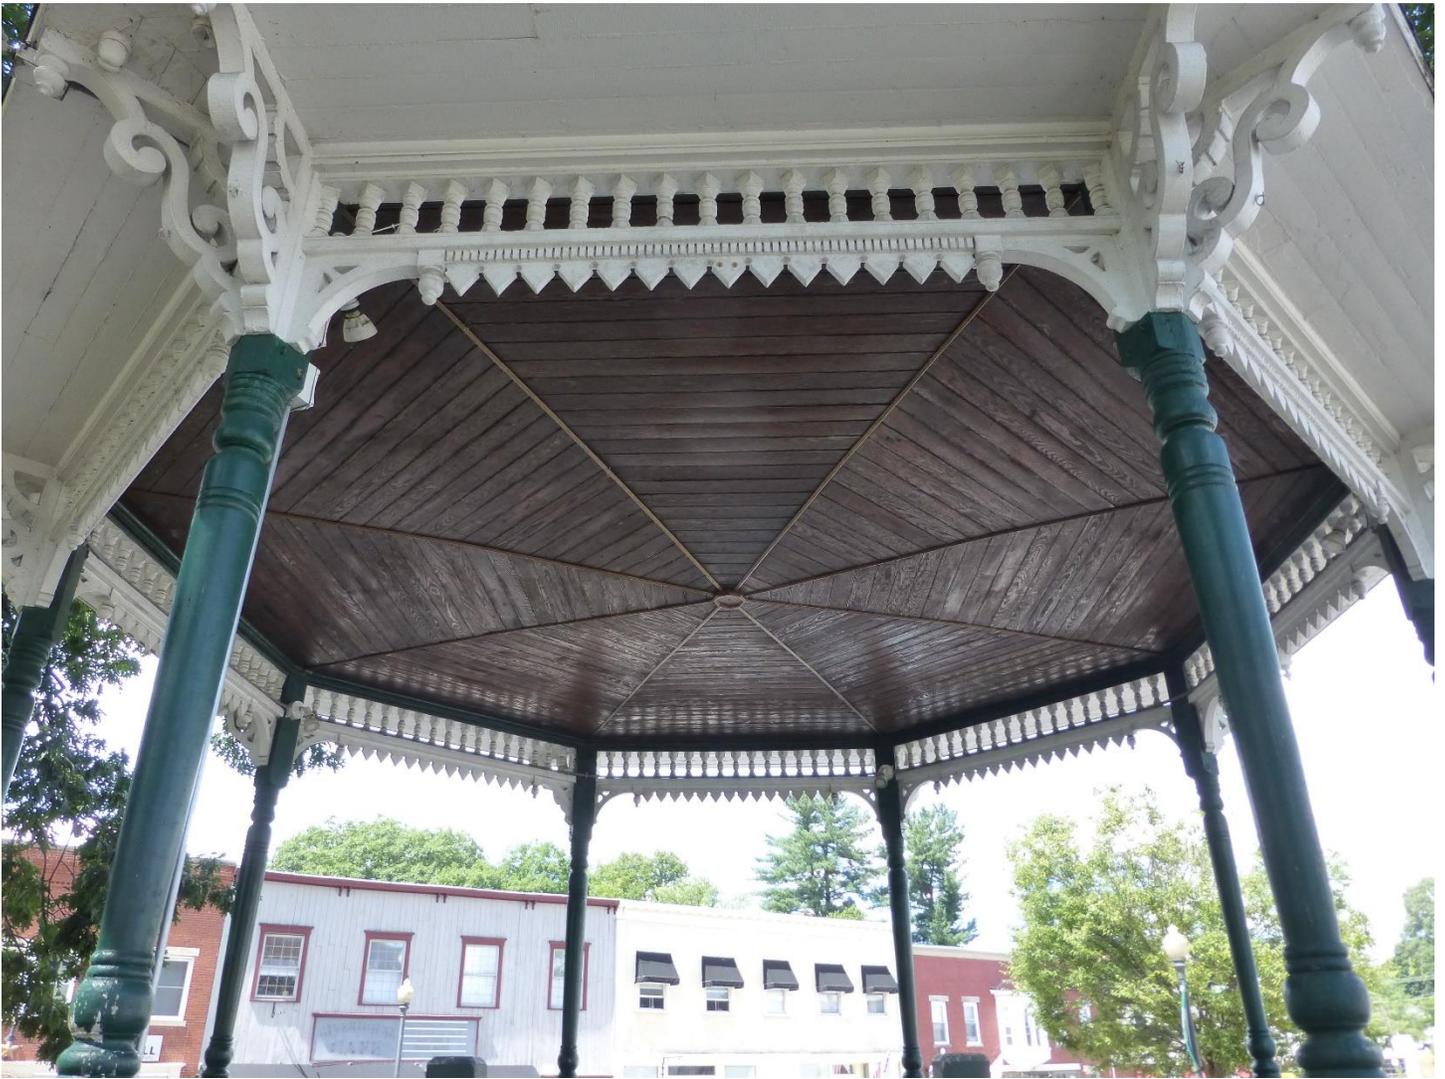
Perhaps this photo better displays the inverted ceiling fairly common on bandstands for acoustical enhancement.

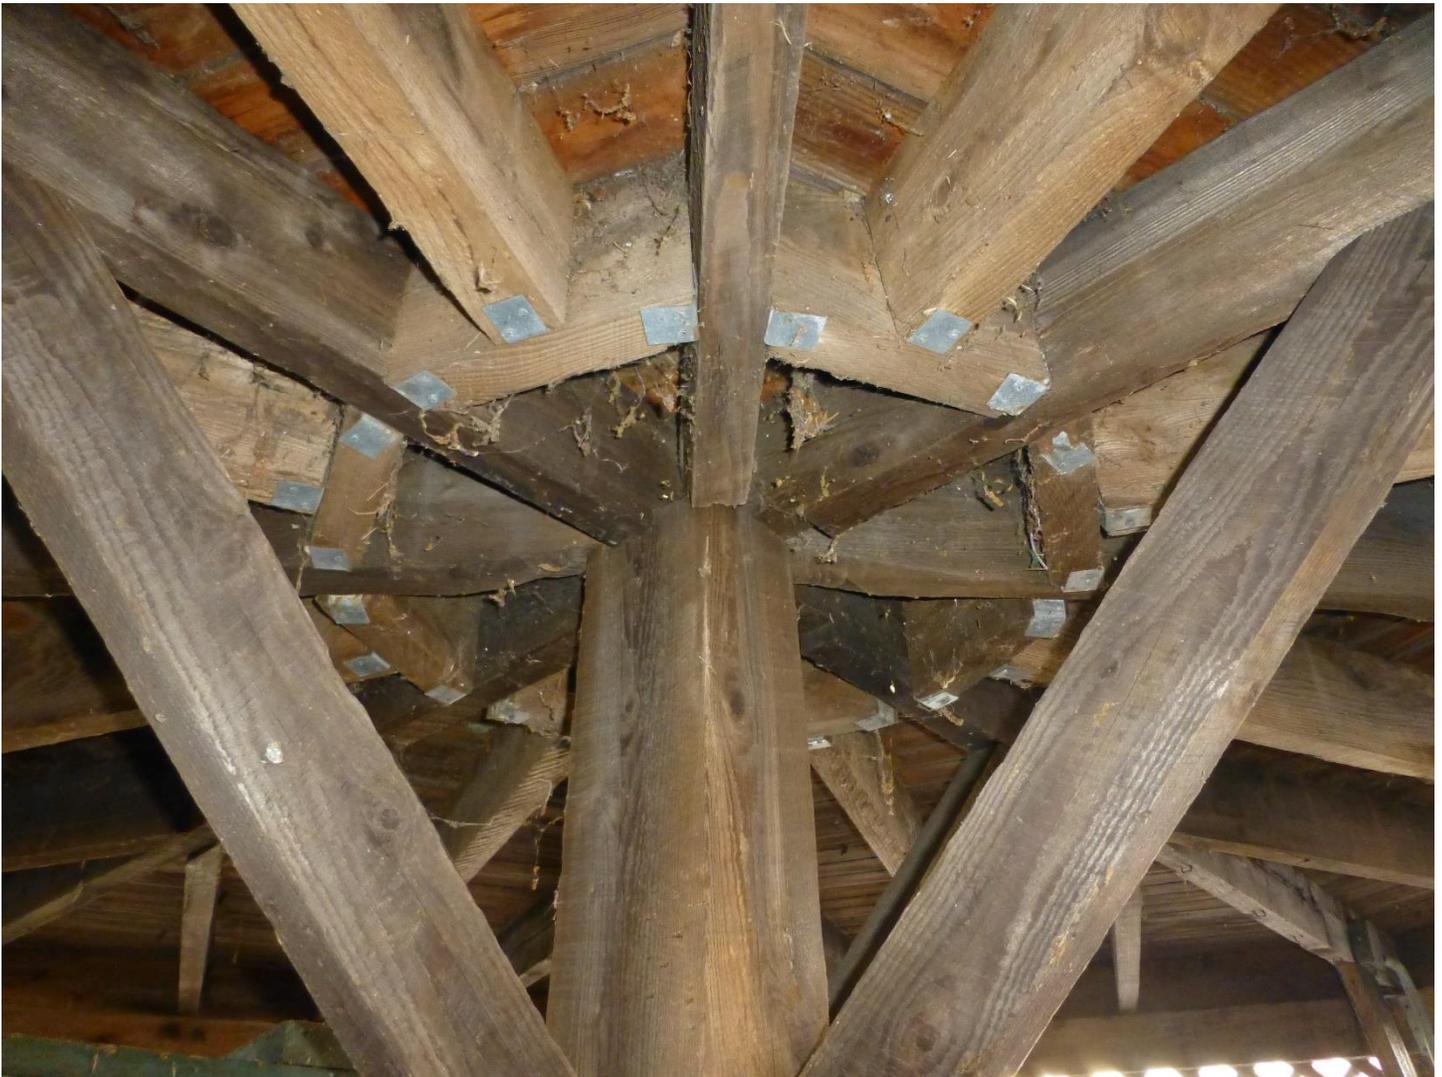
Here is where it all comes together at the center post. To help tie the center hub and floor joists together they utilized small metal hangers, this along with the look of the sawn lumber helps with the dating of framing. The hangers and nails appear to be galvanized and look to be holding up quite well.

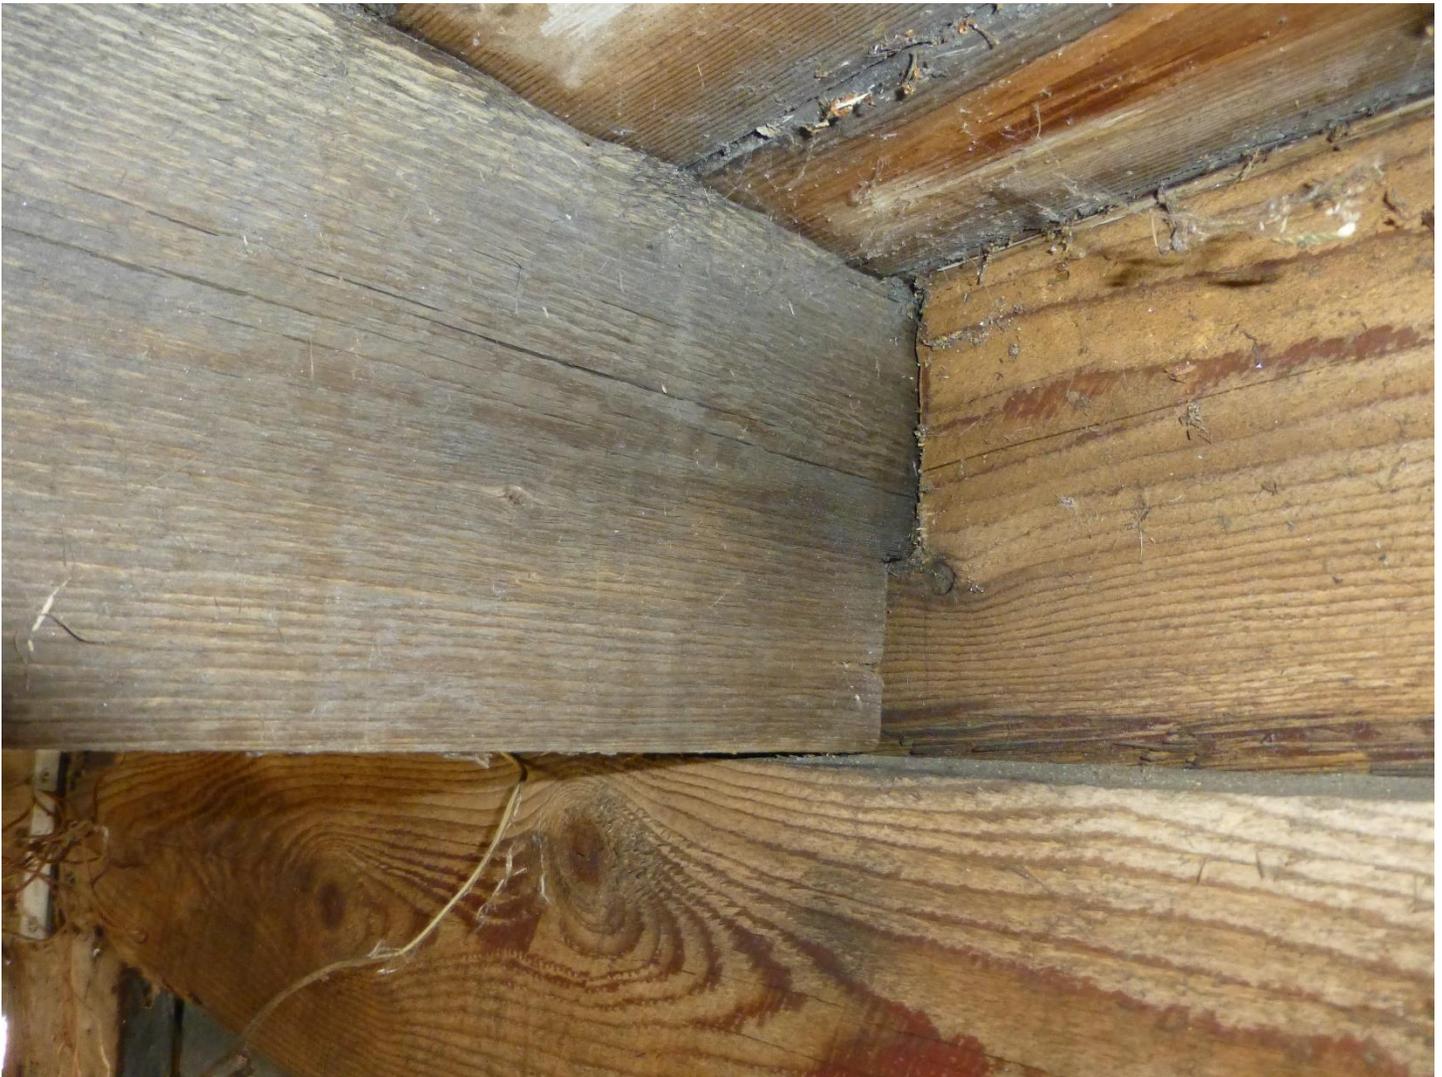
Typical joist mortise and tenoned into the 6" x 6" perimeter sill. The 2" x 6" ledger board you see under the floor joist appears to have been added later.
